**FEMA Levee Certification
Ventura County, California**

**Arroyo Santa Rosa Floodwall (ASR-2)
At East Las Posas Road**

Evaluation Report
February 13, 2009

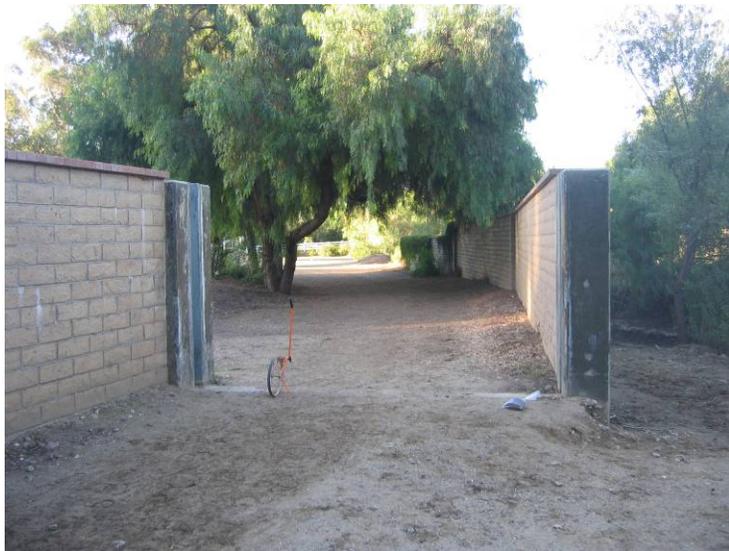
Arroyo Santa Rosa Floodwall, at E Las Posas Road (Photo No. P1) – 12' wide, 7' high opening for 18-beam stop log system

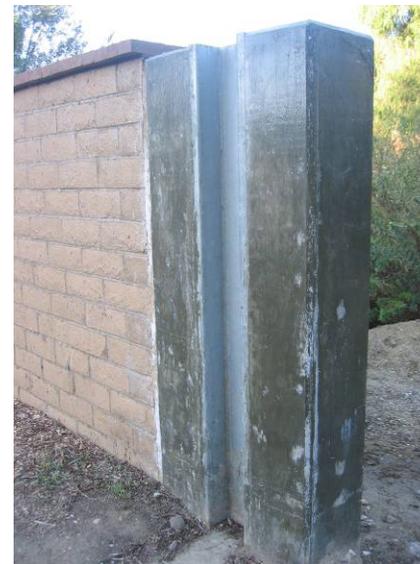
Arroyo Santa Rosa Floodwall, at E Las Posas Road (Photo No. P3) – A typical 7' high slot for stop log beams

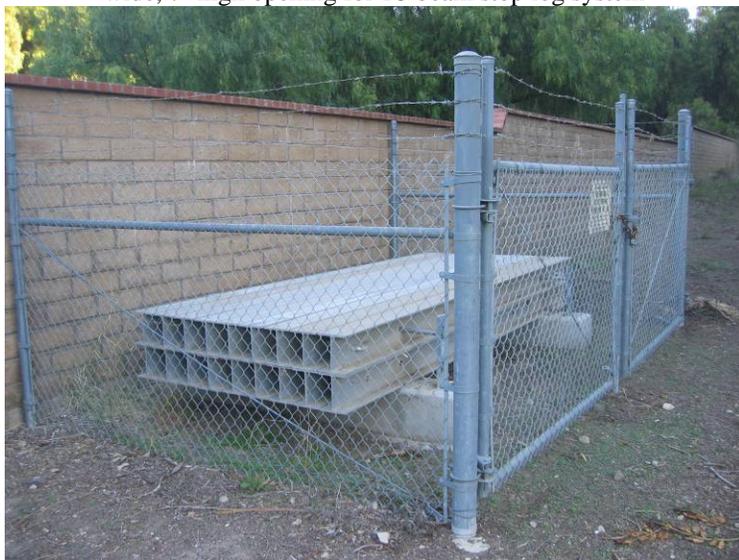
Arroyo Santa Rosa Floodwall, at E Las Posas Road (Photo No. P2) – A stock pile of 18 aluminum stop log beams locked inside chain link fence

B-5	per Sec. 2.16 USACE levee Owner Manual, Aluminum stop logs should be supported along entire length where stored.	Noted, this will be evaluated in the structural analysis.
		Appendix C, Photos of Maintenance Required Locations	M22R Photo Caption, revise borrow to read "burrow"	Change made.
	Joe Lampara	General Comment	Similar to AS-7, this levee system is identified as extending along Arroyo Simi from f ^l . Street to Erringer Road. In actuality this reach is a combination of a series of levees, including a floodwall located immediately upstream of f ^l Street, and levees located in the immediately vicinity of the channel drop structures, and along one reach of low land at the upstream end adjacent to the channel. Between these locations there are reaches of incised channel which do not meet the definition of a levee or levee system.	Determination of the levee situation on certain lengths of the levee system will require a hydraulic analysis. This analysis will be performed during the next phase of work.

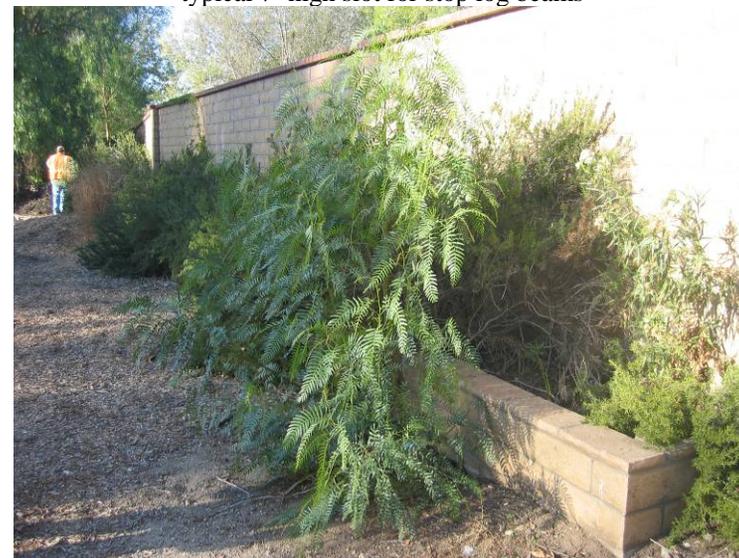
Arroyo Santa Rosa Floodwall, at E Las Posas Road (Photo No. F1) – Planter box behind floodwall with landscaping trees (Landward side)

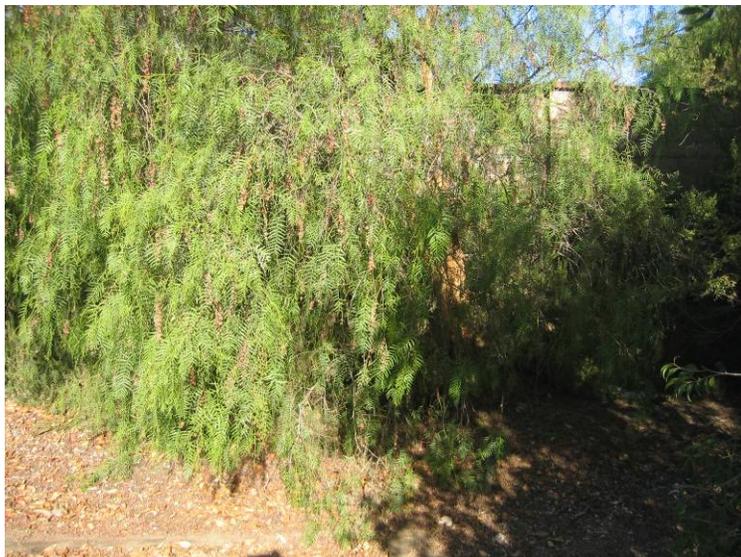
Arroyo Santa Rosa Floodwall (Photo No. M1) – Vegetation (a pepper tree) within 15' of floodwall face (Landward side).

GPS		*Photo No.	Description	Action Required
Lat	Long			
<i>Arroyo Santa Rosa Floodwall (ASR-2)</i>				
N34.24204	W118.89998	M1	Vegetation within 15' of floodwall face or 8' from foundation (Landward side).	Remove all vegetation and root balls, fill voids with impervious material and firmly compact.
N34.24243 to N34.24207	W118.89968 to W118.90018	M2	The channel invert downstream of the stop log opening is experiencing erosion. (Riverward side).	Further engineering analysis recommended.
N34.24228	W118.89977	M3	Undercutting below the grade control structure's concrete apron (Riverward side).	Repair the grade control structure. This repair will likely require design and engineering to construct the grade control structure. Certified as-built drawings need to be prepared.
N34.24294	W118.89899	M4	Debris (e.g. dead trees) along the earthen channel (Riverward side).	Remove debris from the channel.

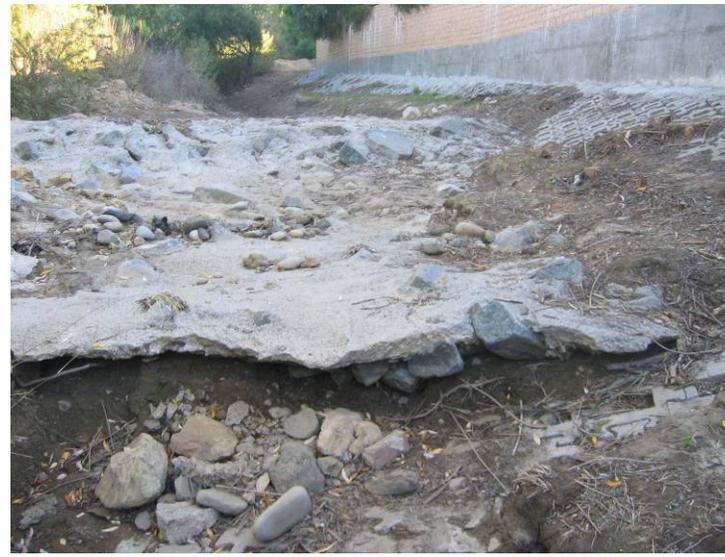
2. The downstream end of the concrete grade control structure is being undermined by undercutting of riprap due to active degradation downstream.
3. Multiple cracks were observed on both sides of pilasters for the floodwall in the lower section.

Arroyo Santa Rosa Floodwall (Photo No. M3) – Undercutting below the grade control structure's concrete apron (Riverward side).

M3	Undercutting below the grade control structure's concrete apron (Riverward side).	Repair the grade control structure. Further engineering analysis recommended.	C5 - Obtain direction from D&C, will Hydrology studies be required for this repair?.	E2	Depends on type of repair: new or in kind			This repair will likely require design and engineering to construct the grade control structure. Certified As-builts drawings need to be prepared.
M4	Debris (e.g. dead trees) along the earthen channel (Riverward side).	Remove debris from the channel.	C1	E1	Removal of downed material ok w/o permits

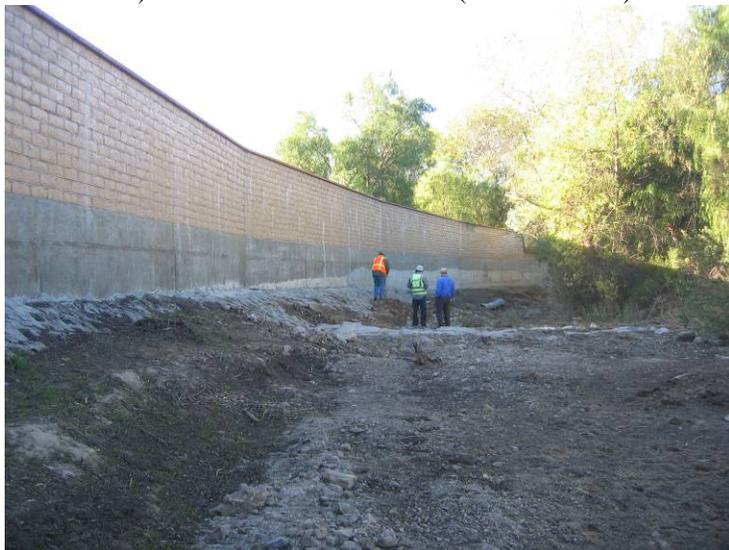
During the site visit, erosion at the toe of the floodwall was observed. Analysis of the stability of the floodwall with respect to the erosion should be evaluated.

1. Erosion on invert likely due to a steep invert slope, the creek has been experiencing degradation and channel incision. A concrete grade control structure has been installed to stabilize the degradation process, and concrete blocks were added on the side slope of the channel just in front of the floodwall to prevent bank erosion. A few field measurements during this field investigation found that the current invert elevation may be lower than or equal to the bottom of the floodwall footing which may affect the structural integrity of the floodwall.

Arroyo Santa Rosa Floodwall (Photo No. M2) – The current channel invert elevation may be lower than the floodwall footing (Riverward side).

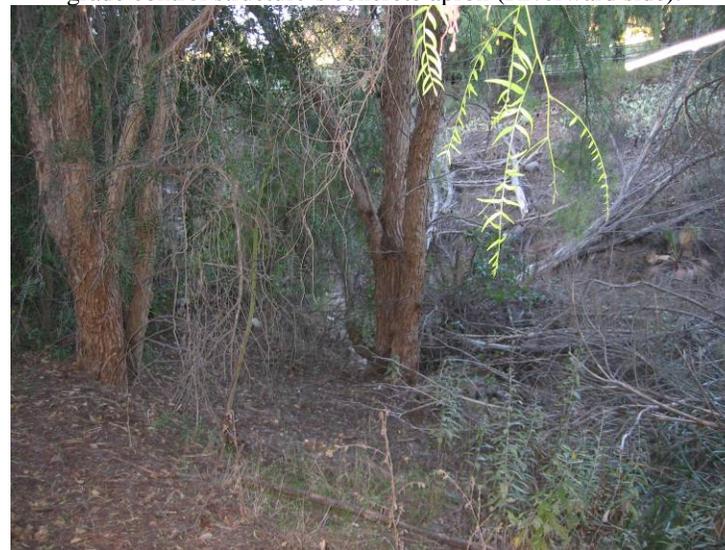
8. Encroachments					A No trash, debris, excavations, structures, adverse sediment accumulation, or other obstructions present within the project easement area.	- A significant amount of debris and vegetation was observed in the channel and could impact the flow capacity of channel.
					M Trash, debris, excavations, structures, adverse sediment accumulation, or other obstructions present, or inappropriate activities that will not inhibit project operations and maintenance or emergency operations.	
			X		U Trash, debris, excavations, structures, adverse sediment accumulation, or other obstructions present, or inappropriate activities that will inhibit project operations and maintenance or emergency operations.

Arroyo Santa Rosa Floodwall (Photo No. M4) – Debris (e.g. dead trees) along the earthen channel (Riverward side)
