**FEMA Levee Certification
Ventura County, California**

**Ventura River Levee (VR-1)
Pacific Ocean to Canada de San Joaquin**

**Evaluation Report
February 20, 2009**

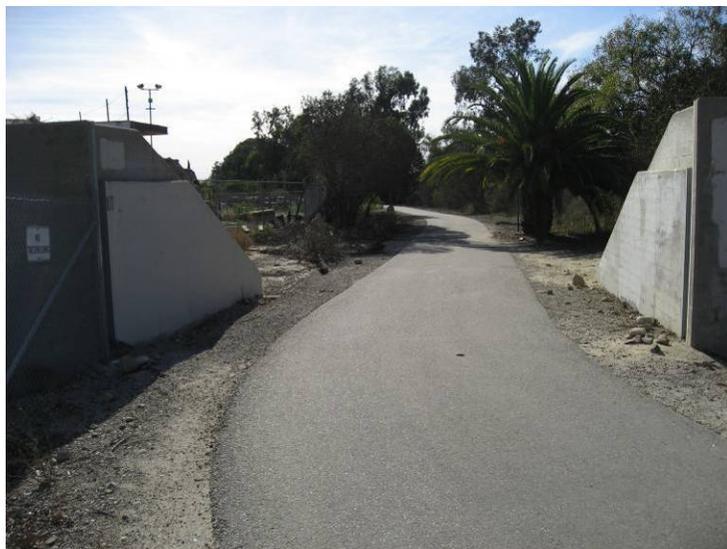
2. Multiple cracks were observed on the downstream stop log concrete structure.
3. Restoration of levee top is required in certain locations due to runoff erosion.

Ventura River Levee, From Ocean to Canada de San Joaquin. (Photo No. P1) - 12 beam stop log system at bicycle path crossing (riverward side)

Documentation of this structure is required as part of the certification. Work will also include an assessment of the impacts of the cracks in the structure observed during the field investigation and any corrective actions that may be required.

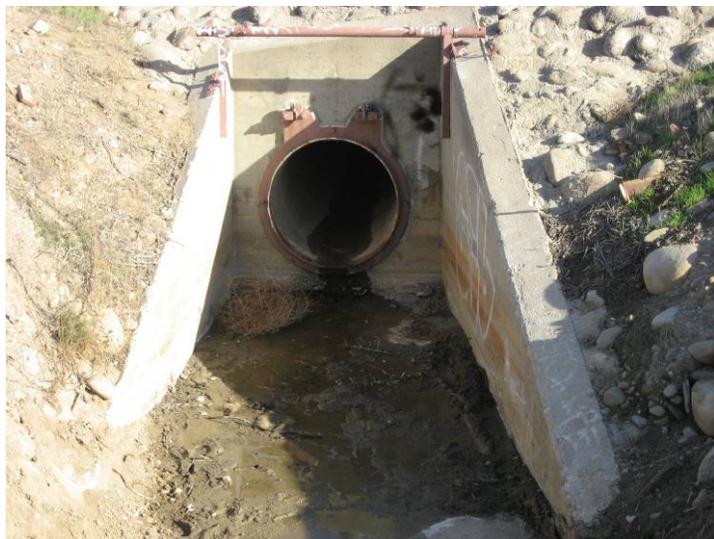
5. Stanley Drain outlet is missing its closure device (flap gate). County personnel stated that it was being repaired. Closure devices are necessary to avoid flooding behind the levee caused by the backup of the channel flow.

Ventura River Levee, From Ocean to Canada de San Joaquin. (Photo No. P6) - 48" RCP with missing flap gate being repaired on 12/10/08, Stanley Drain (riverward side)

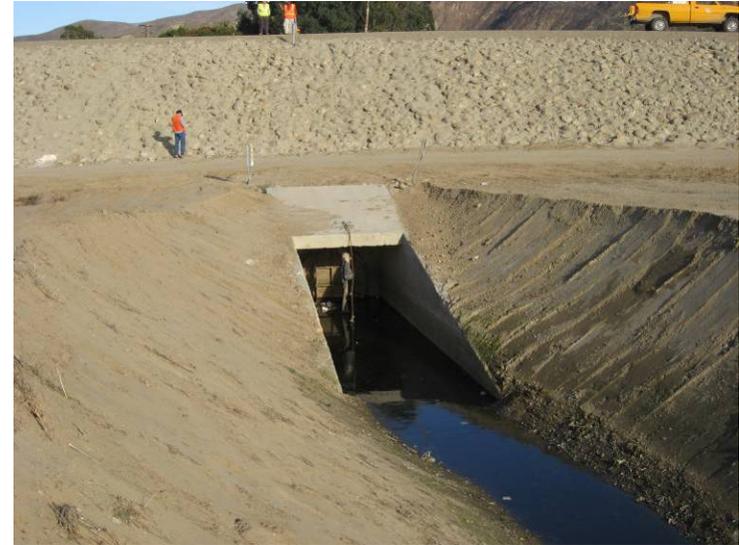
6. The Romona Drain concrete outlet structure is spalling and has exposed rebar. The concrete outlet structure should be repaired.

Ventura River Levee, From Ocean to Canada de San Joaquin. (Photo No. P11) - 72" RCP with flap Gate, Ramona Drain (riverward side)

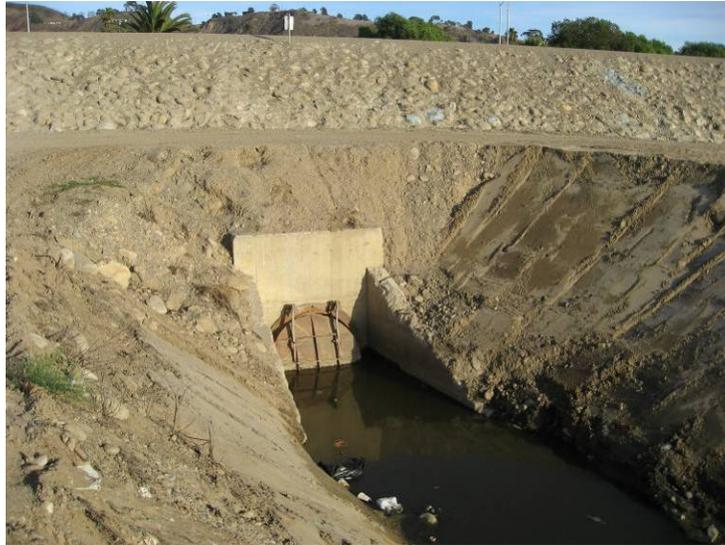
7. The Simpson Drain concrete outlet structure is spalling and has exposed rebar. The concrete outlet structure should be repaired. Also the flap gate is stuck open due to sediment debris. Removal of sediment that has accumulated in is required to allow drainage and proper operation of the flapgate.
8. Broken up concrete and debris have been dumped over the levee bank near the Main Street gate obscuring any observation of the rip-rap.
9. Multiple animal burrows were observed in the field. They are located near the toe of the slope.
10. Removal of heavy vegetation (trees, shrubs, willows) within 15 feet of levee toe is required between the (3) 48" drainage outlet from the CalTrans yard and the end of the levee.

Ventura River Levee, From Ocean to Canada de San Joaquin. (Photo No. P13) - 48" pipe with flap gate, Simpson Drain (riverward side)

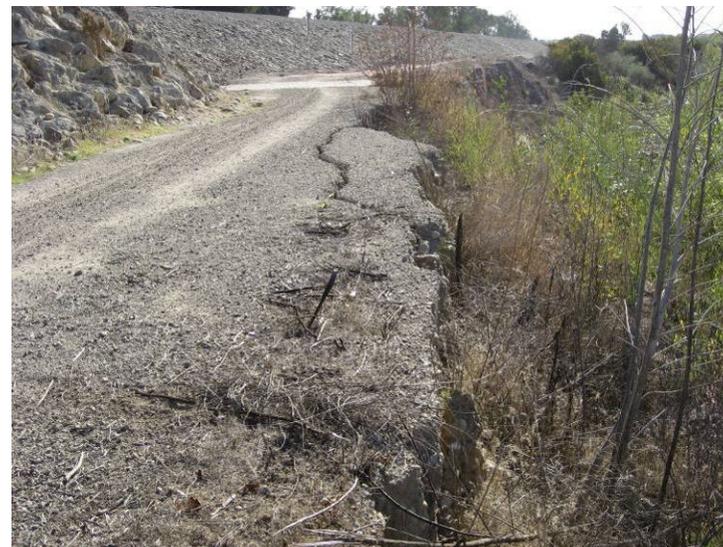
Ventura River Levee, From Ocean to Canada de San Joaquin. (Photo No. F3) – Looking d/s at low flow erosion (riverward side)

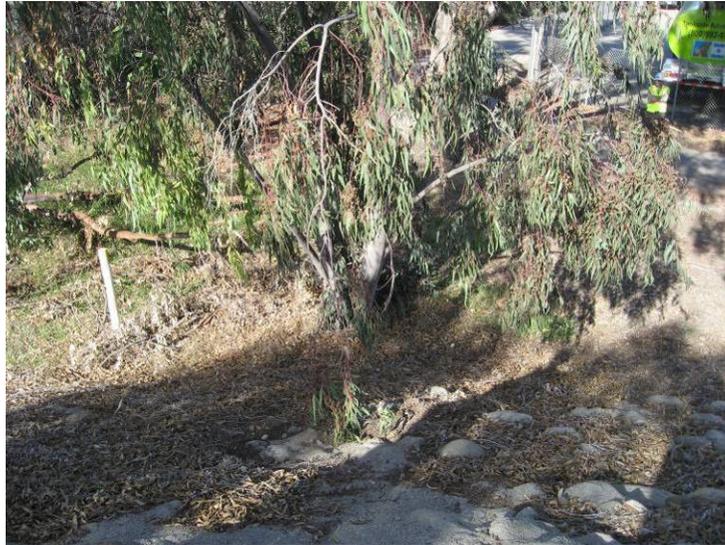
Ventura River Levee, From Ocean to Canada de San Joaquin. (Photo No. M1) - Vegetation within 15' of levee toe (riverward side)

GPS		*Photo No.	Description	Action Required
Lat	Long			
<i>Ventura River Levee (VR-1)</i>				
N34.30771	W119.29797	M1	Vegetation within 15' of levee toe (riverward side)	Remove vegetation and root ball, fill voids with impervious material and firmly compact.
N34.28953	W119.30733	M2, M3	Damaged concrete on 72" RCP Ramona Drain headwall with rebar exposed (riverward side)	Repair the concrete headwall portion of outlet structure
N34.28646	W119.30661	M4, M5	Damaged concrete on 48" Simpson Drain headwall with rebar exposed, flap gate stuck open with sediment (riverward side)	Repair concrete. Remove sediment from pipe opening and ensure complete seal around flap gate
N34.27725 to N34.27552	W119.30705 to W119.30687	M6, M7	Vegetation within 15' of levee toe, approximately 500' along levee (riverward side)	Remove vegetation and root ball, fill voids with impervious material and firmly compact.
N34.30764 to N34.30745	W119.29728 to W119.29767	M8	Vegetation within 15' of levee toe, approximately 123' along levee (landward side)	Remove vegetation and root ball, fill voids with impervious material and firmly compact.

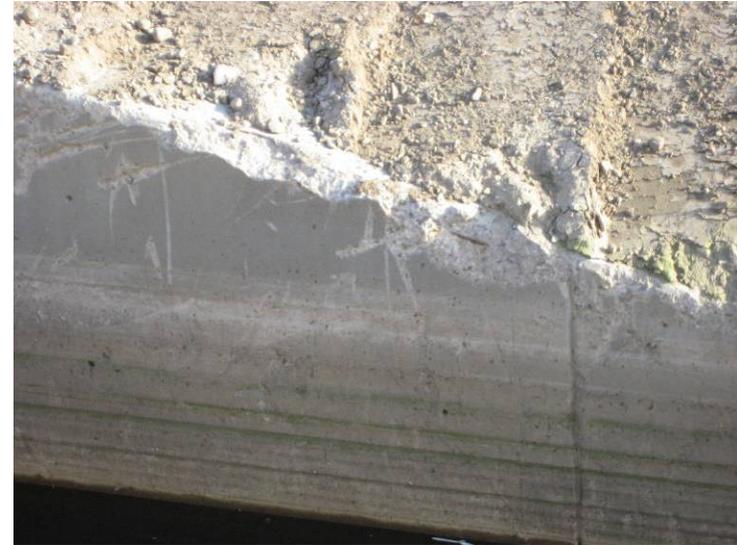
Ventura River Levee, From Ocean to Canada de San Joaquin. (Photo No. M3) - Damaged concrete on headwall with rebar exposed (riverward side)

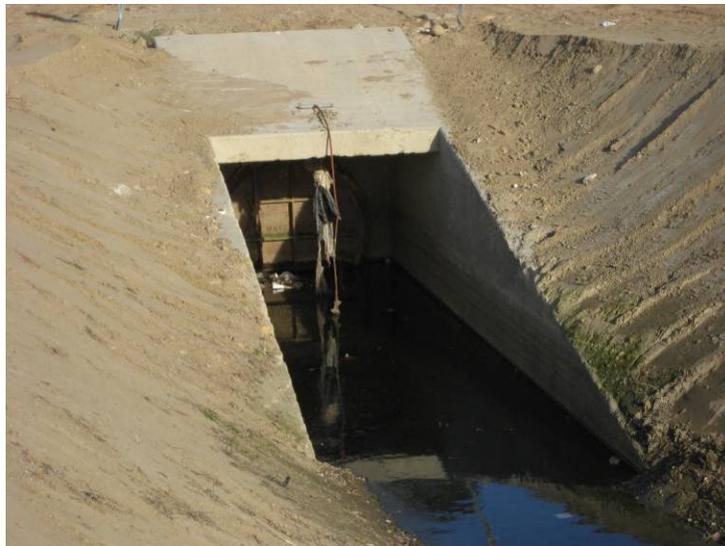
Ventura River Levee, From Ocean to Canada de San Joaquin. (Photo No. M2) - Damaged concrete on 72" RCP headwall (riverward side)

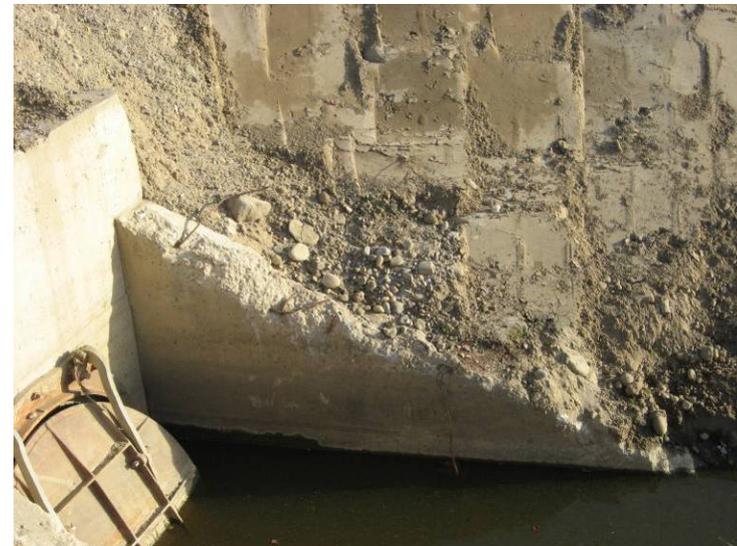
Ventura River Levee, From Ocean to Canada de San Joaquin. (Photo No. M4) - Damaged concrete on headwall with flap gate stuck open (riverward)

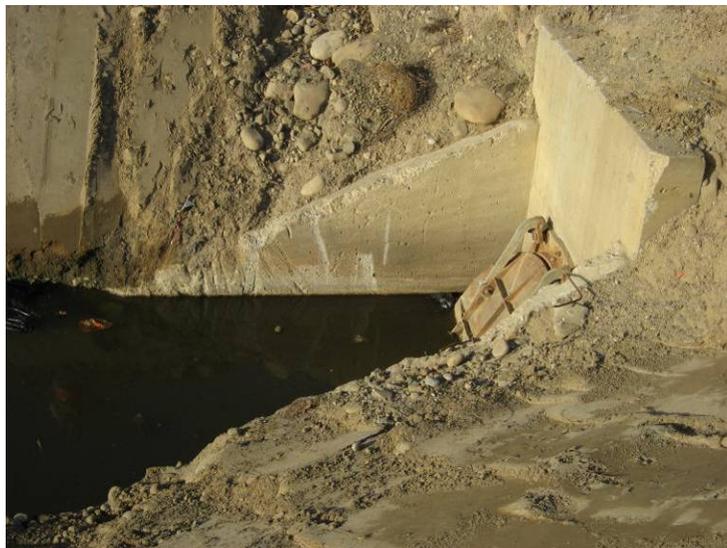
Ventura River Levee, From Ocean to Canada de San Joaquin. (Photo No. M5) - Damaged concrete on headwall with rebar exposed (riverward side)

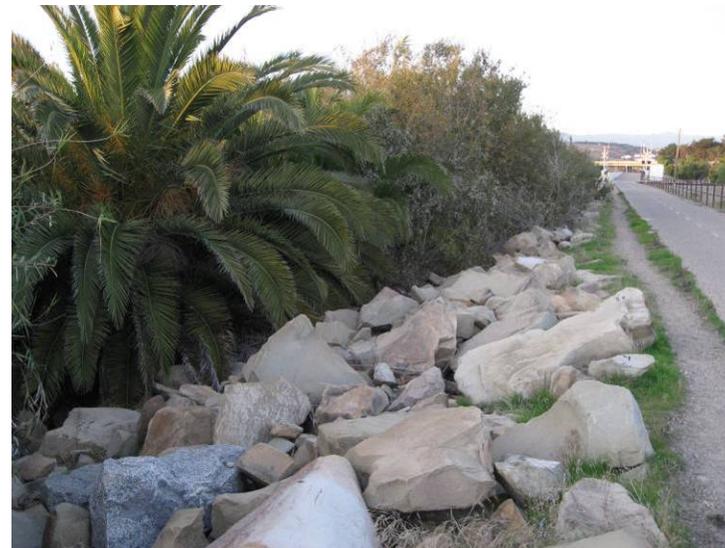
Ventura River Levee, From Ocean to Canada de San Joaquin. (Photo No. M7) - Vegetation within 15' of levee toe, looking u/s (riverward side)

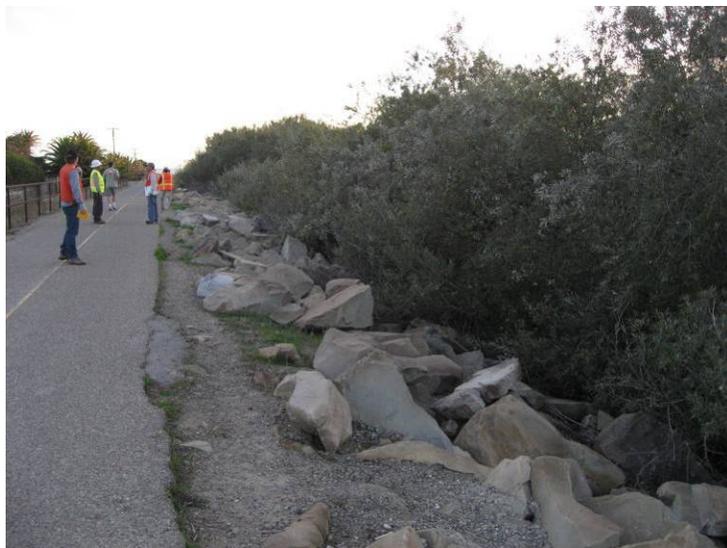
Ventura River Levee, From Ocean to Canada de San Joaquin. (Photo No. M6) - Vegetation within 15' of levee toe, looking d/s (riverward side)

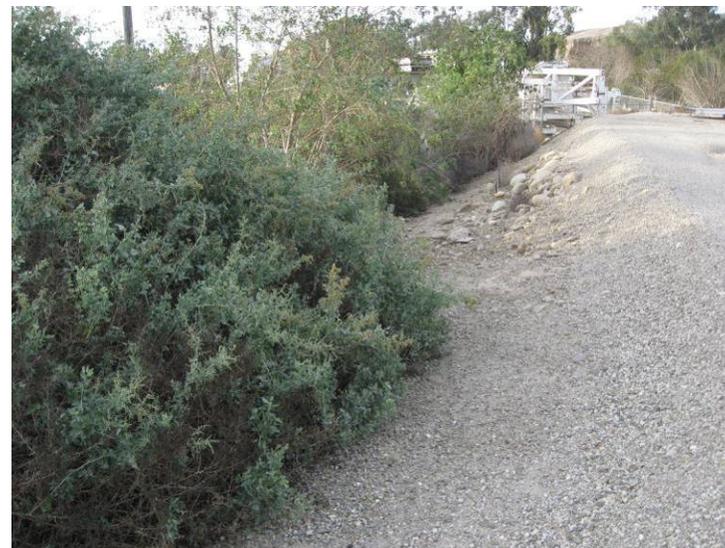
Ventura River Levee, From Ocean to Canada de San Joaquin. (Photo No. M8) - Vegetation within 15' of levee toe, looking d/s (landward side)

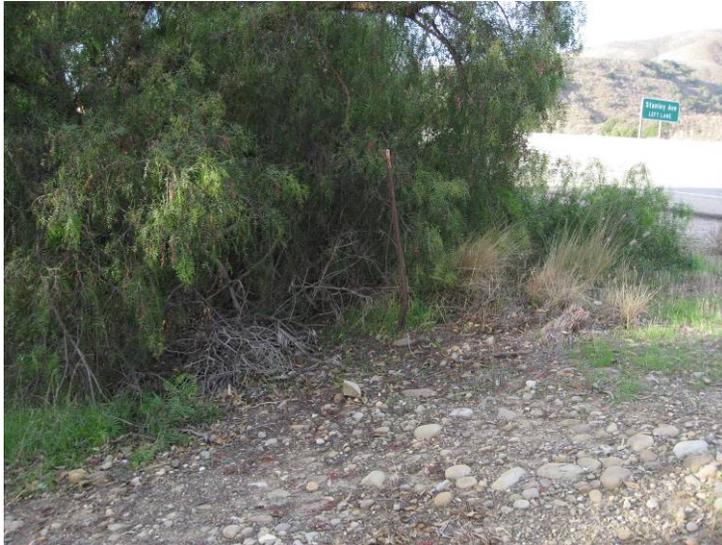
Ventura River Levee, From Ocean to Canada de San Joaquin. (Photo No. M9) - Vegetation within 15' of levee toe, looking d/s (landward side)

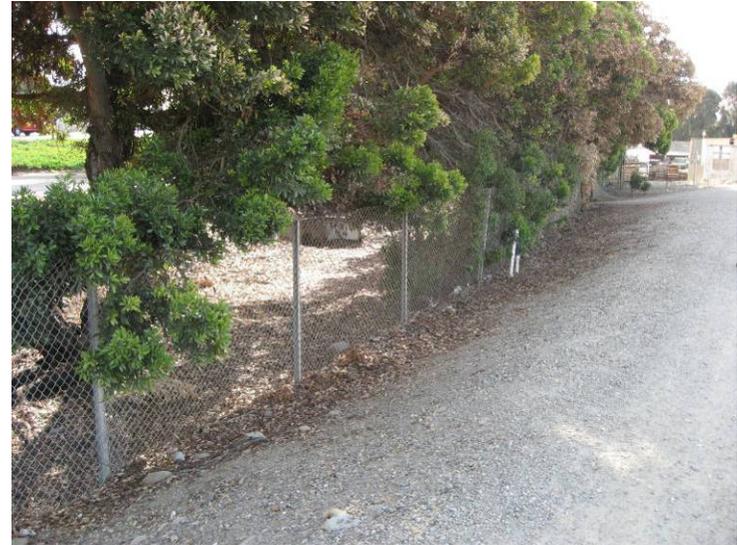
Ventura River Levee, From Ocean to Canada de San Joaquin. (Photo No. M11) - Vegetation within 15' of levee toe, looking d/s (landward side)

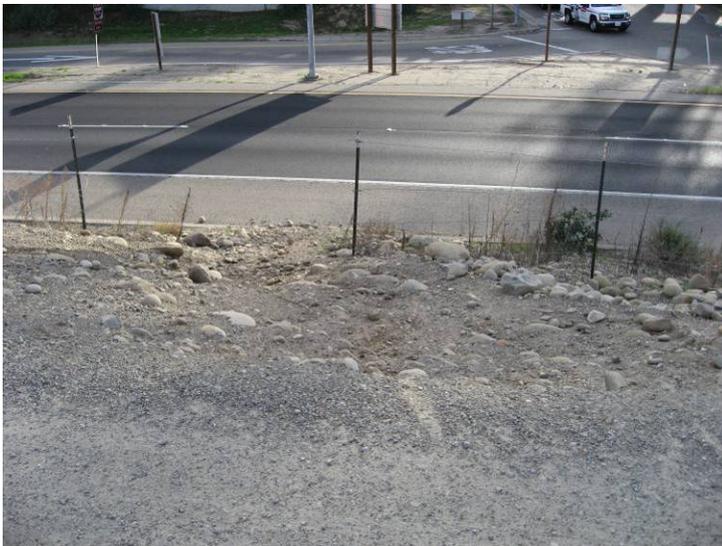
Ventura River Levee, From Ocean to Canada de San Joaquin. (Photo No. M10) - Erosion on levee top and embankment (landward side)

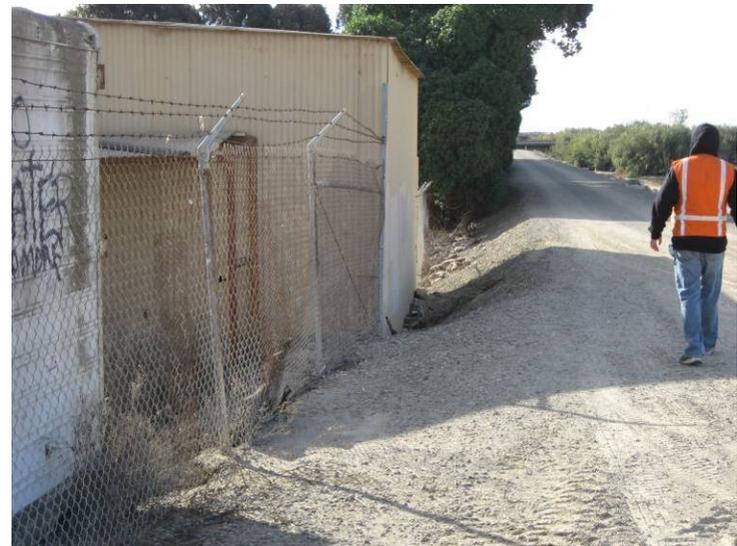
Ventura River Levee, From Ocean to Canada de San Joaquin. (Photo No. M12) - Tin storage shed and miscellaneous debris at levee toe (landward)

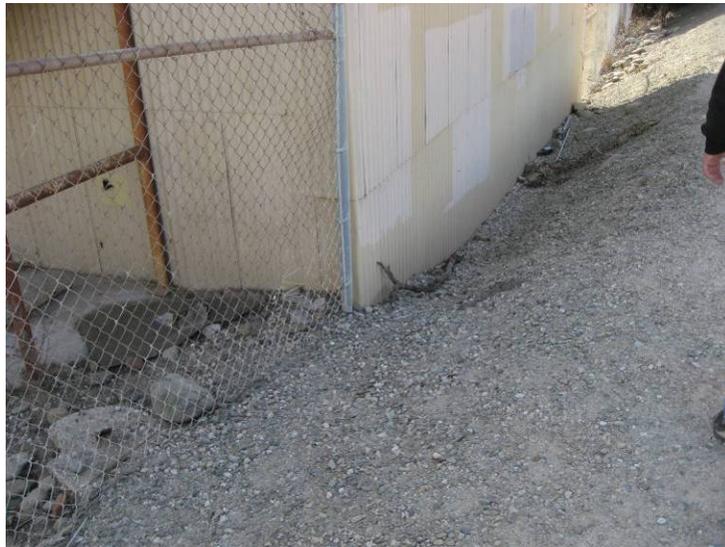
Ventura River Levee, From Ocean to Canada de San Joaquin. (Photo No. M13) - Tin storage shed at levee toe (landward side)

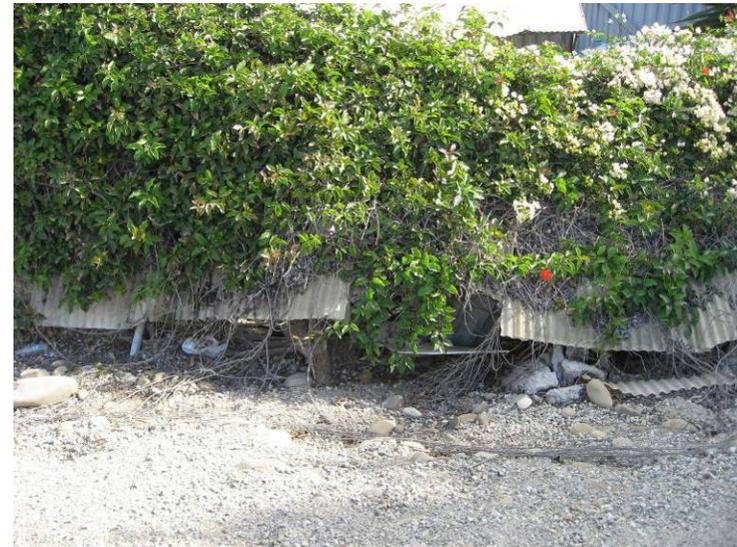
Ventura River Levee, From Ocean to Canada de San Joaquin. (Photo No. M15) - Vegetation within 15' of levee toe (landward side)

N34.28325 to N34.28199	W119.30642 to W119.30661	M15, M16	Vegetation and debris within 15' of levee toe, approximately 300' along levee (landward side)	Remove vegetation and root ball, fill voids with impervious material and firmly compact. Remove debris (within the 15'-zone as appropriate)
N34.28325 to N34.28199	W119.3064 to W119.30661	M17	Levee toe has been undercut (landward side)	Re-establish 2:1 toe of levee embankment. Additional engineering analyses are recommended.

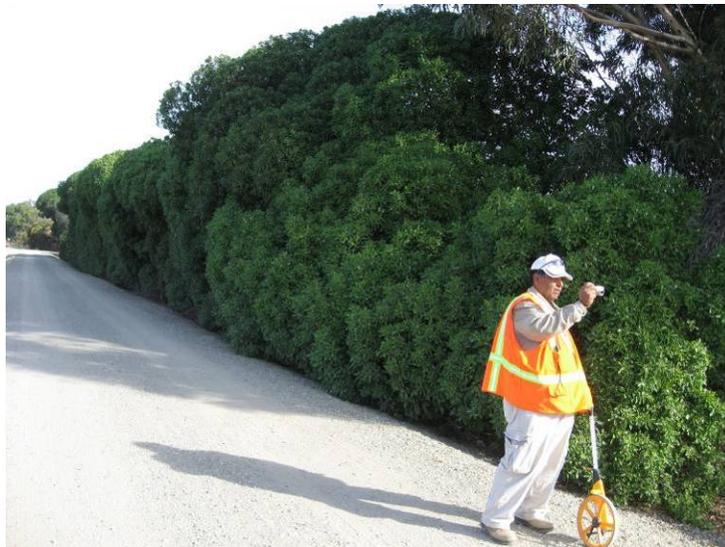
Ventura River Levee, From Ocean to Canada de San Joaquin. (Photo No. M14) - Vegetation within 15' of levee toe, looking d/s (landward side)

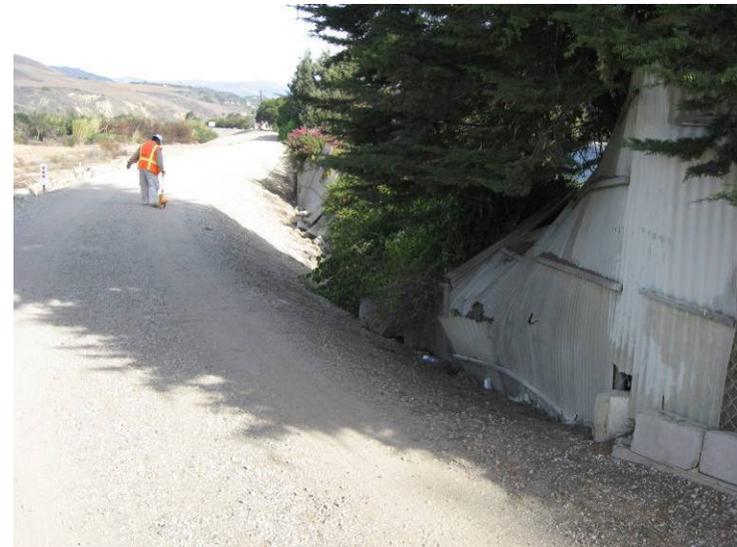
Ventura River Levee, From Ocean to Canada de San Joaquin. (Photo No. M16) - Vegetation within 15' of levee toe, looking u/s (landward side)

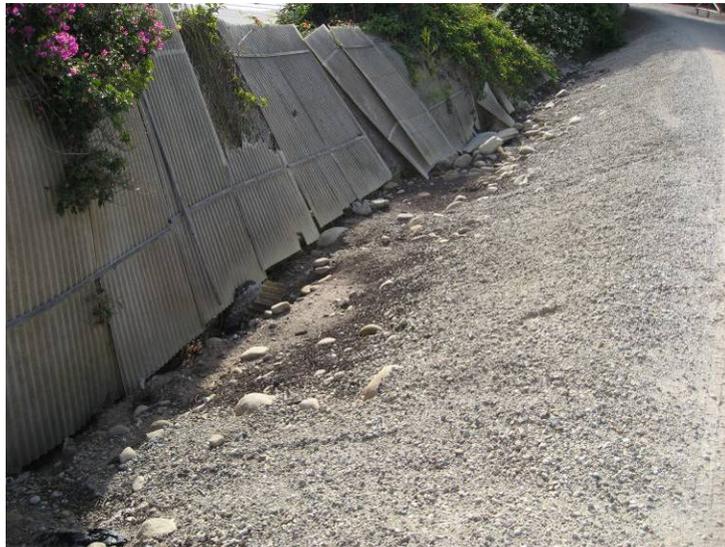
Ventura River Levee, From Ocean to Canada de San Joaquin. (Photo No. M17) – Levee toe has been undercut (landward side)

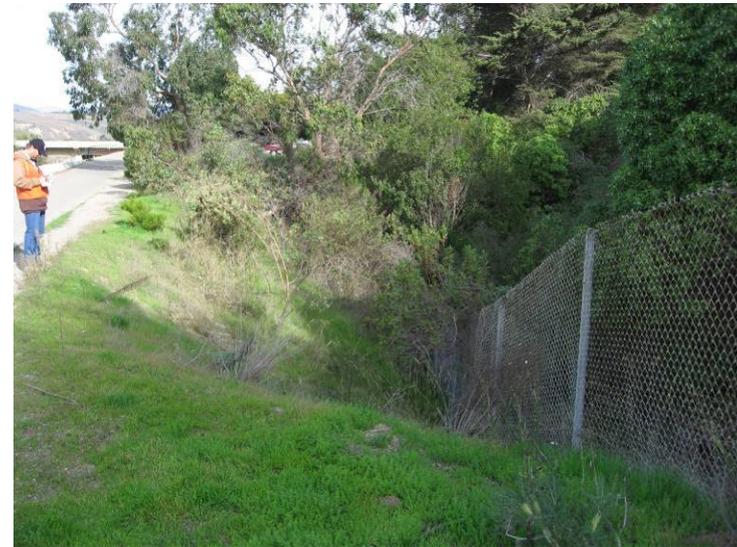
Ventura River Levee, From Ocean to Canada de San Joaquin. (Photo No. M19) - Vegetation within 15' of levee toe (landward side)

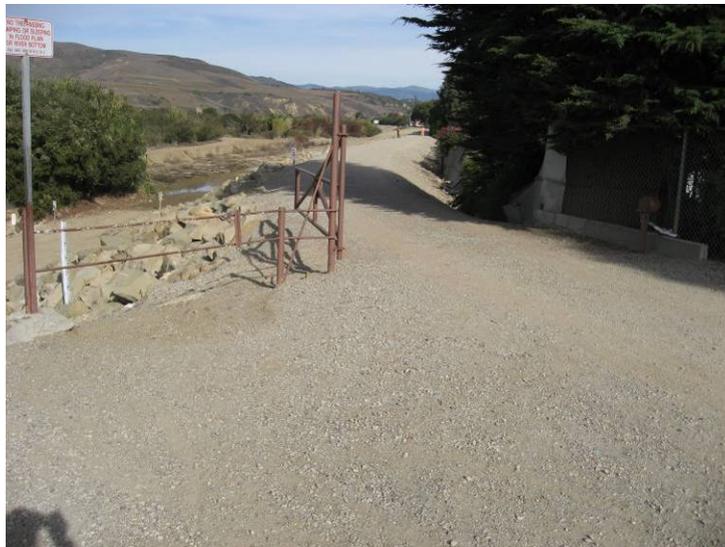
Ventura River Levee, From Ocean to Canada de San Joaquin. (Photo No. M18) - Vegetation within 15' of levee toe, looking d/s (riverward side)

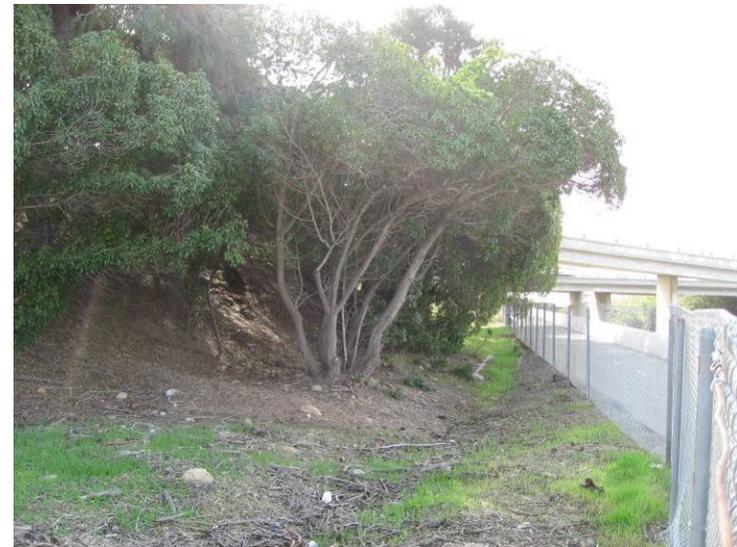
Ventura River Levee, From Ocean to Canada de San Joaquin. (Photo No. M20) - Vegetation within 15' of levee toe, looking u/s (landward side)

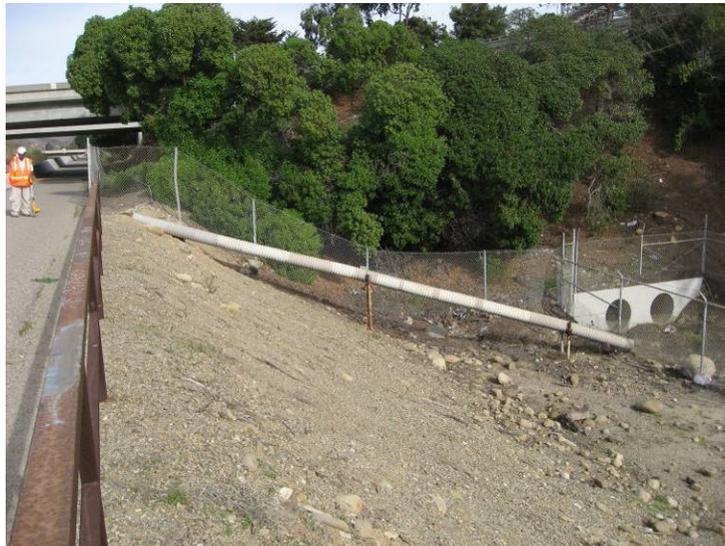
Ventura River Levee, From Ocean to Canada de San Joaquin. (Photo No. M21) – Vegetation within 15' of levee toe, looking u/s (landward side)

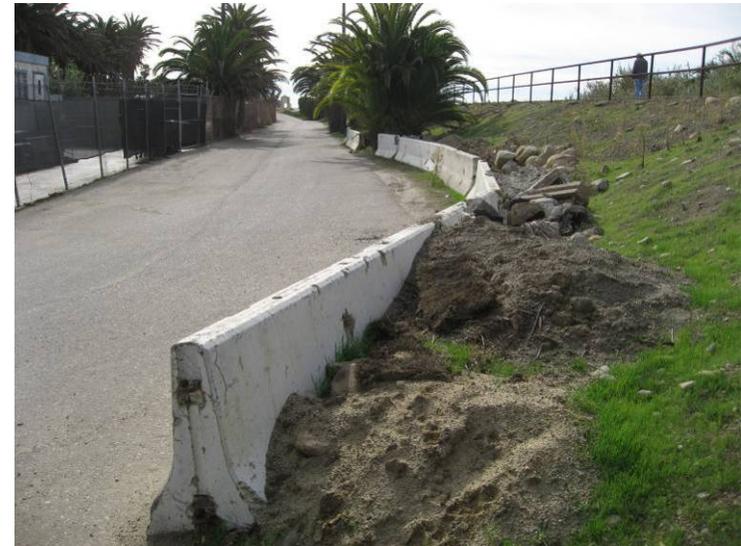
Ventura River Levee, From Ocean to Canada de San Joaquin. (Photo No. M23) – K-rails and debris along levee toe, looking d/s (landward side)

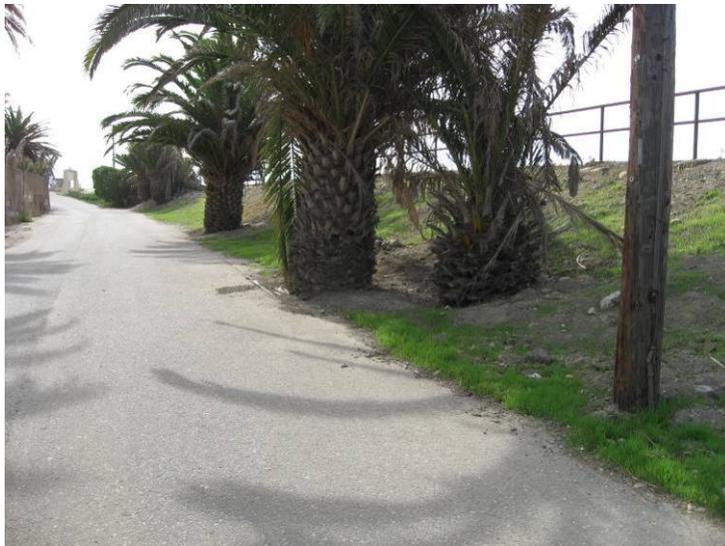
Ventura River Levee, From Ocean to Canada de San Joaquin. (Photo No. M22) - Vegetation within 15' of levee toe, looking d/s (landward side)

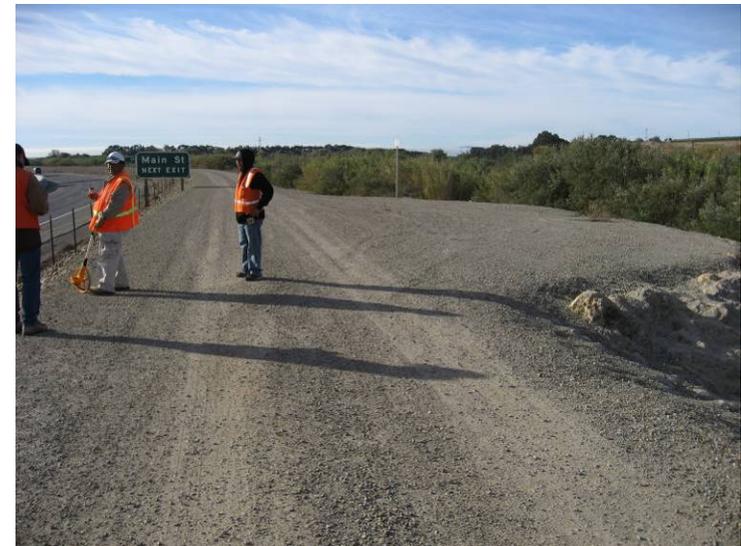
Ventura River Levee, From Ocean to Canada de San Joaquin. (Photo No. M24) – Freeway sign installed in levee bank looking u/s (landward side)

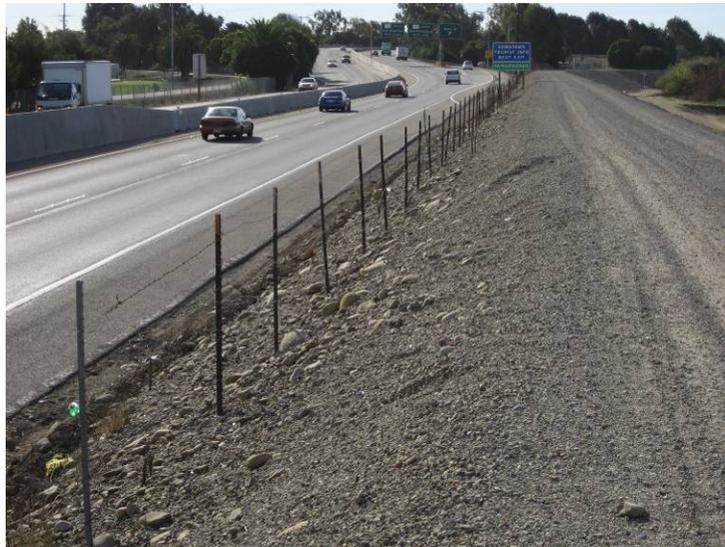
Ventura River Levee, From Ocean to Canada de San Joaquin. (Photo No. M25) – Freeway sign installed in levee bank, looking u/s (landward side)

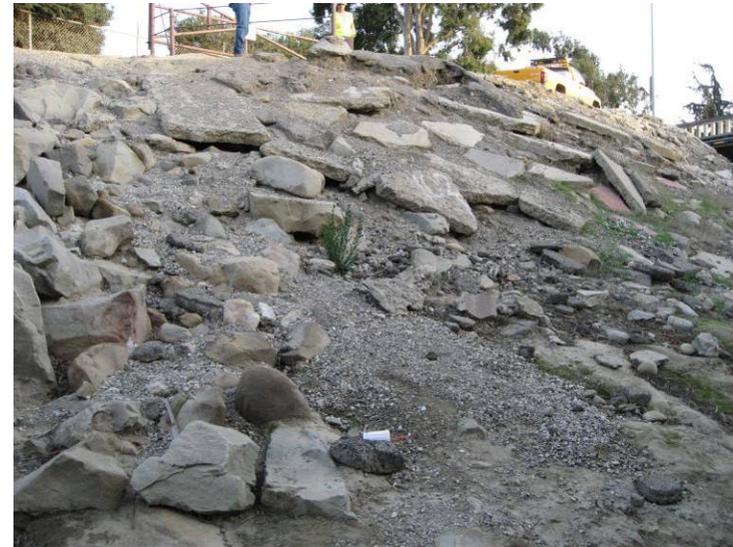
Ventura River Levee, From Ocean to Canada de San Joaquin. (Photo No. M27) – Dumped debris over levee embankment (riverward side)

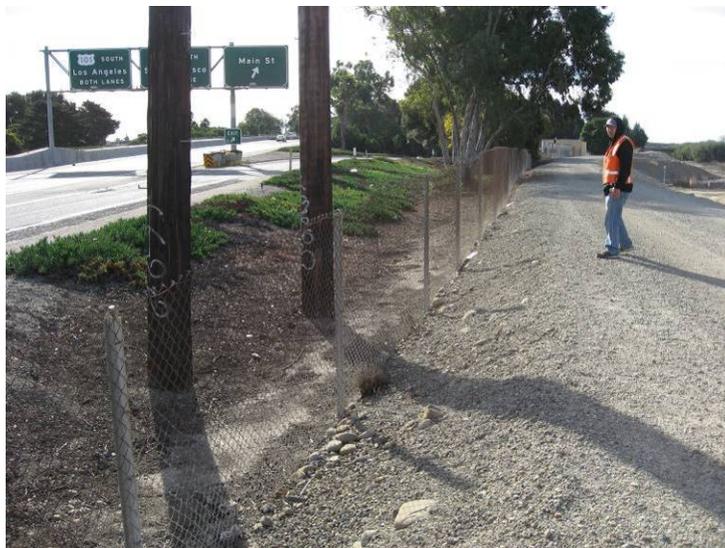
Ventura River Levee, From Ocean to Canada de San Joaquin. (Photo No. M26) – Power poles within 15' of levee toe, looking d/s (landward side)

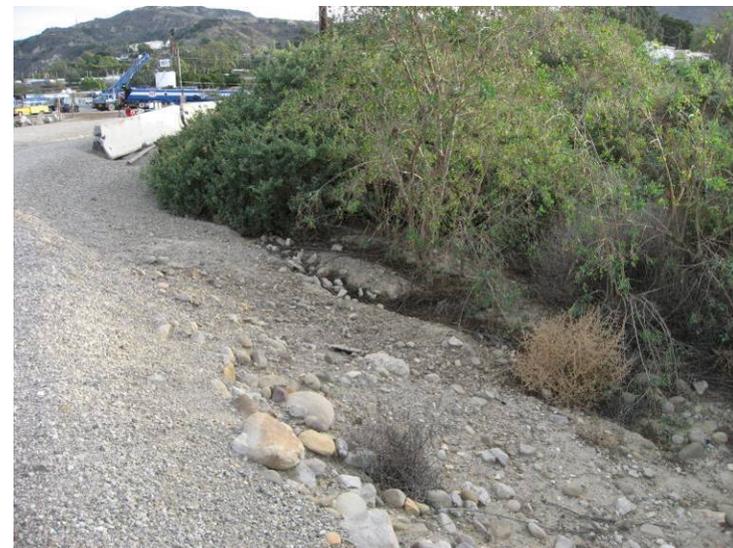
Ventura River Levee, From Ocean to Canada de San Joaquin. (Photo No. M28) – Erosion along levee toe (landward side)

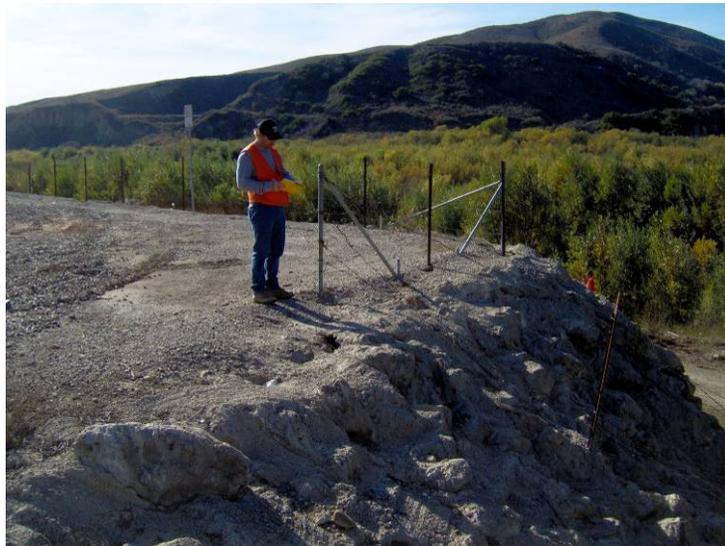
Ventura River Levee, From Ocean to Canada de San Joaquin. (Photo No. M29) – Fence piping on top of levee bank, looking u/s (riverward side)

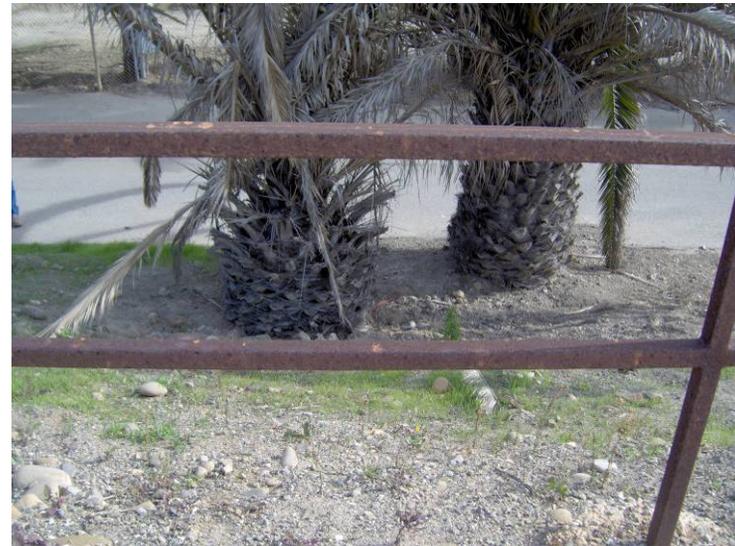
Ventura River Levee, From Ocean to Canada de San Joaquin. (Photo No. M31) – Animal burrows along levee toe (landward side)

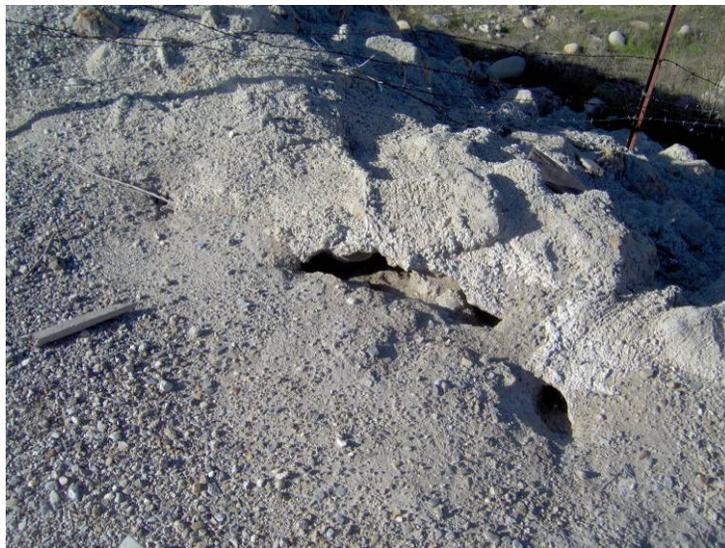
Ventura River Levee, From Ocean to Canada de San Joaquin. (Photo No. M30) – Sink holes on top of levee embankment (riverward side)

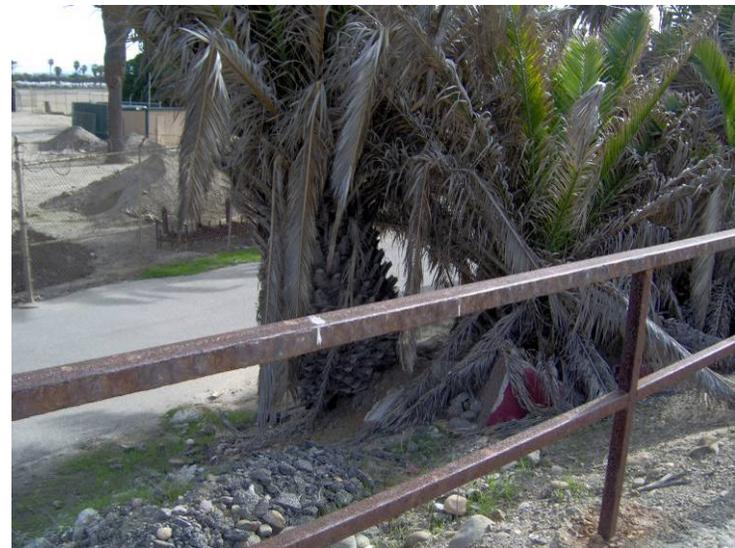
Ventura River Levee, From Ocean to Canada de San Joaquin. (Photo No. M30) – Animal burrows along levee toe (landward side)

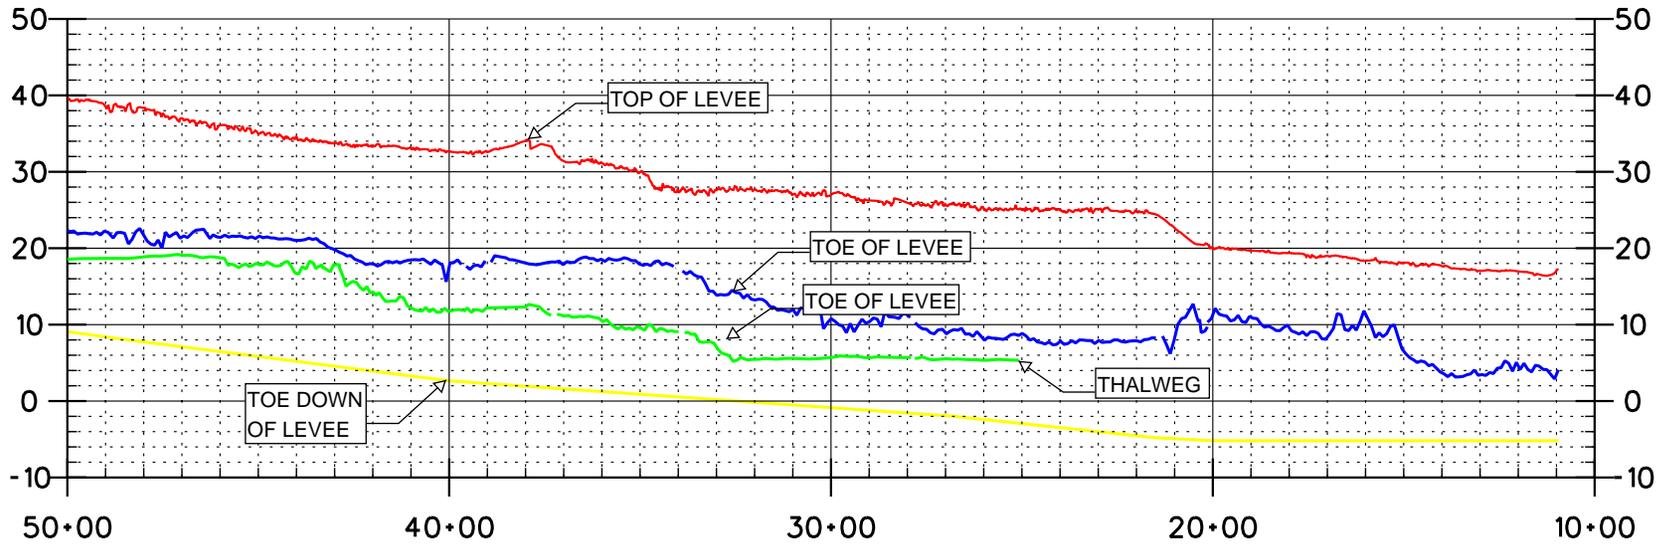
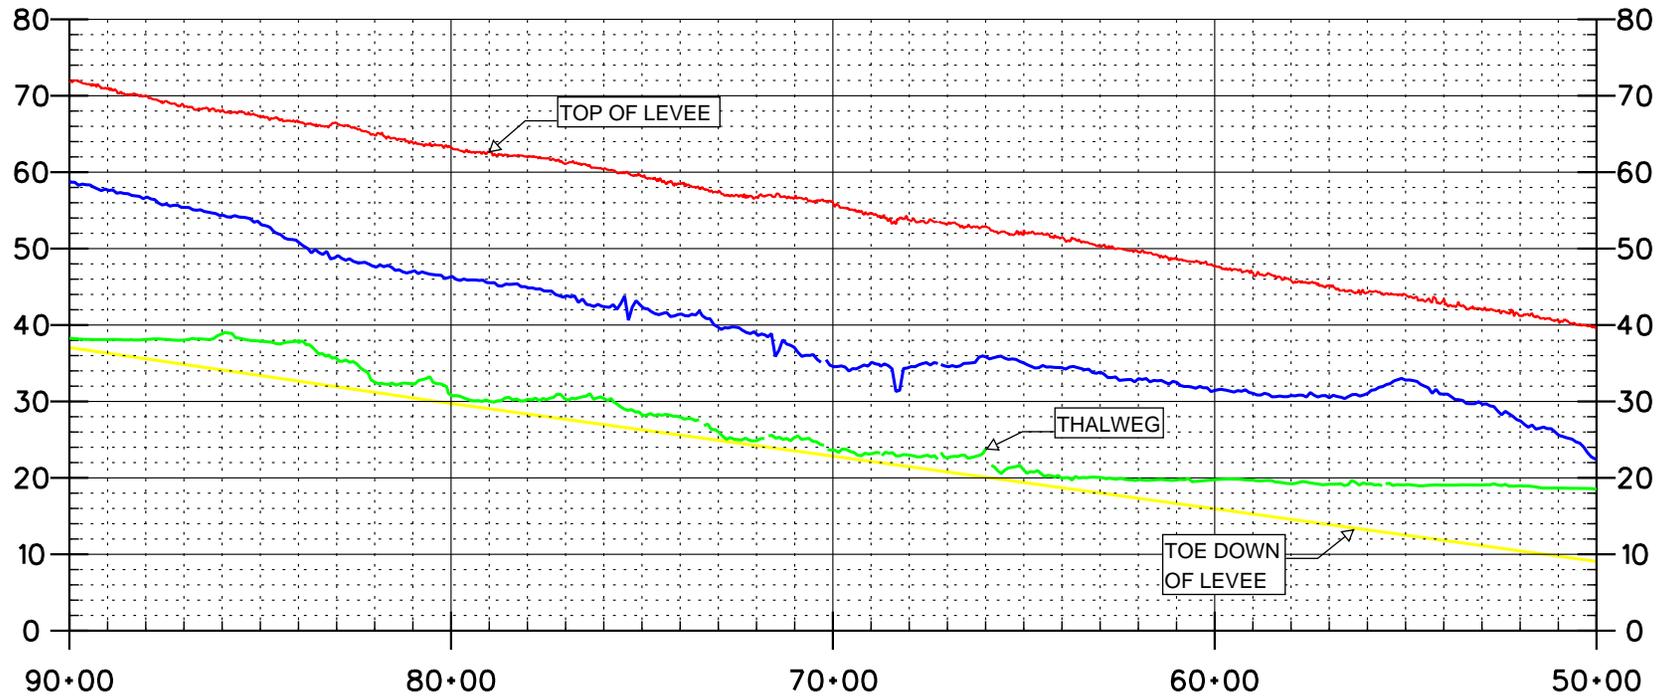
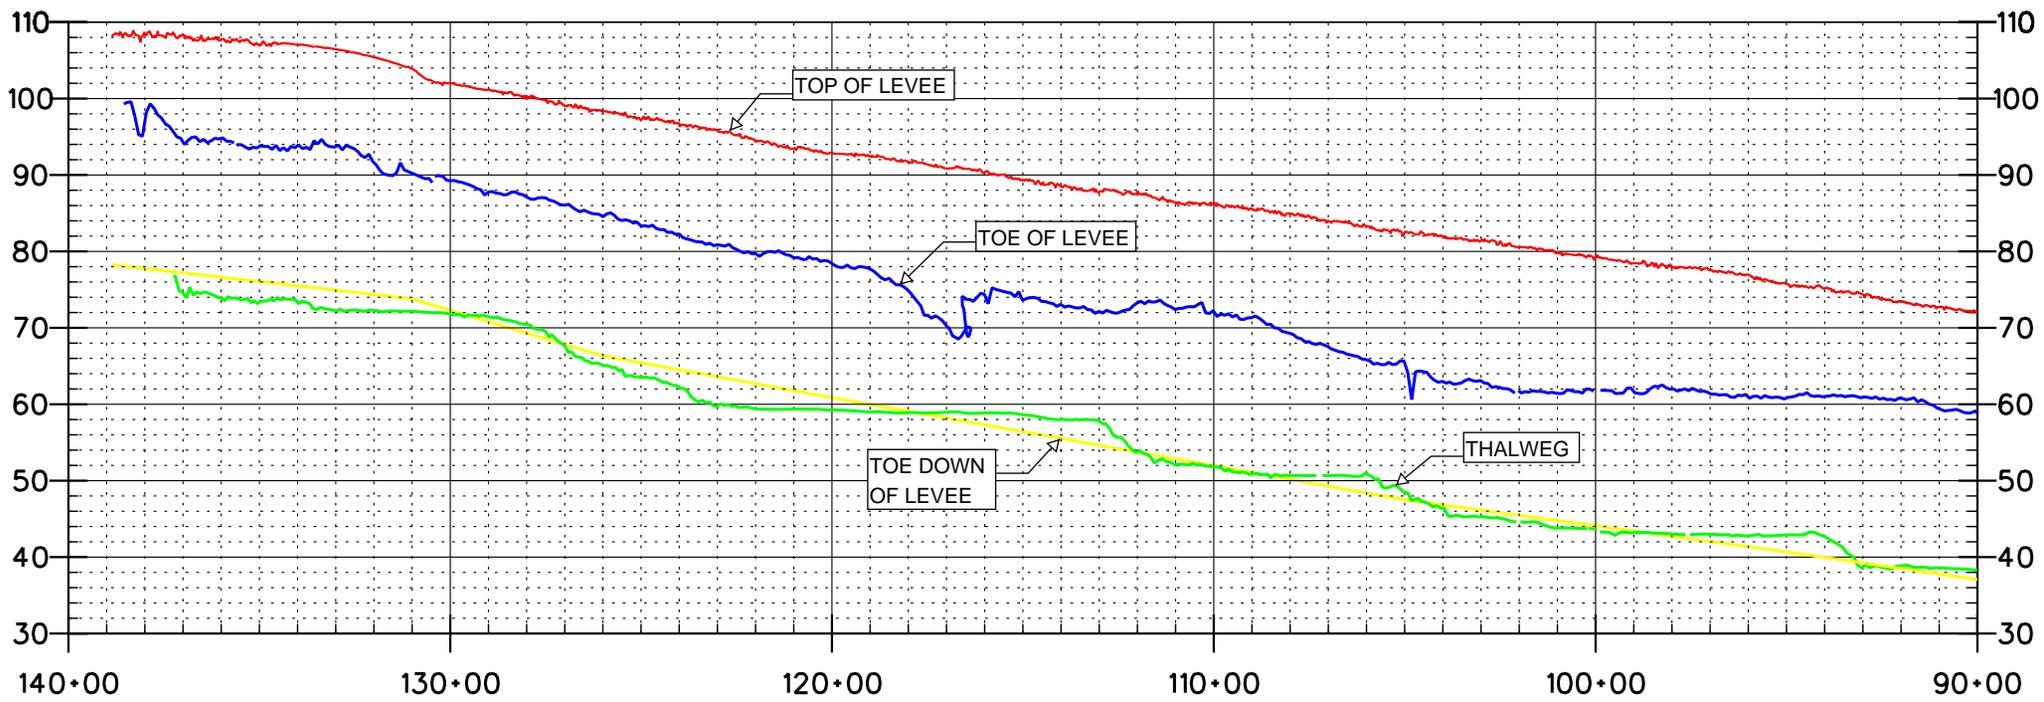
prepared and is presented in Exhibit 2. The 1949 as-built plans show 8-feet of toedown was provided when the levee was initially constructed. Over the last 60 years the Ventura River has degraded along the VR-1 levee to a point where currently, there is minimal to no toedown protection.

Presented in Exhibit 2 are the profiles of the existing thalweg and the levee toedown along the entire 2.65-mile levee system. It reveals that approximately 1.4 miles of the Ventura River thalweg, from Station 64+00 to Station 138+50, is either below or very close to the existing levee toedown. There are no geological features, such as bedrock, or manmade feature, such as rock groins, that would prevent the thalweg of the river from migrating toward the levee and undermining the toedown. Thus, the existing levee has a reasonable failure potential due to toedown undermining during major flood events and cannot be certified in its current condition.
