**FEMA Levee Certification
Ventura County, California**

**Arroyo Simi Levee (AS-6)
First Street to Erringer Road**

**Evaluation Report
February 13, 2009**

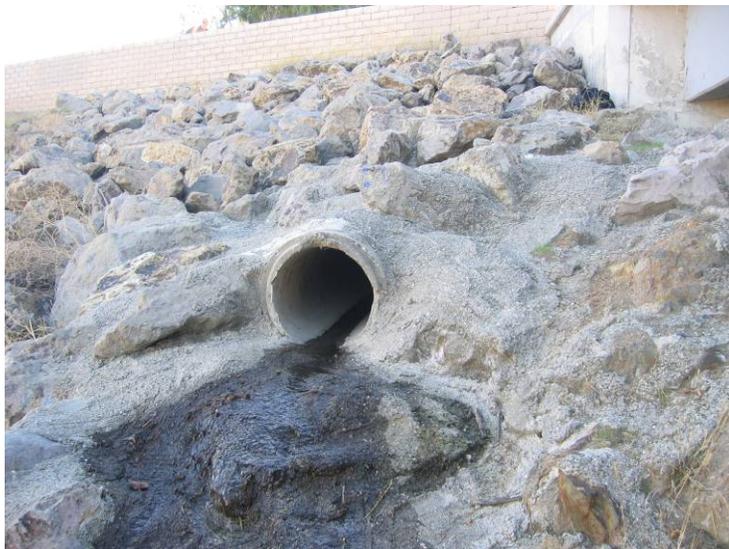
Arroyo Simi AS-6 (Photo No. P1L) – 18" RCP w/o a closure device

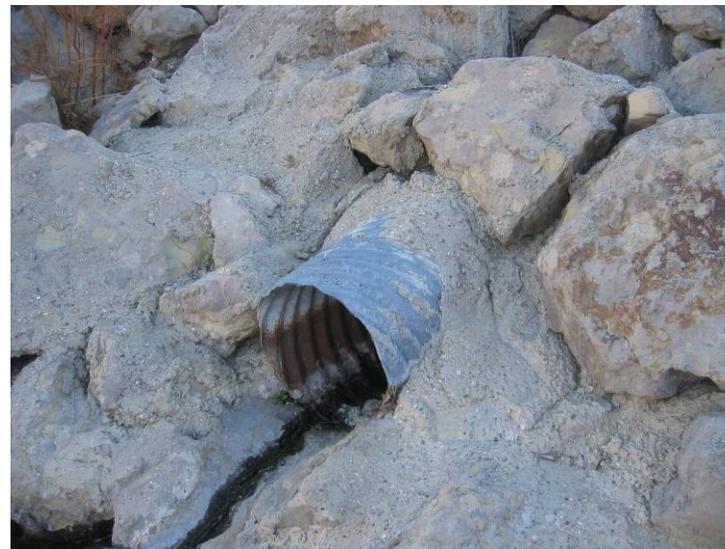
Arroyo Simi AS-6 (Photo No. P3L) – 18" CMP w/o a closure device. (not shown on the as-built plan)

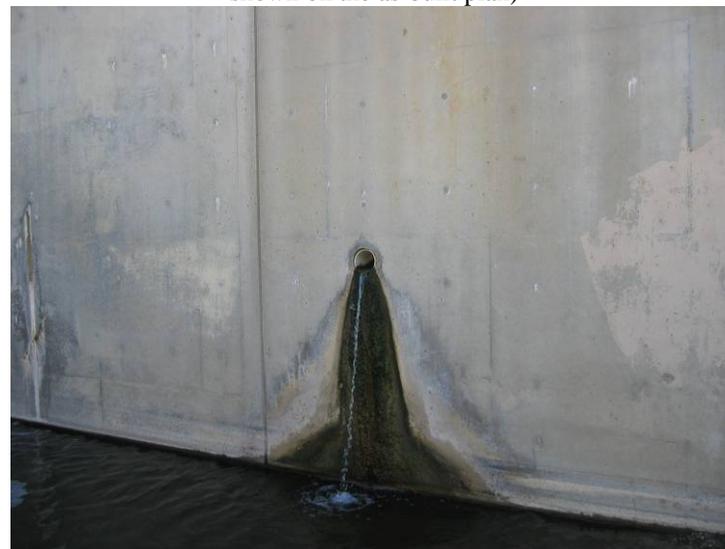
Arroyo Simi AS-6 (Photo No. P4L) – 6" PVC subdrain on the side wall of a drop structure with an active stream of flow

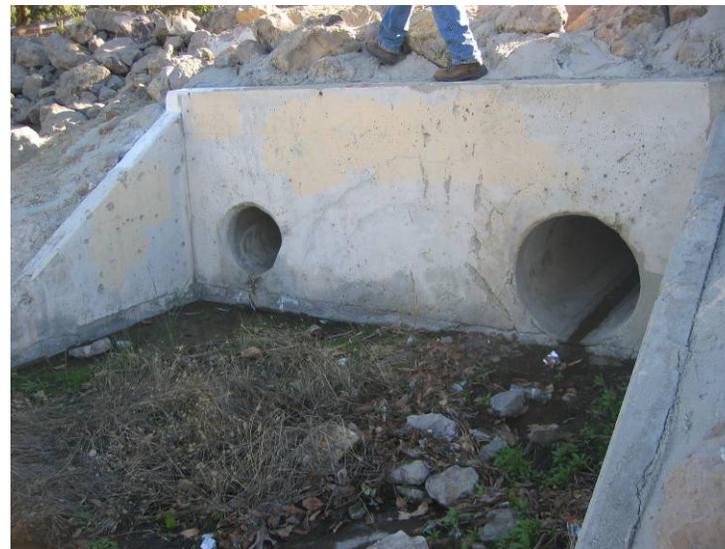
Arroyo Simi AS-6 (Photo No. P7L) – A concrete outlet structure with 27" RCP and 18" CMP w/o a closure device

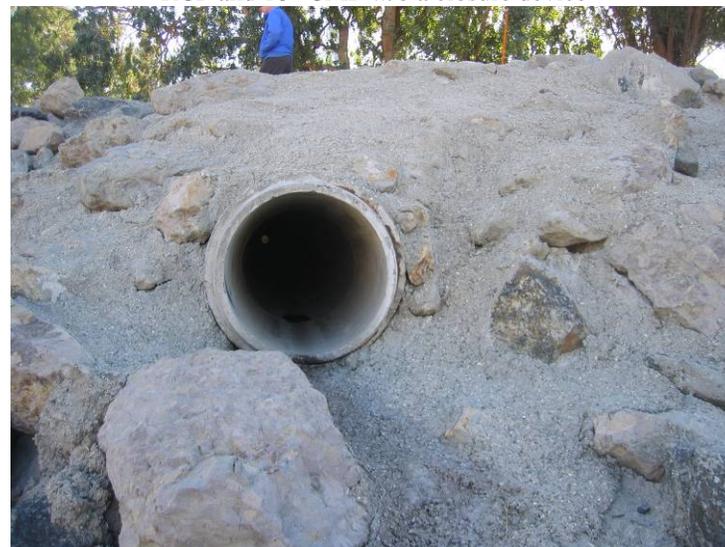
Arroyo Simi AS-6 (Photo No. P8L) – 24" RCP w/o a closure device. Angled towards downstream

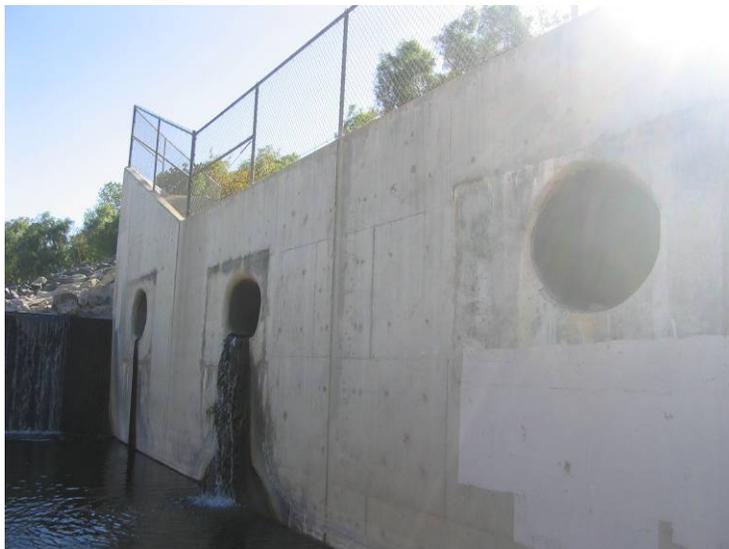
90+58	N34.26770	W118.77024	P9L	2-36" CMP w/o a closure device on the side wall of a drop structure
90+75	N34.26770	W118.77024	P9L	36" RCP w/o a closure device on the side wall of a drop structure. An active stream was observed.
90+95	N34.26770	W118.77024	P9L	42" RCP w/o a closure device on the side wall of a drop structure. An active stream was observed.
97+10	N34.26732	W118.76803	P10L	16" CMP w/o a closure device, draining areas behind the levee
105+90	N34.26735	W118.76524	P11L	36" CMP w/o a closure device, draining areas behind the levee
117+00	N34.26657	W118.76170	P12L, P13L	Opening for 6-beam stop log system near at the top of channel access ramp near Erringer Road bridge (Not shown on as-built plan)

Arroyo Simi AS-6 (Photo No. P9L) – 2-36" CMPs and 42" RCP w/o closure device on the side wall of a drop structure

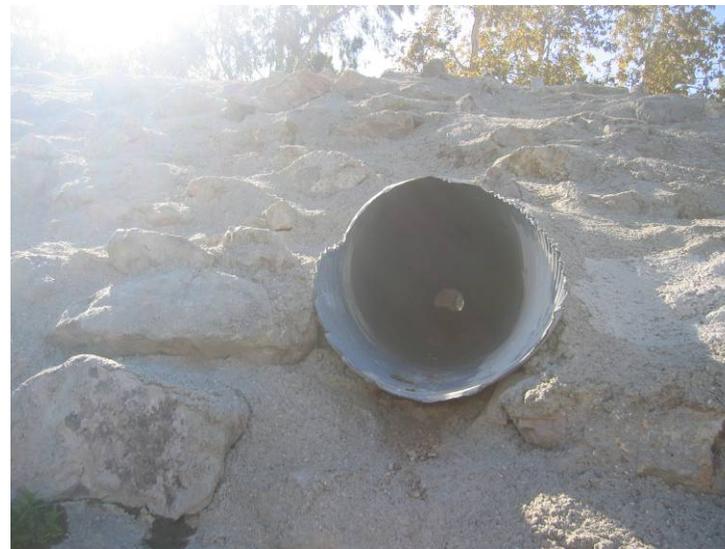
Arroyo Simi AS-6 (Photo No. P11L) – 36" CMP w/o a closure device, draining areas behind the levee

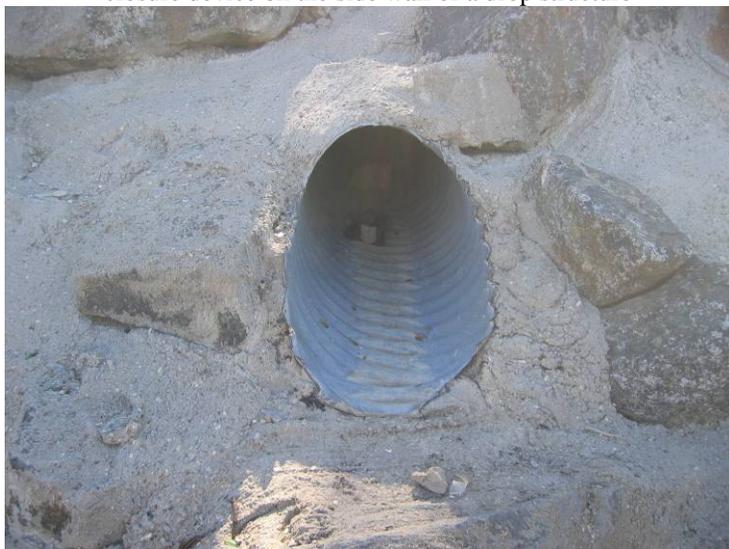
Arroyo Simi AS-6 (Photo No. P10L) – 16" CMP w/o a closure device, draining areas behind the levee

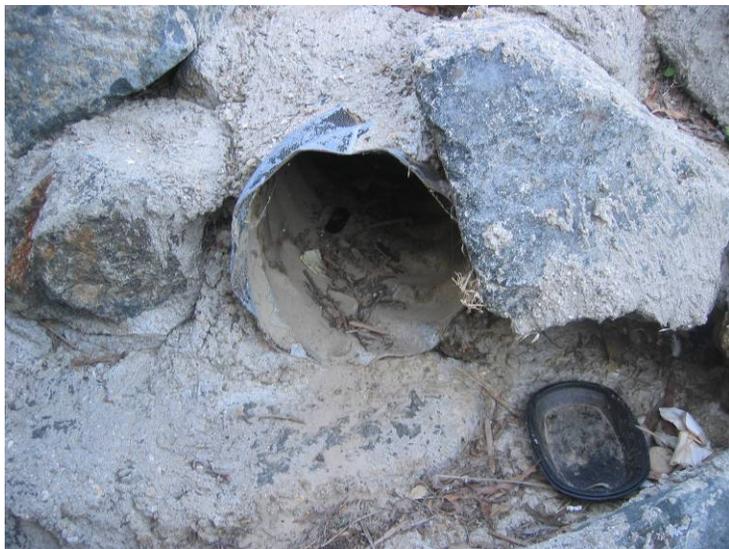
Arroyo Simi AS-6 (Photo No. P1R) – 12" CMP w/o a closure device

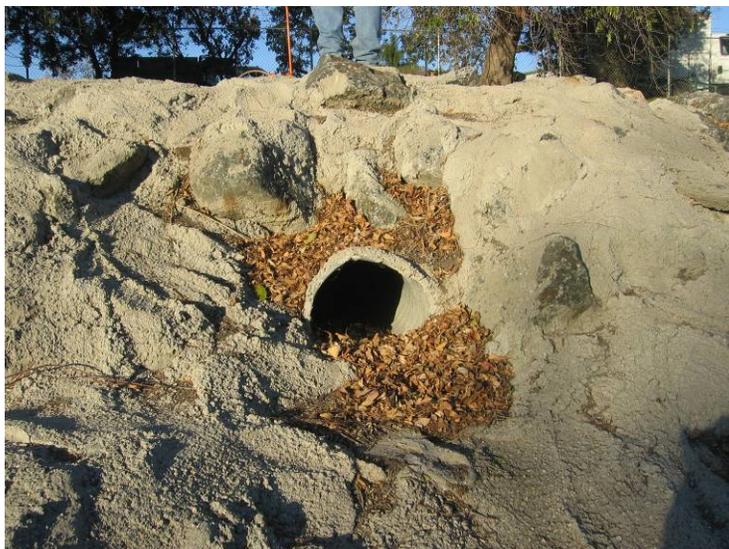
Arroyo Simi AS-6 (Photo No. P2R) – 18" CMP w/o a closure device. A drop inlet is located on the landward side of levee

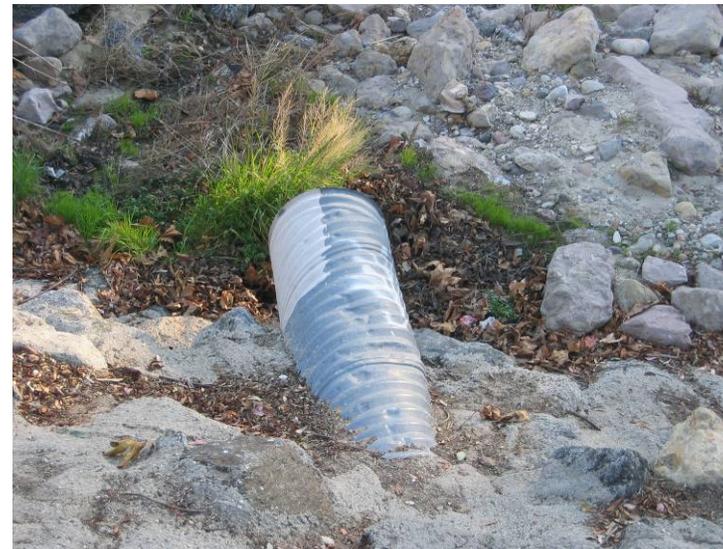
Arroyo Simi AS-6 (Photo No. P4R) – 18" CMP w/o a closure device. A drop inlet is located inside a property parking lot behind the levee

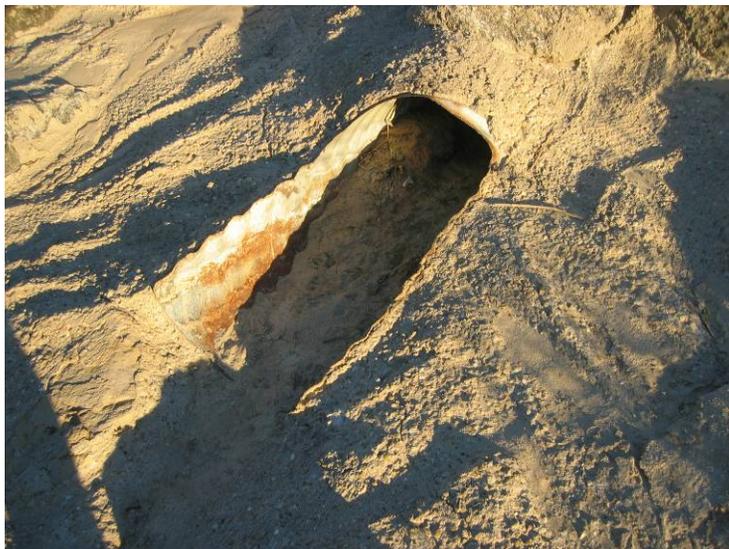
Arroyo Simi AS-6 (Photo No. P5R) – 18" CMP w/o a closure device.
Currently, one third of opening is blocked by debris and rusted

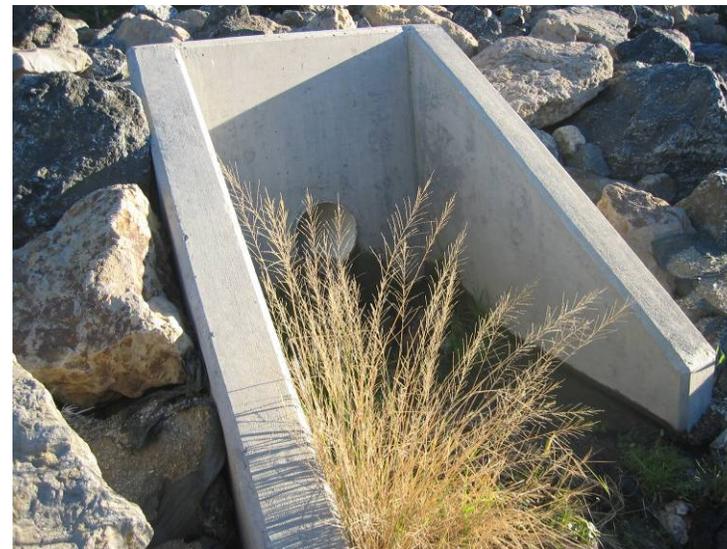
Arroyo Simi AS-6 (Photo No. P7R) – 10" PVC with a concrete outlet structure but w/o a closure device. An active stream was observed

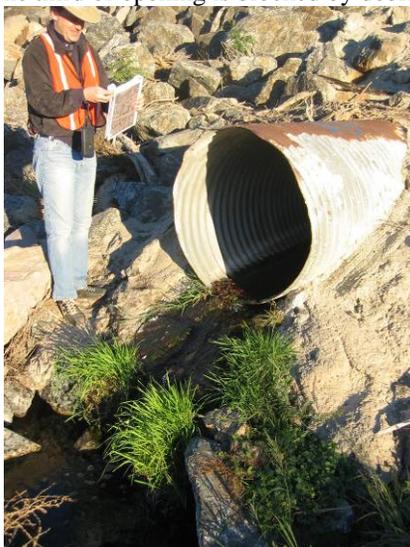
Arroyo Simi AS-6 (Photo No. P6R) – 36" CMP w/o a closure device. An active stream was observed

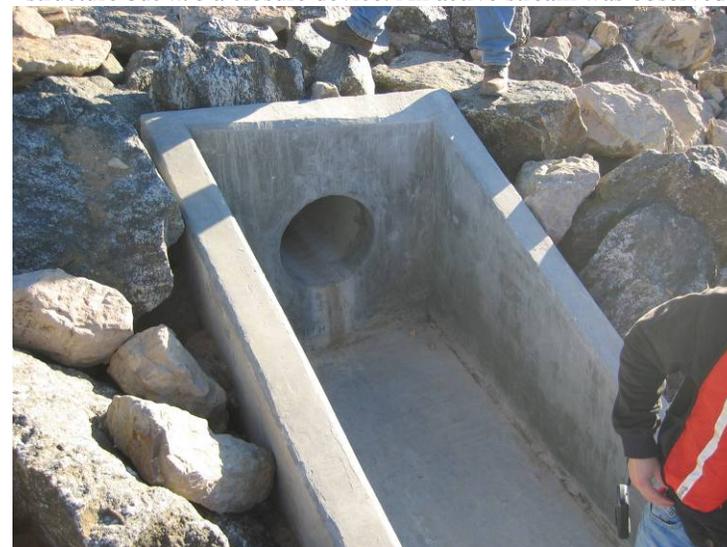
87+92	N34.26834	W118.77088	P8R	18" RCP with a concrete outlet structure but w/o a closure device.
89+91	N34.26804	W118.77035	P9R	18" RCP with a concrete outlet structure but w/o a closure device.
90+09	N34.26793	W118.77018	P10R	24" CMP w/o a closure device
101+93	N34.26784	W118.76654	P11R	60" RCP with a concrete outlet structure but w/o a closure device. An active stream was observed.
104+14	N34.26780	W118.76581	P12R	18" RCP with a Flap Gate and concrete outlet structure
106+06	N34.26771	W118.76518	P13R	24" RCP with a Flap Gate and concrete outlet structure
108+00	N34.26754	W118.76457	P14R	12" RCP with a Flap Gate and concrete outlet structure
110+80	N34.26740	W118.76355	P15R	16" CMP w/o a closure device
113+85	N34.26715	W118.76264	P16R	24" CMP w/o a closure device
115+40	N34.26701	W118.76209	P17R	12" CMP w/o a closure device
117+15	N34.26683	W118.76159	P18R	24" CMP w/o a closure device through a concrete abutment just downstream of Erringer Road bridge

Arroyo Simi AS-6 (Photo No. P8R) – 18" RCP with a concrete outlet structure but w/o a closure device

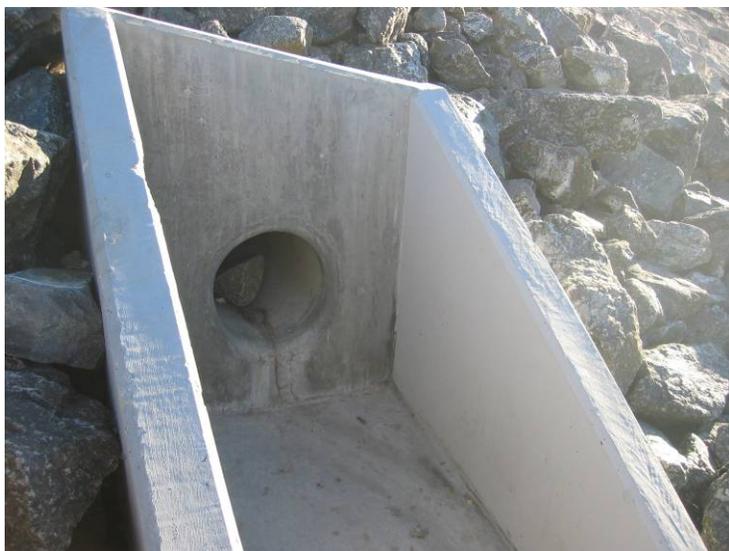
Arroyo Simi AS-6 (Photo No. P9R) – 18" RCP with a concrete outlet structure but w/o a closure device

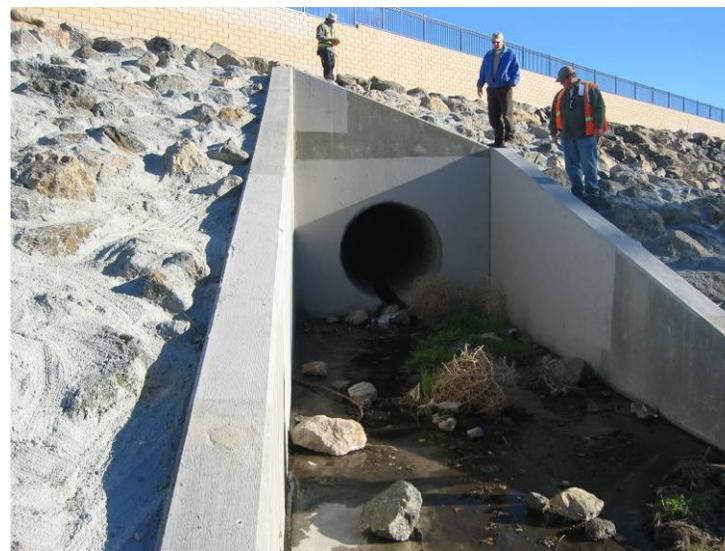
Arroyo Simi AS-6 (Photo No. P11R) – 60" RCP with a concrete outlet structure but w/o a closure device. An active stream was observed

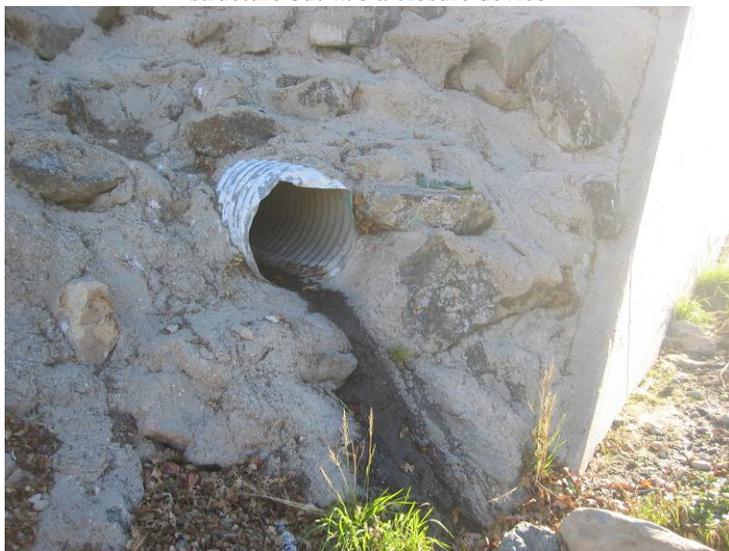
Arroyo Simi AS-6 (Photo No. P10R) – 24" CMP w/o a closure device

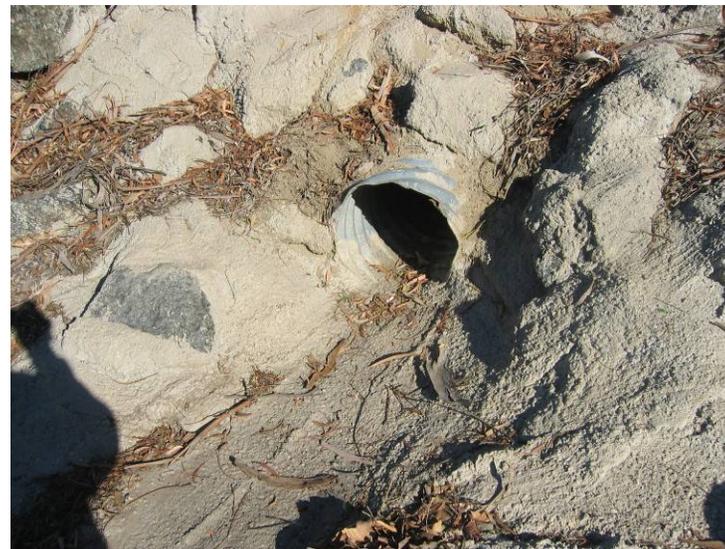
Arroyo Simi AS-6 (Photo No. P15R) – 16" CMP w/o a closure device

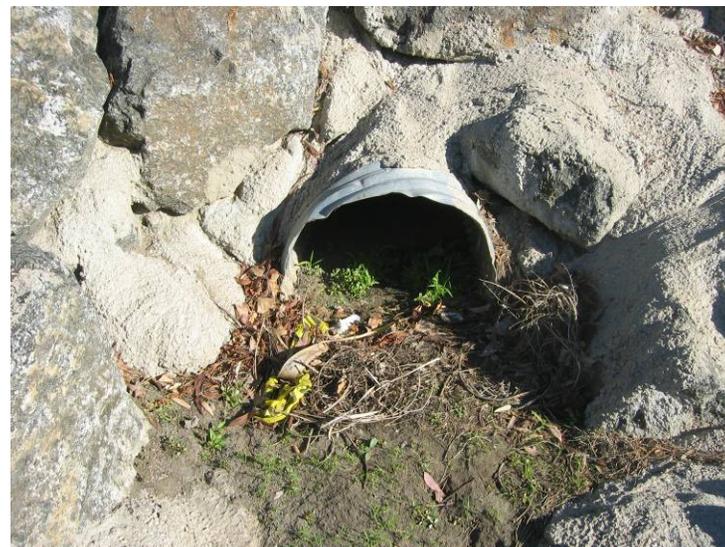
Arroyo Simi AS-6 (Photo No. P16R) – 24" CMP w/o a closure device

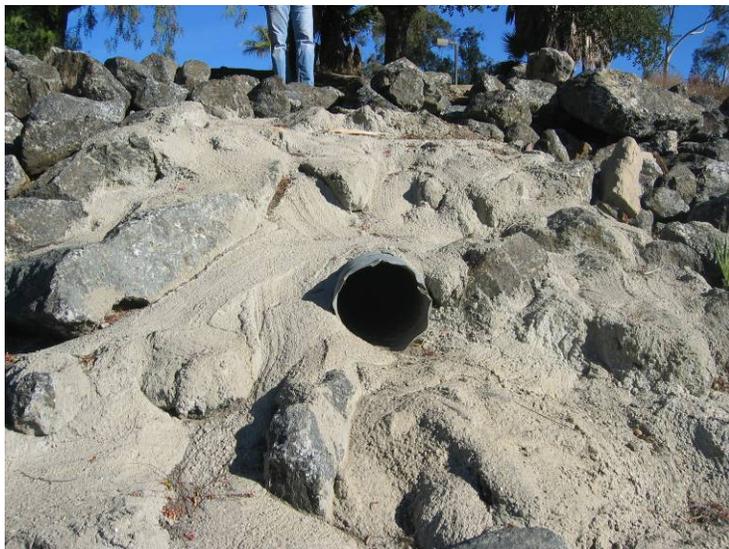
Arroyo Simi AS-6 (Photo No. P17R) – 12" CMP w/o a closure device

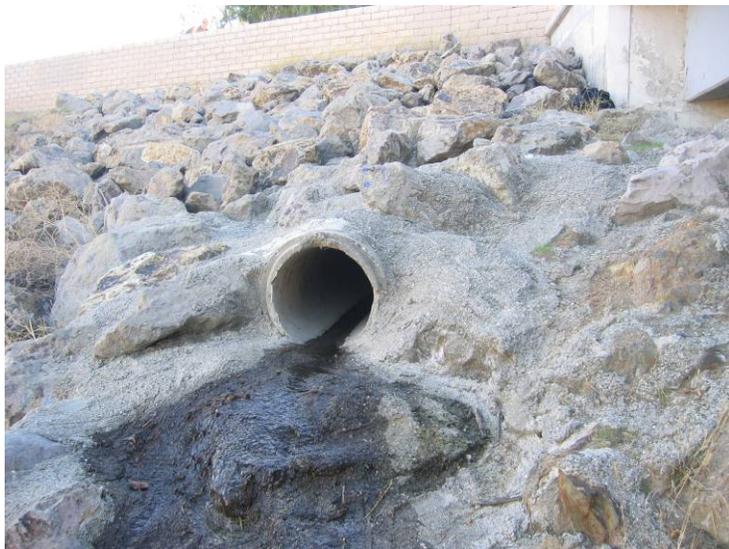
**Arroyo Simi (AS-6), (Photo No. M1L) – 18" RCP w/o a closure device
(Sta.63+35)**

GPS		*Photo No.	Description	Action Required
Lat	Long			
<i>Arroyo Simi Levee (AS-6) – Left Levee</i>				
N34.27018	W118.77863	M1L	18" RCP w/o a closure device (Sta.63+35)	Install a closure device, if appropriate.
N34.26948	W118.77635	M2L	18" CMP w/o a closure device (Sta.70+70)	Install a closure device, if appropriate.
N34.26943	W118.77617	M3L	Seepage through revetment (Riverward side)	Additional engineering analysis recommended
N34.26938	W118.77596	M4L	6" PVC w/o a closure device (Sta.73+90)	Install a closure device, if appropriate
N34.26938	W118.77596	M5L	Sink hole on top levee directly over 6" PVC	Repair a possibly broken 6" PVC line and fill the void with impervious material and firmly compact.
N34.26883	W118.77345	M6L	27" CMP w/o a closure device (Sta.80+42)	Install a closure device, if appropriate
N34.26883	W118.77345	M6L	18" CMP w/o a closure device (Sta.80+50)	Install a closure device, if appropriate

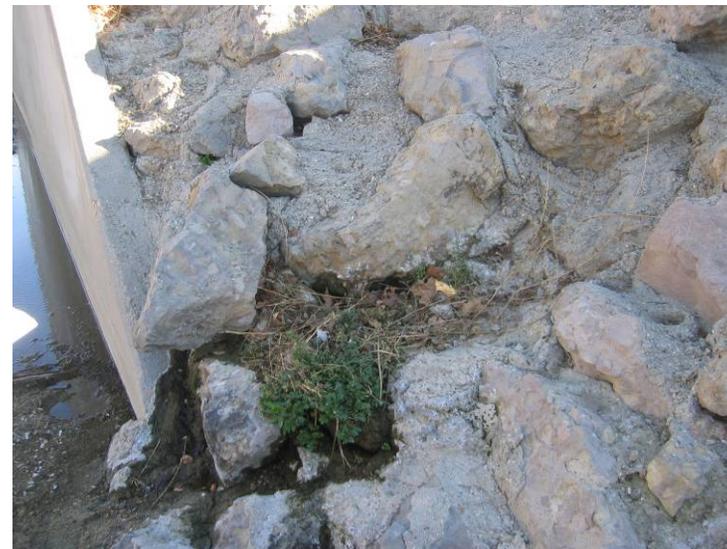
3. Seepage through the transitional grouted riprap revetment near the vertical walls of the drop structure was observed. At the time of the field investigation, an active trickle of water through slurry and subsequent growth of vegetation were observed. A source of the seepage is a recreational lake behind the levee. Impact to the integrity of the levee needs to be evaluated.

**Arroyo Simi (AS-6), (Photo No. M3L) – Seepage through revetment
(Riverward side)**

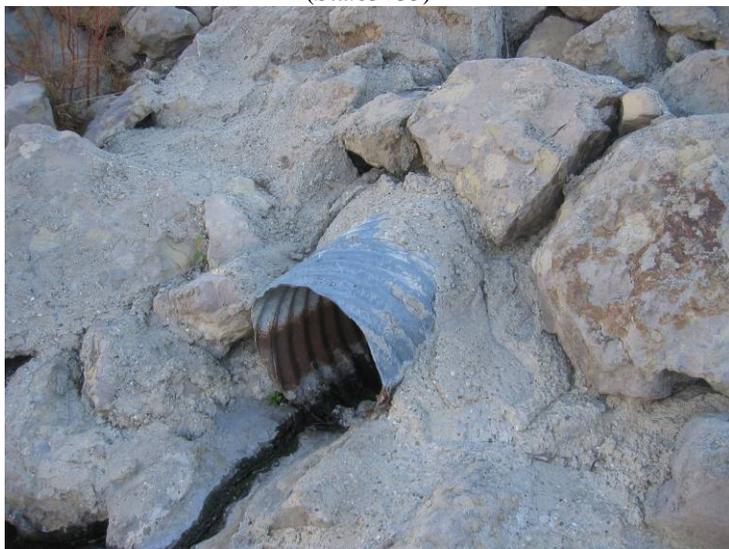
**Arroyo Simi (AS-6), (Photo No. M2L) – 18" CMP w/o a closure device
(Sta.70+70)**

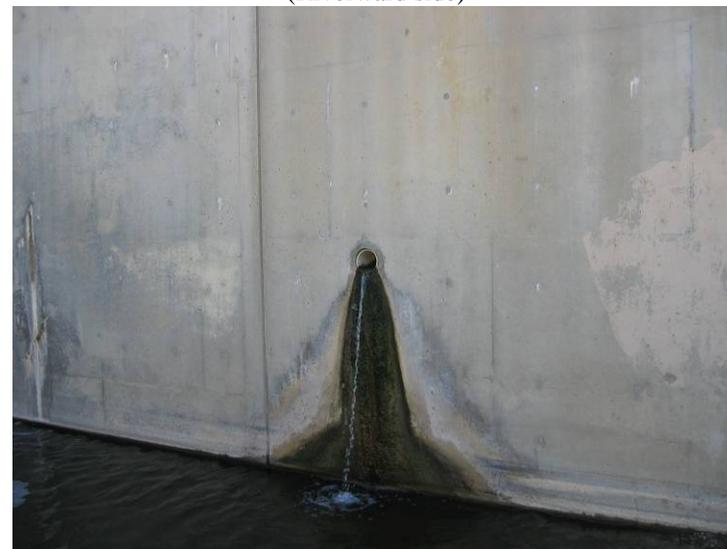
**Arroyo Simi (AS-6), (Photo No. M4L) – 6" PVC w/o a closure device
(Sta.73+90)**

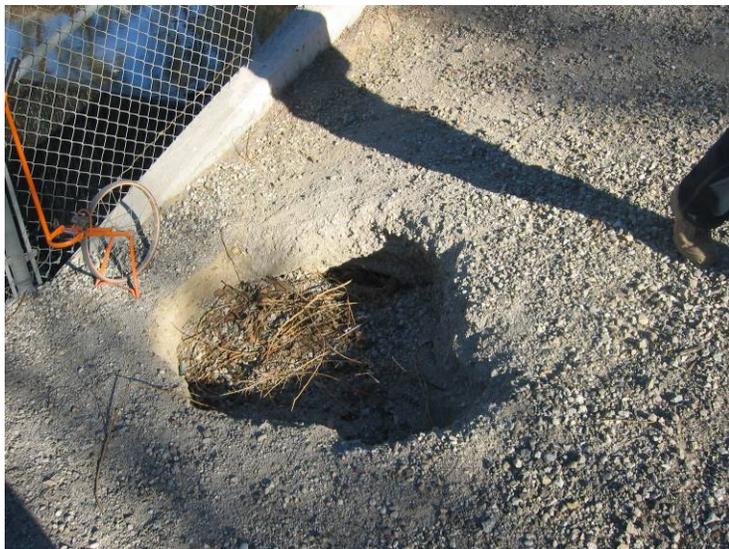
4. A sink hole was observed at the top of the levee. The hole may be created by the breakage of PVC pipe underneath with piping of material into the broken pipe and removed during periods of flow. County personnel stated that the hole is filled every year, however, a permanent repair needs to be applied.

3. Erosion / Bank Caving					A No active erosion, undermining, or bank caving due to riverbed degradation or flow impingement, observed on the landward or on the riverward side of the levee.	- A large sink hole, which is probably caused by fractured 6" PVC pipe directly underneath was observed on the left levee. - Erosion was noted on the landward side approximately at station 74+75 on the right levee which was caused by surface flow from top of the levee.
		X			M There are areas where active erosion is occurring or has occurred on or near the levee embankment, but levee integrity is not threatened.	
					U Erosion, undermining, or caving is occurring or has occurred along the toes that threatens the stability and integrity of the levee. The erosion or caving has progressed into the levee section or into the extended footprint of the levee foundation and has compromised the levee foundation stability.

Arroyo Simi (AS-6), (Photo No. M5L) – Sink hole on top levee directly over 6" PVC

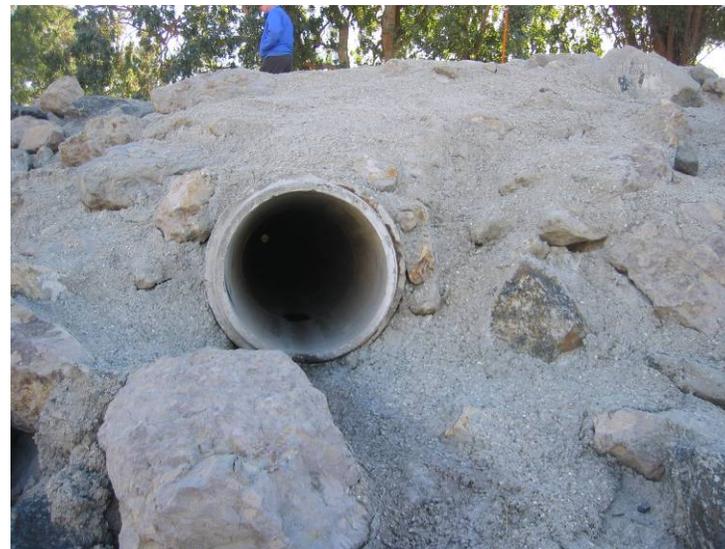
Arroyo Simi (AS-6), (Photo No. M7L) – 24" RCP w/o a closure device (Sta.84+50)

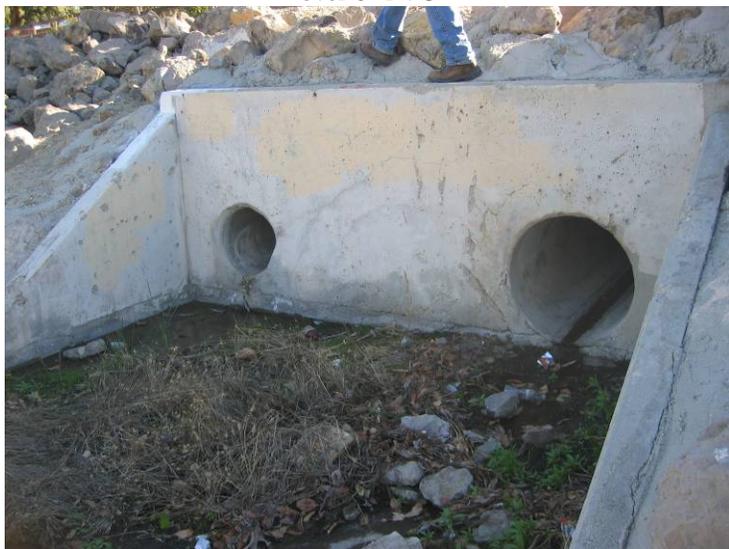
Arroyo Simi (AS-6), (Photo No. M6L) – A concrete outlet structure with 27" RCP and 18" CMP w/o a closure device

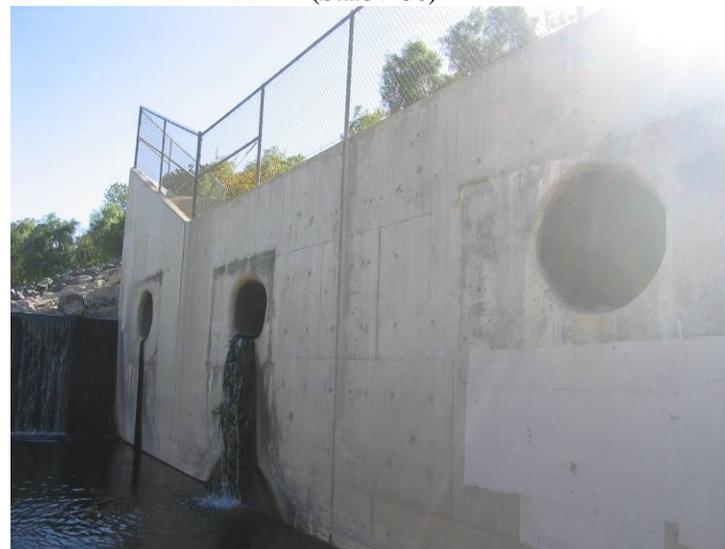
Arroyo Simi (AS-6), (Photo No. M8L) – 2-36" CMPs and 42" RCP w/o closure device on the side wall of a drop structure

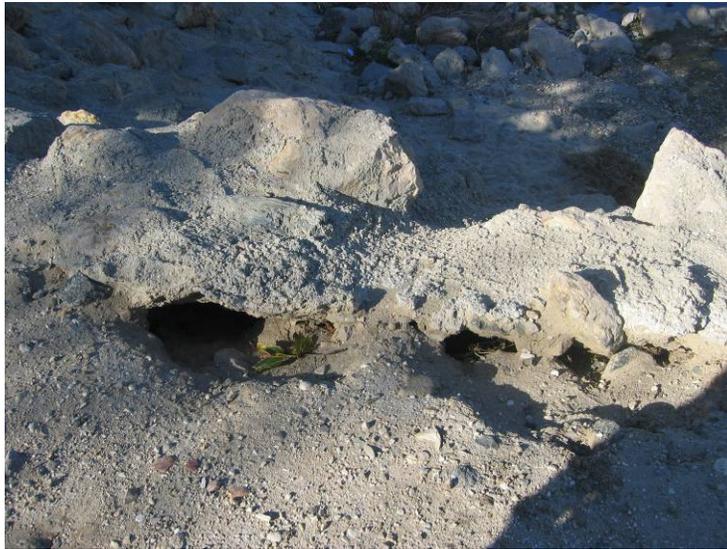
2. Multiple animal burrows were observed in the field. They are located near the top of the slope and along the interface between the revetment and dirt embankment. A few burrow holes were located on the asphalt-paved top of the levee. They do not affect the structural integrity of the levee, however, they need to be repaired during maintenance.

**Arroyo Simi (AS-6), (Photo No. M9L) – Animal burrow on top of levee
(Riverward side)**

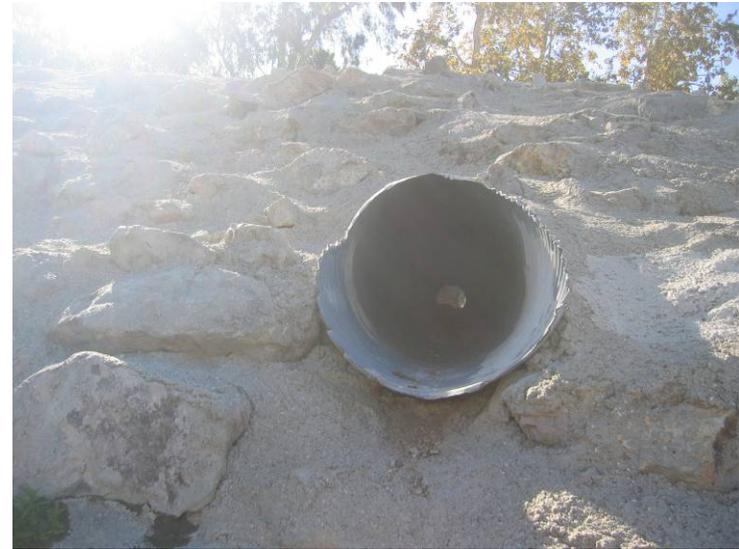
**Arroyo Simi (AS-6), (Photo No. M11L) – 36" CMP w/o a closure device
(Sta.105+90)**

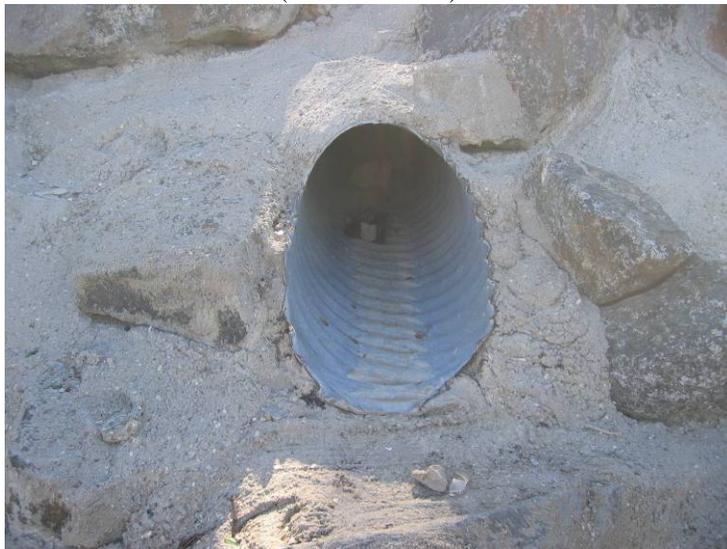
**Arroyo Simi (AS-6), (Photo No. M10L) – 16" CMP w/o a closure device
(Sta.97+10)**

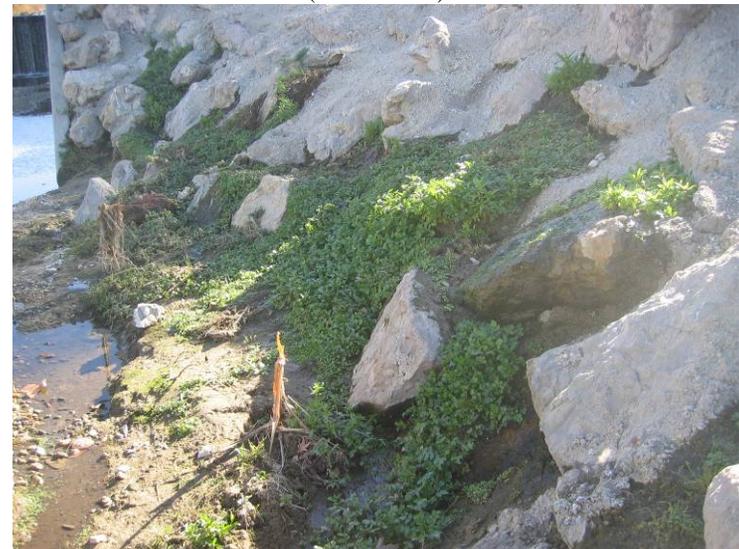
**Arroyo Simi (AS-6), (Photo No. M12L) – Seepage through revetment
(Riverward side)**

GPS		*Photo No.	Description	Action Required
Lat	Long			
N34.26742	W118.76515	M12L	Seepage through revetment (Riverward side)	Additional engineering analysis recommended
N34.27018 to N34.26652	W118.77863 to W118.76153	M13L	Vegetation within 15' of Toe (Landward side)	Remove vegetation and root ball, fill voids with impervious material and firmly compact.
<i>Arroyo Simi Levee (AS-6) – Right Levee</i>				
N34.27037	W118.77862	M1R	12" CMP w/o a closure device (Sta.62+95)	Install a closure device, if appropriate.
N34.27003	W118.77754	M2R	18" CMP w/o a closure device (Sta.66+50)	Install a closure device, if appropriate
N34.26981	W118.77668	M3R	24" RCP w/o a closure device (Sta.69+38)	Install a closure device, if appropriate
N34.26969	W118.77613	M4R	18" CMP w/o a closure device (Sta.70+90)	Install a closure device, if appropriate
N34.26953	W118.77491	M5R	Surface erosion exposing an utility line (Landward side)	Fill voids with impervious material and firmly compact

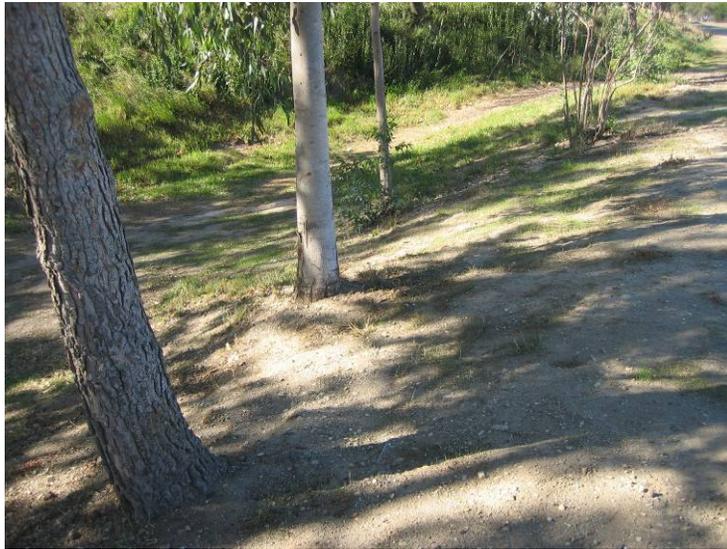
Arroyo Simi (AS-6), (Photo No. M13L) – Vegetation within 15' of Toe
(Landward Side)

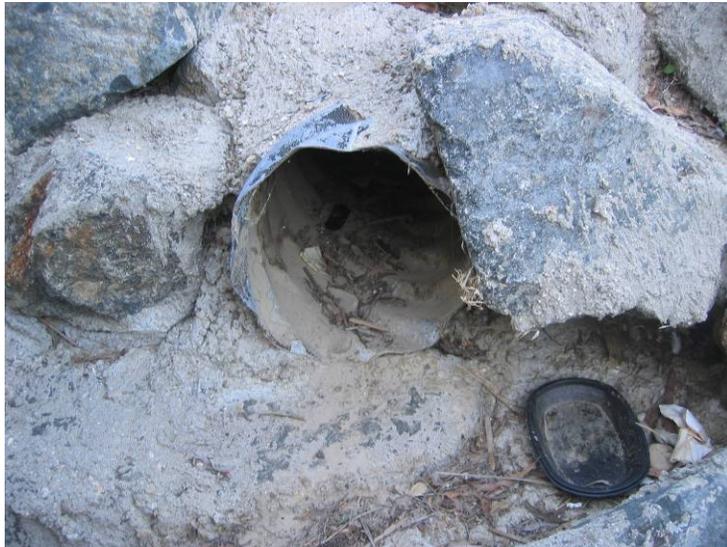
**Arroyo Simi (AS-6), (Photo No. M1R) – 12" CMP w/o a closure device
(Sta.62+95)**

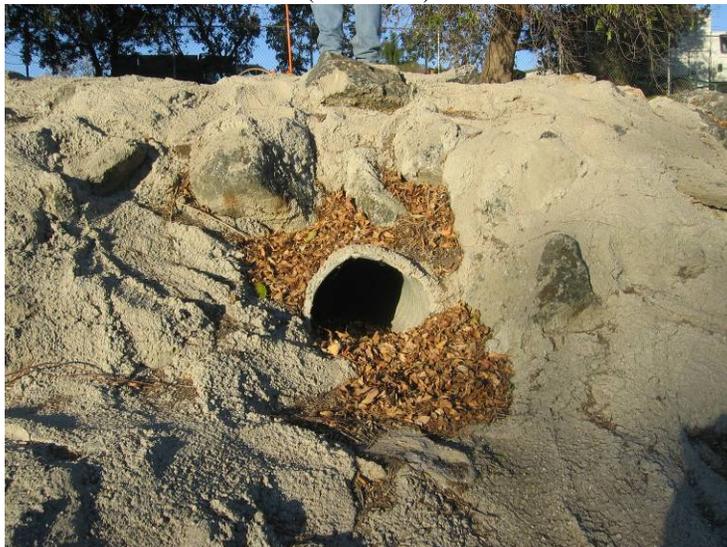
**Arroyo Simi (AS-6), (Photo No. M2R) – 18" CMP w/o a closure device
(Sta.66+50)**

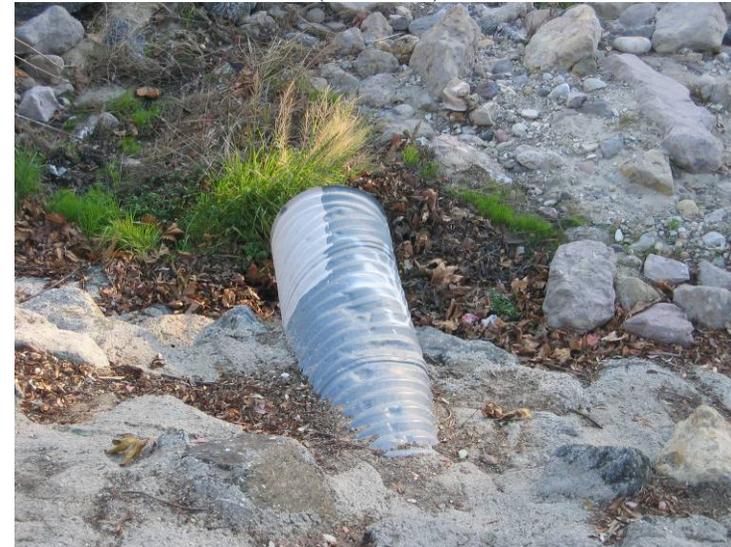
**Arroyo Simi (AS-6), (Photo No. M4R) – 18" CMP w/o a closure device
(Sta.70+90)**

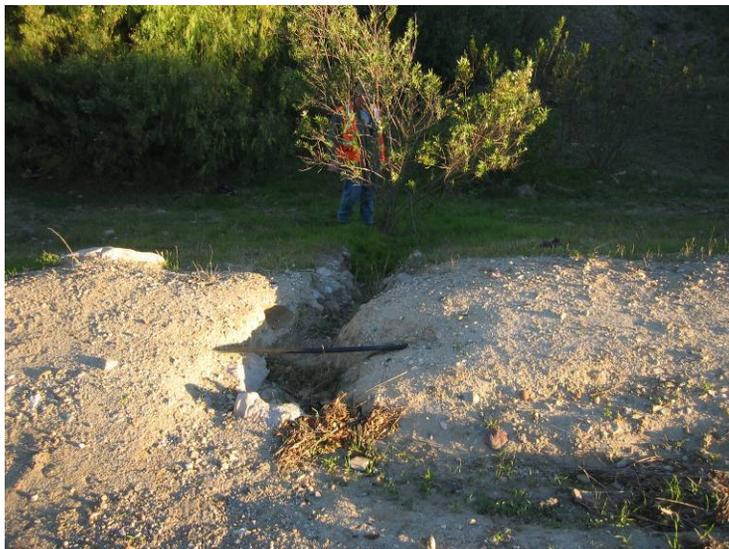
Arroyo Simi (AS-6), (Photo No. M5R) – Surface erosion exposing an utility line (Landward side)

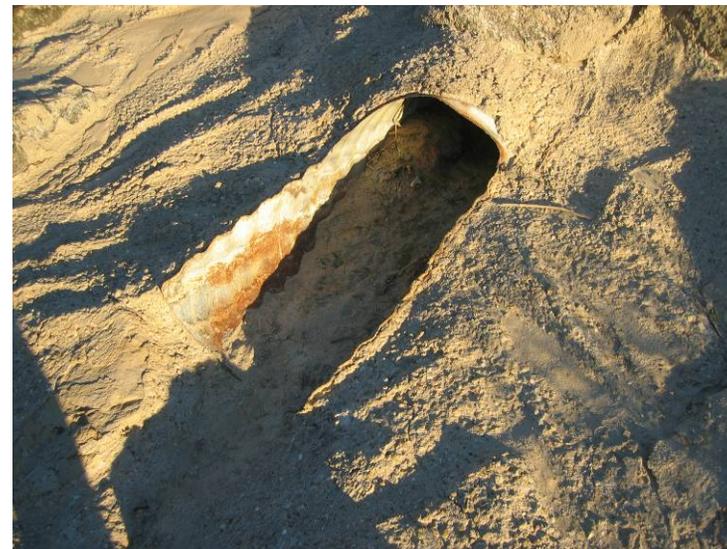
Arroyo Simi (AS-6), (Photo No. M7R) – 18” CMP w/o a closure device (Sta.74+80)

N34.26953	W118.77491	M6R	A stock pile of debris and trash at toe (Landward side)	Remove debris and trash.
N34.26939	W118.77494	M7R	18" CMP w/o a closure device (Sta.74+80)	Install a closure device, if appropriate
N34.26920	W118.77402	M8R	36" CMP w/o a closure device (Sta.77+90)	Install a closure device, if appropriate
N34.26855	W118.77132	M9R	10" PVC w/o a closure device (Sta.86+34)	Install a closure device, if appropriate
N34.26855	W118.77132	M10R	A hole at the bottom of outlet structure for 10" PVC	Remove debris and repair the concrete slab portion of outlet structure.
N34.26834	W118.77088	M11R	18" RCP w/o a closure device (Sta.87+92)	Install a closure device, if appropriate
N34.26804	W118.77035	M12R	18" RCP w/o a closure device (Sta.89+91)	Install a closure device, if appropriate
N34.26793	W118.77018	M13R	24" CMP w/o a closure device (Sta.90+09)	Install a closure device, if appropriate

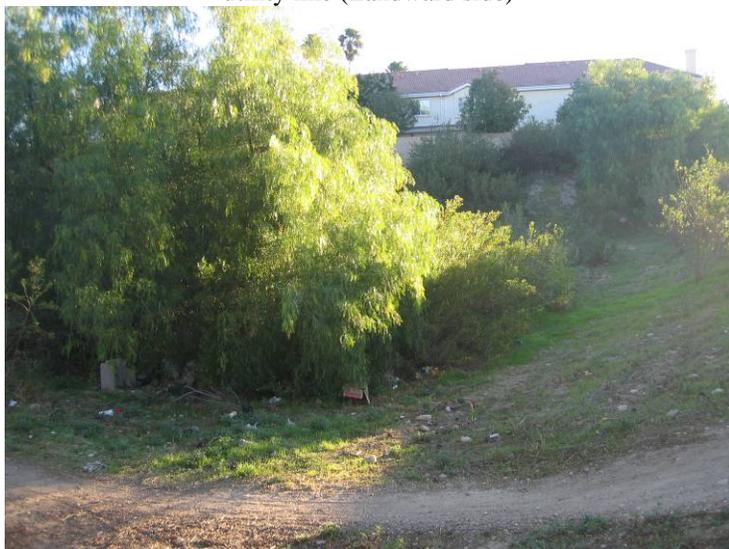
Arroyo Simi (AS-6), (Photo No. M6R) – A stock pile of debris and trash at toe (Landward side)

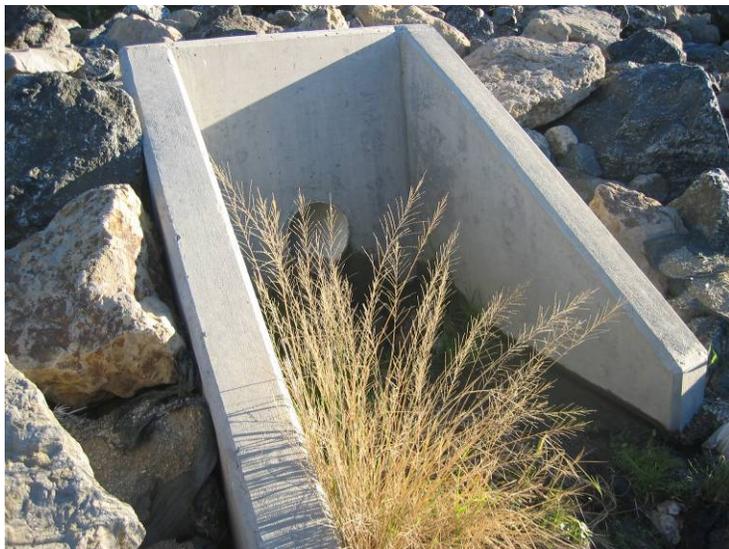
**Arroyo Simi (AS-6), (Photo No. M9R) – 10” PVC w/o a closure device
(Sta.86+34)**

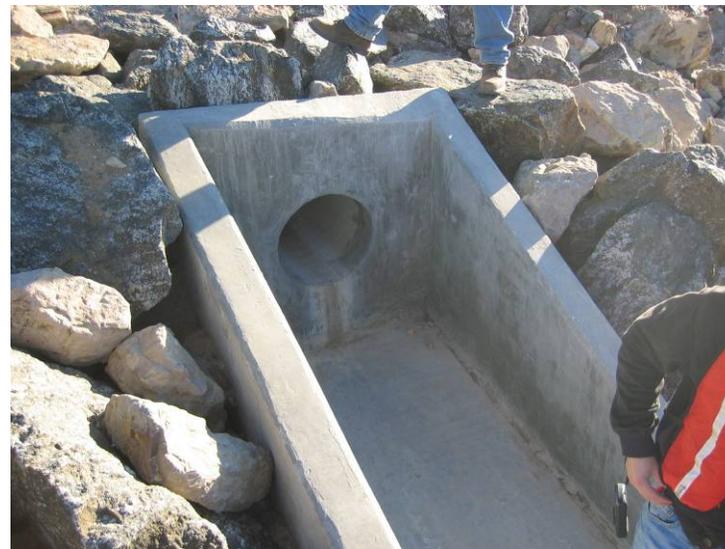
**Arroyo Simi (AS-6), (Photo No. M11R) – 18” RCP w/o a closure device
(Sta.87+92)**

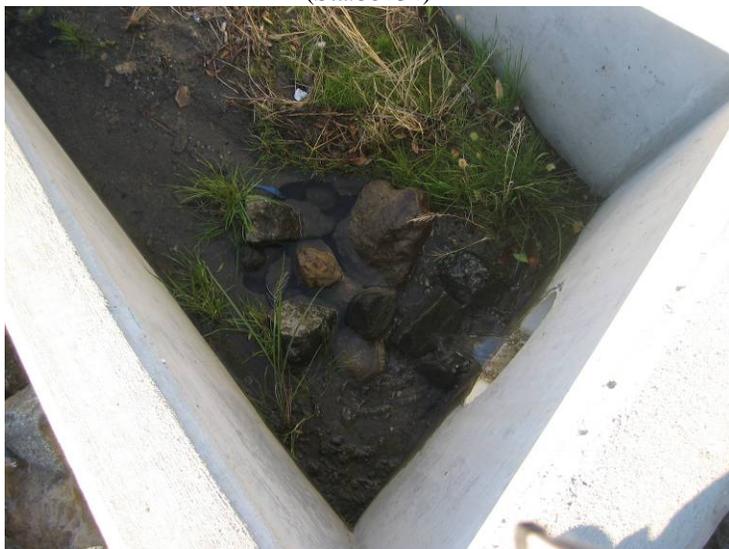
5. A concrete outlet structure for a 10-inch PVC pipe on the right side levee has a 12-inch diameter hole at the invert of the structure and needs to be repaired.

**Arroyo Simi (AS-6), (Photo No. M10R) – A hole at the bottom of outlet
structure for 10” PVC**

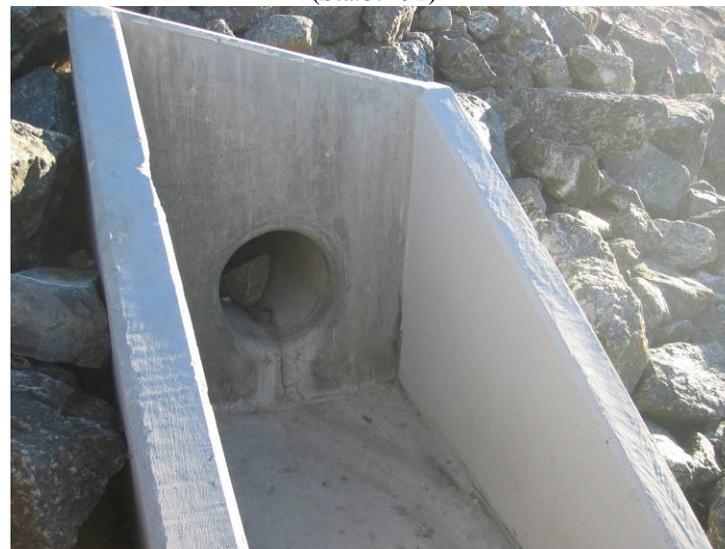
**Arroyo Simi (AS-6), (Photo No. M12R) – 18” RCP w/o a closure device
(Sta.89+91)**

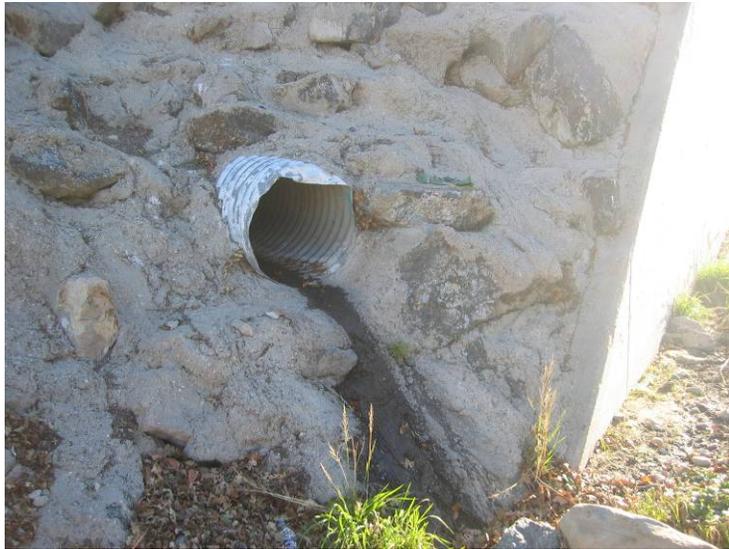
**Arroyo Simi (AS-6), (Photo No. M13R) – 24" CMP w/o a closure device
(Sta.90+09)**

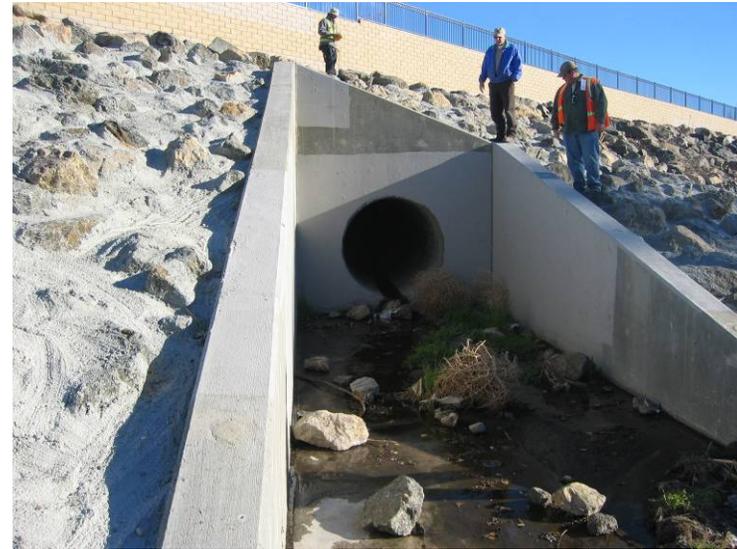
**Arroyo Simi (AS-6), (Photo No. M15R) – 60" RCP w/o a closure device
(Sta.101+93)**

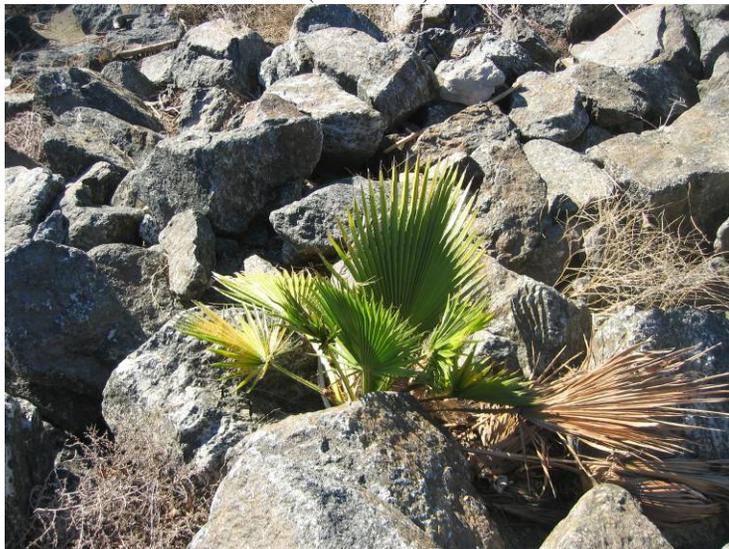
**Arroyo Simi (AS-6), (Photo No. M14R) – A small palm tree through
revetment (Riverward side)**

GPS		*Photo No.	Description	Action Required
Lat	Long			
N34.26768	W118.76773	M14R	A small palm tree through revetment (Riverward side)	Remove vegetation and root ball, fill voids with impervious material and firmly compact.
N34.26784	W118.76654	M15R	60" RCP w/o a closure device (Sta.101+93)	Install a closure device, if appropriate
N34.26769	W118.76510	M16R	Seepage through revetment (Riverward side)	Additional engineering analysis recommended
N34.26754	W118.76457	M17R	Debris inside a outlet structure for 12" RCP with a flap gate (Riverward side)	Remove debris and establish a clear passage from pipe to the channel
N34.26740	W118.76355	M18R	16" CMP w/o a closure device (Sta.110+80)	Install a closure device, if appropriate
N34.26715	W118.76264	M19R	24" CMP w/o a closure device (Sta.113+85)	Install a closure device, if appropriate
N34.26701	W118.76209	M20R	12" CMP w/o a closure device (Sta.115+40)	Install a closure device, if appropriate

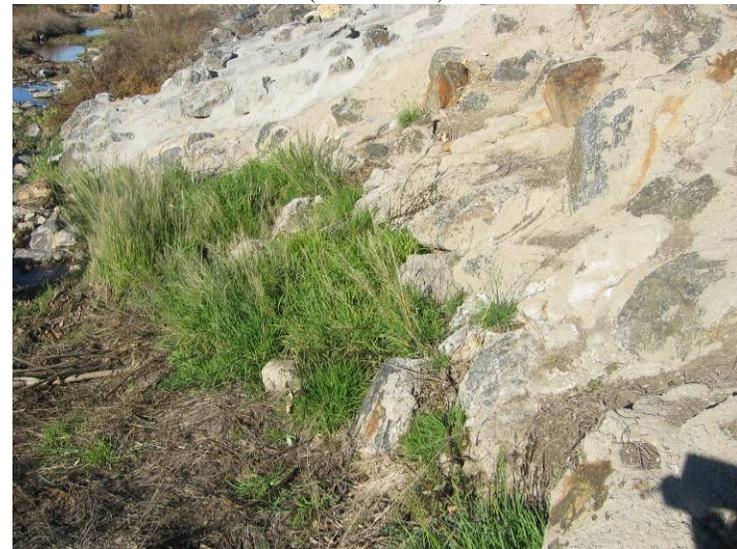
**Arroyo Simi (AS-6), (Photo No. M16R) – Seepage through revetment
(Riverward side)**

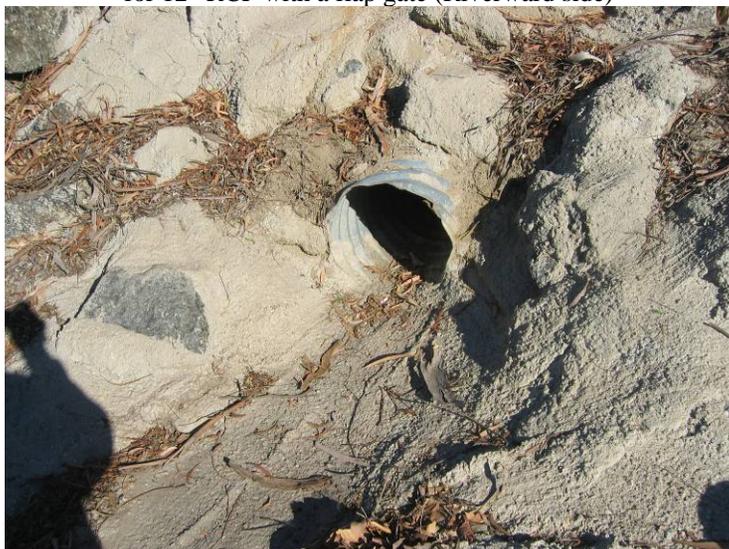
Arroyo Simi (AS-6), (Photo No. M18R) – 16" CMP w/o a closure device (Sta.110+80)
