**FEMA Levee Certification
Ventura County, California**

**Arroyo Simi Levee (AS-6)
First Street to Erringer Road**

**Evaluation Report
February 13, 2009**

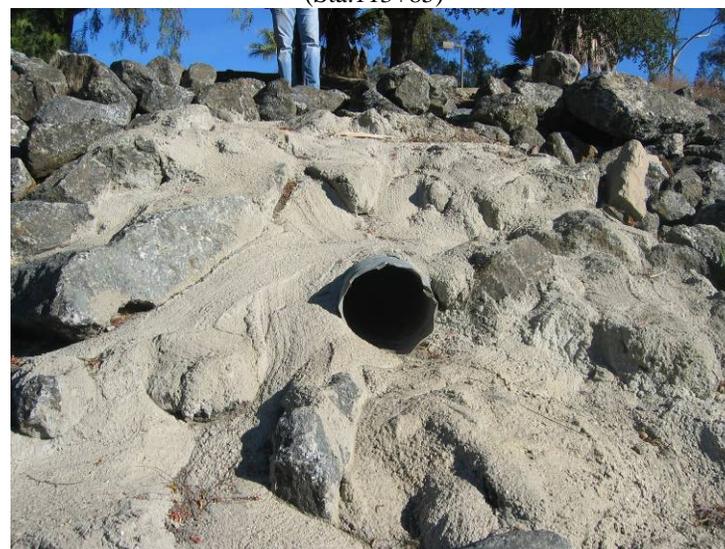
Arroyo Simi (AS-6), (Photo No. M20R) – 12" CMP w/o a closure device (Sta.115+40)

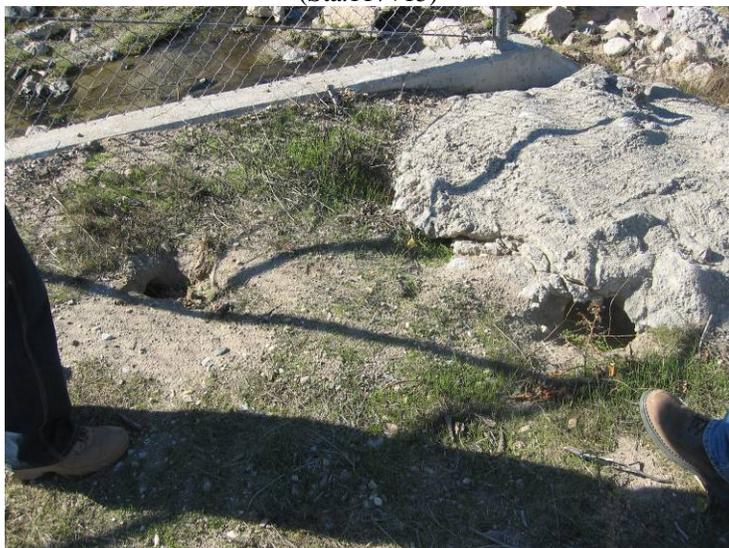
**Arroyo Simi (AS-6), (Photo No. M22R) – Animal burrow on top of levee
(Riverward side)**
