**FEMA Levee Certification
Ventura County, California**

**Arroyo Simi Floodwall (AS-7)
South Pacific Railroad Bridge to Stow Street**

**Evaluation Report
February 13, 2009**

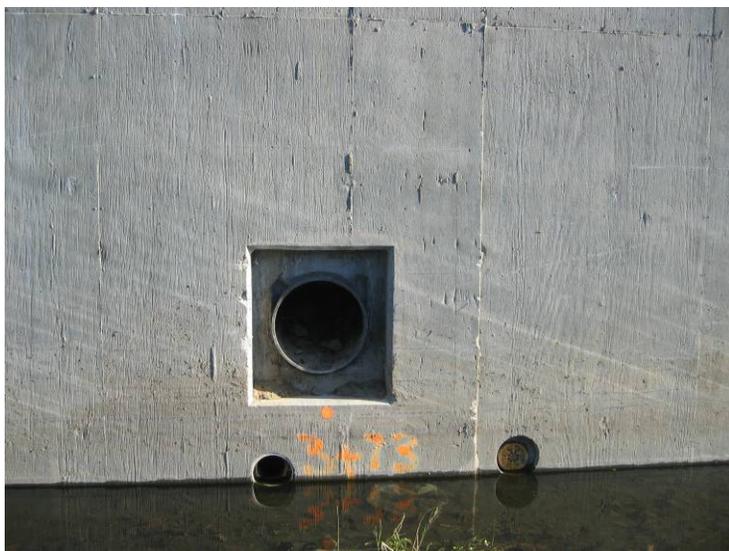
Arroyo Simi Floodwall (AS-7) (Photo No. P1L) – 18” CMP with a missing flap gate

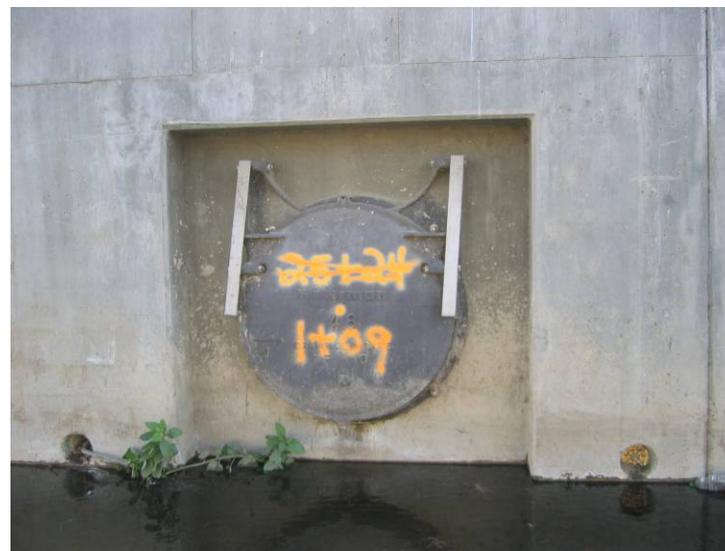
Arroyo Simi Floodwall (AS-7) (Photo No. P3L) – 48” RCP with a 48” dia. flap gate. A catch basin is located at Katherine Rd.

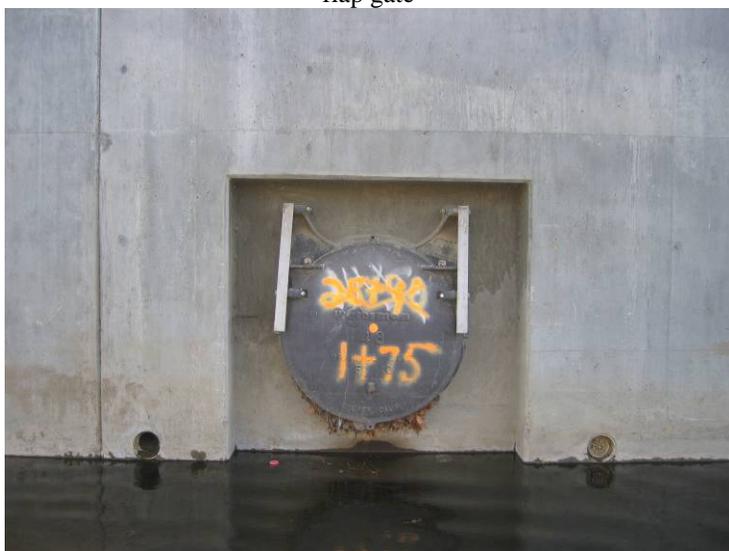
Arroyo Simi Floodwall (AS-7) (Photo No. P2L) – 48” RCP with a 48” dia. flap gate. A catch basin is located at Katherine Rd.

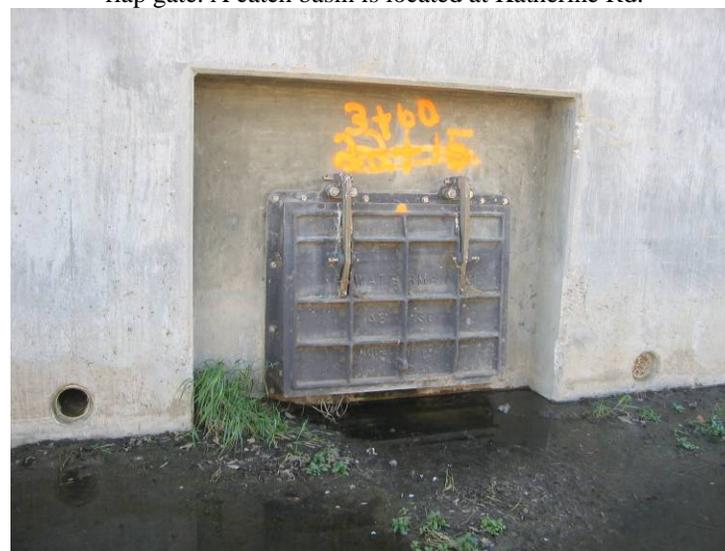
Arroyo Simi Floodwall (AS-7) (Photo No. P4L) – 36”RCP with a 48”x36” flap gate

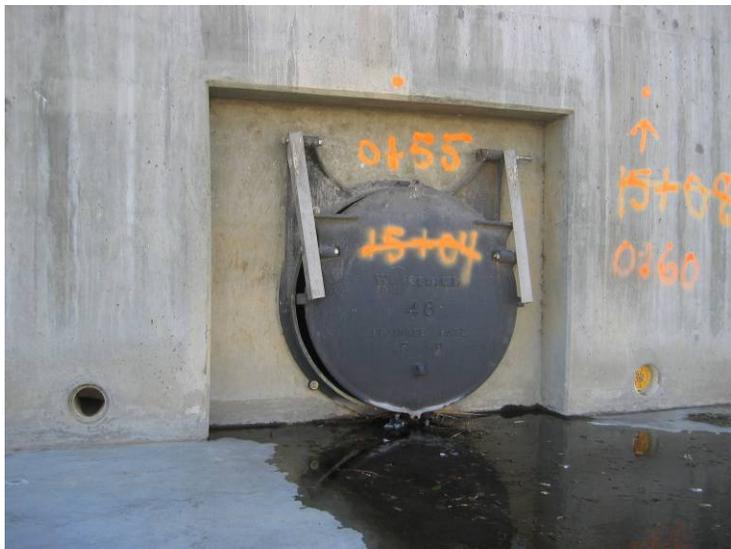
Arroyo Simi Floodwall (AS-7) (Photo No. P5L) – 48” RCP with a 48” dia. flap gate

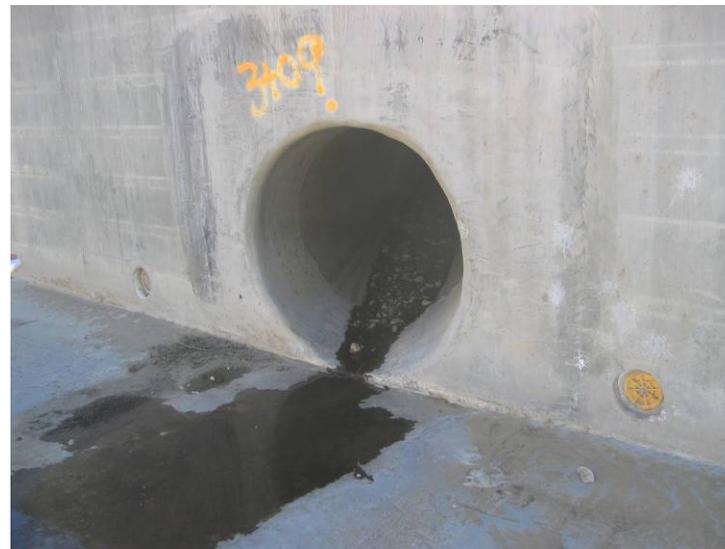
Arroyo Simi Floodwall (AS-7) (Photo No. P7L) – 48” RCP w/o a closure device

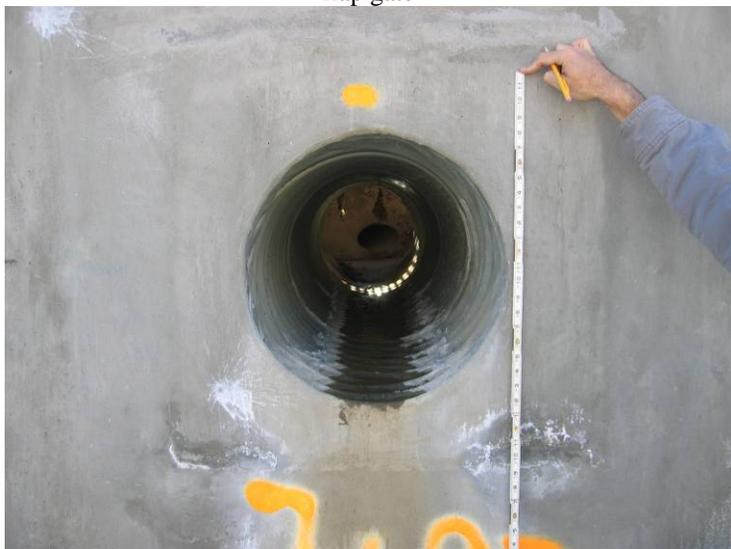
Arroyo Simi Floodwall (AS-7) (Photo No. P6L) – 18” CMP w/o a closure device

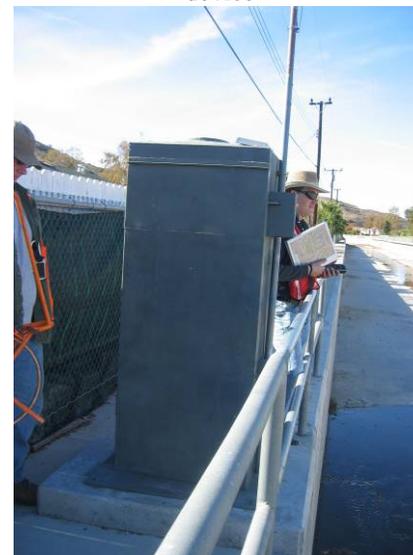
Arroyo Simi Floodwall (AS-7) (Photo No. FIL) – A stream gaging station on top of the channel.

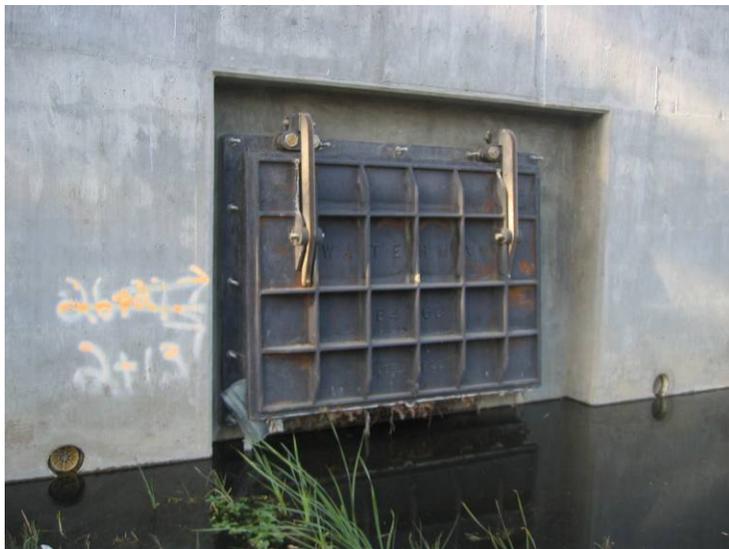
Arroyo Simi Floodwall (AS-7) (Photo No. P1R) – 60” RCP with a 84”x
60” flap gate

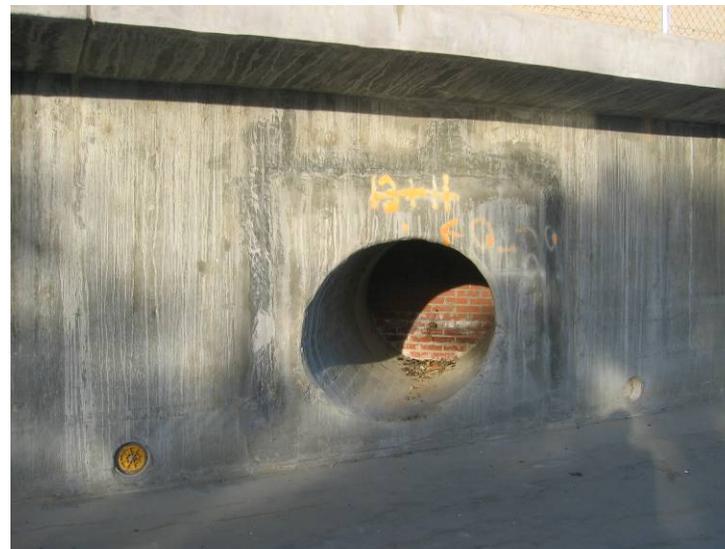
Arroyo Simi Floodwall (AS-7) (Photo No. P3R) – Abandoned 48” RCP
Stubout with 8” thick brick and mortar

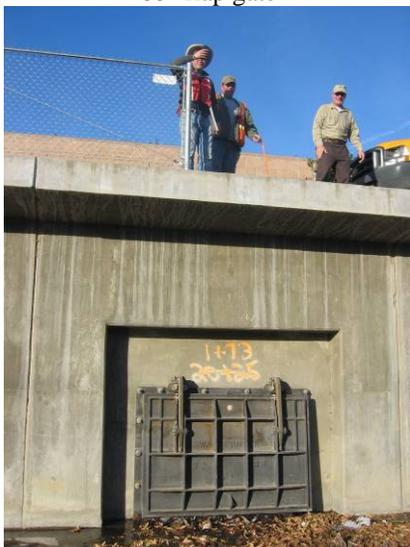
Arroyo Simi Floodwall (AS-7) (Photo No. P2R) – 48” CMP with a
72”x42” flap gate

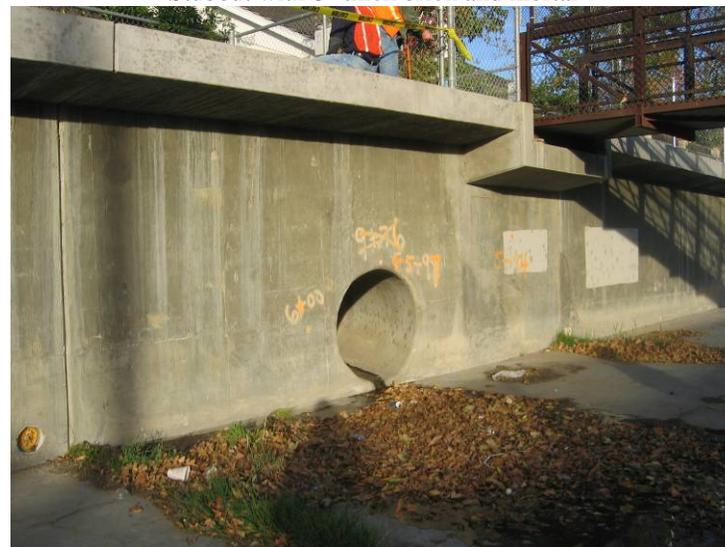
Arroyo Simi Floodwall (AS-7) (Photo No. P4R) – 48” RCP w/o a closure
device

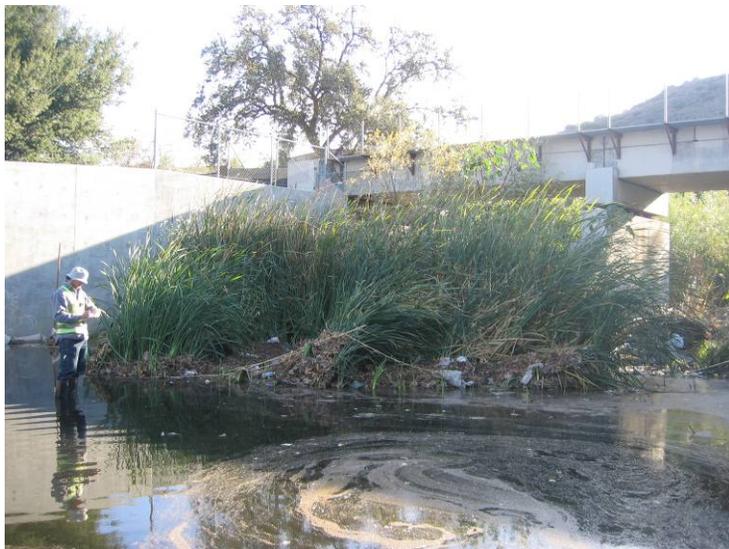
2. Heavy infestation of vegetation was present at the downstream end of the rectangular channel near the existing railroad bridge. The vegetation is likely a continuation of the existing vegetation from the natural creek downstream creeping into the concrete channel bottom. Currently, the vegetation acts as an obstruction of flow creating backwater up to 12 inches deep for more than a few hundred feet upstream of the vegetation. Deposition of fine sediment and growth of algae were observed in the backwater area. The vegetation needs to be removed in order to restore the design channel capacity.

Arroyo Simi Floodwall (AS-7) (Photo No. M1L) – Heavy vegetation at the downstream end of the concrete channel creating over 8” deep backwater

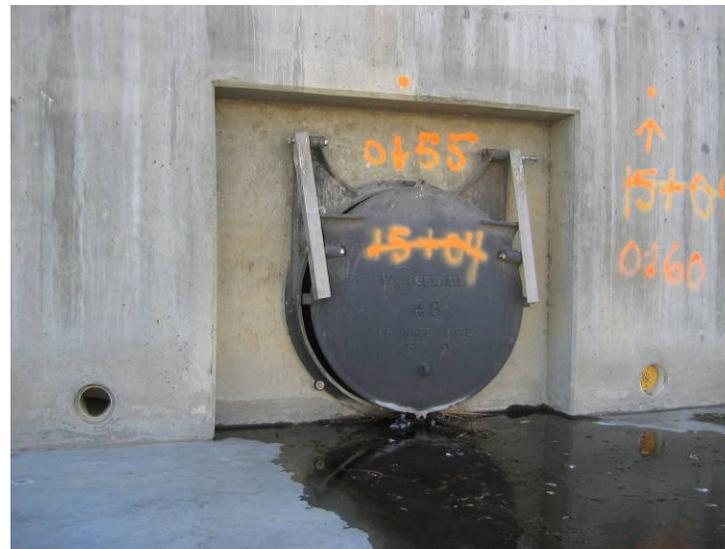
Arroyo Simi Floodwall (AS-7) (Photo No. M3L) – 48” RCP with a misaligned 48” dia. flap gate (Sta.113+72.8)

M3L	48" RCP with a misaligned 48" dia. flap gate (Sta.113+72.8)	Adjust a flap gate to ensure a complete seal around pipe opening.	C5 - Survey needed for drain elevation, Maybe City of Simi Valley	E1	Flapgate adjustment ok	X		
M4L	Seepage through 3 expansion joints of vertical wall (Riverward side)	Additional engineering analysis recommended	C5 - Obtain direction from D&C.	Depends on corrective action	E2 if need to excavate and recompact, install new drain		What degree of seepage becomes a problem that prevents certification?	Further analysis is required to make that determination. Provided that the wall and channel bottom have been designed to accommodate this condition and that existing and anticipated future groundwater conditions are within the anticipated ranges utilized in design, certification may proceed.
M5L	18" CMP w/o a closure device (Sta.120+72)	Install a closure device, if appropriate.	C5 - Survey needed for drain elevation, Maybe City of Simi Valley	E2	Install of headwall =excav/concrete in levee	X	Is this flap gate required? Who will determine ownership?	Determination of the need for a flap gate will require a channel hydraulic analysis and an interior drainage analysis. These analyses will be performed during the next phase of work. If as-builts are not available to determine ownership a survey will be required to establish elevations of the storm drain inverts and tops of outlet, inlets, manholes..etc.

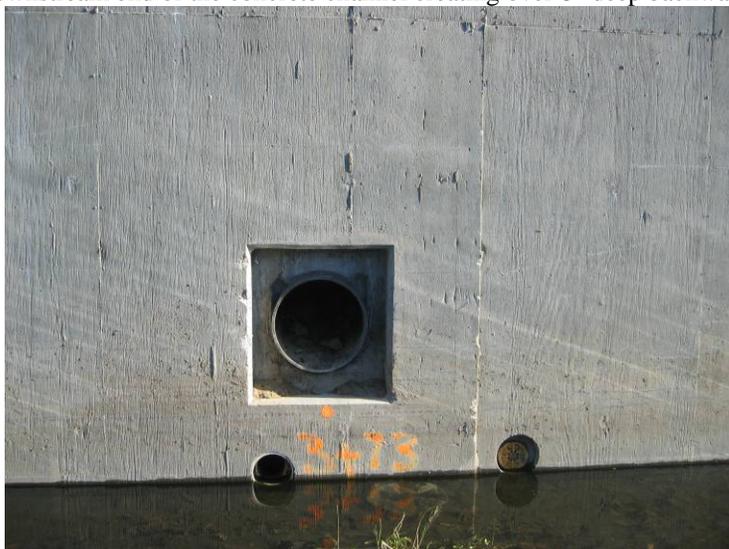
Arroyo Simi Floodwall (AS-7) (Photo No. M2L) – 18” CMP with a missing flap gate (Sta.101+13)

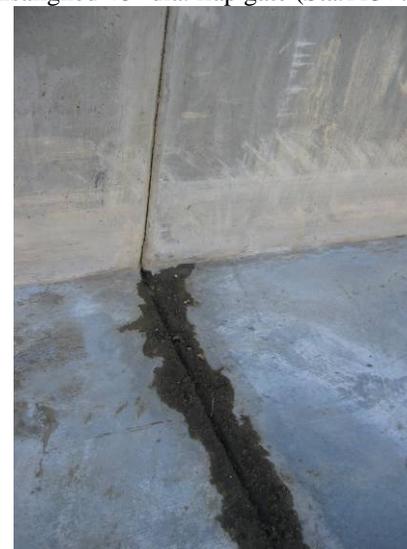
3. Leakage of ground water was observed through expansion joints of the concrete channel's vertical and invert sections. No active seepage was observed during the inspection, however, traces of effloresce was observed

Arroyo Simi Floodwall (AS-7) (Photo No. M4L) – Seepage through 3 expansion joints of vertical wall (Riverward side)

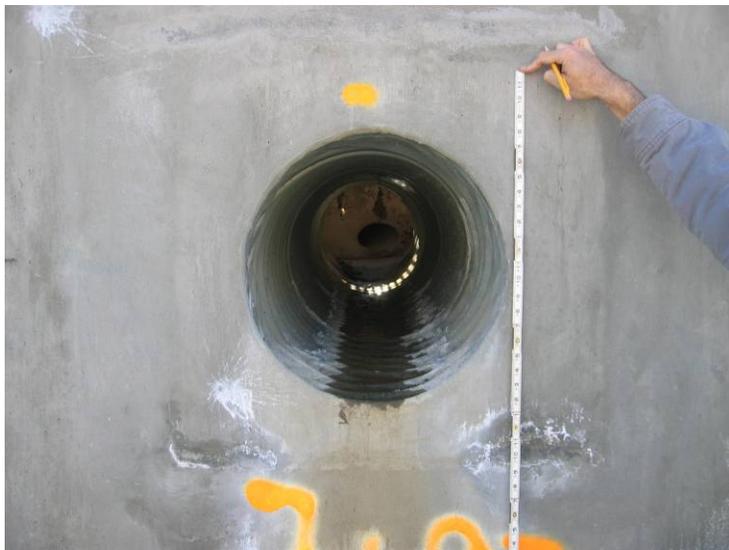
Arroyo Simi Floodwall (AS-7) (Photo No. M5L) – 18” CMP w/o a closure device (Sta.120+72)

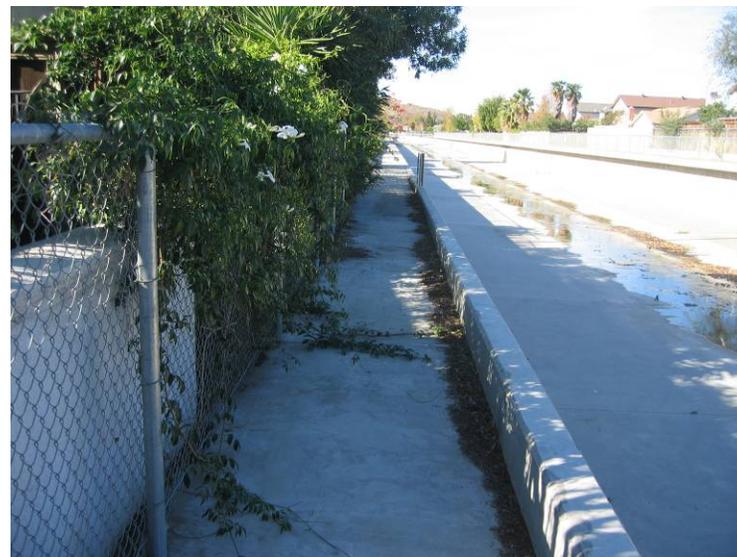
Arroyo Simi Floodwall (AS-7) (Photo No. M7L) – Vegetation within 15’ of floodwall face or 8’ from foundation (Landward side)

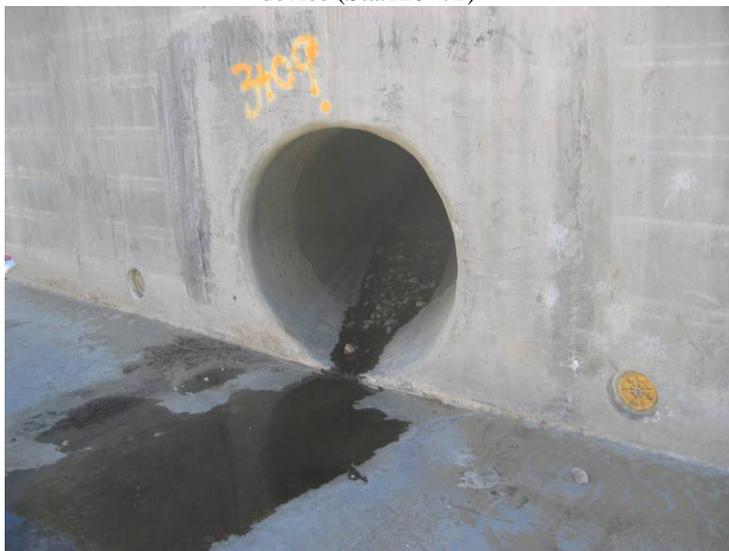
Arroyo Simi Floodwall (AS-7) (Photo No. M6L) – 48” RCP w/o a closure device (Sta.125+66.1)

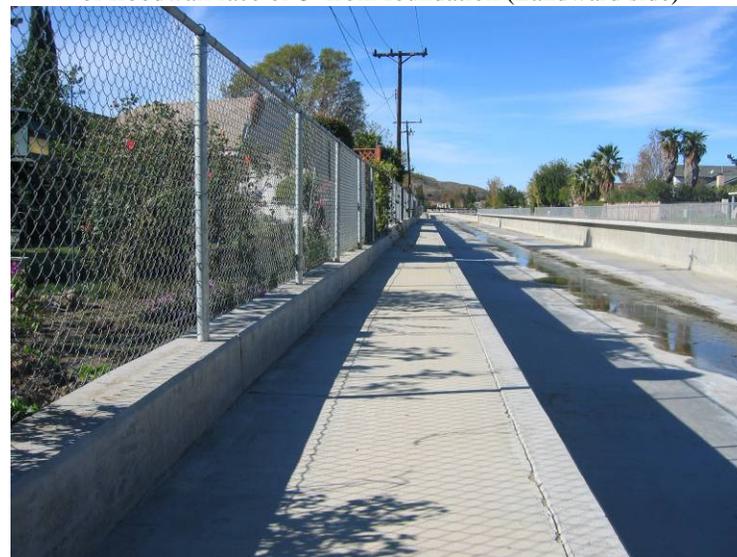
Arroyo Simi Floodwall (AS-7) (Photo No. M8L) – Utility poles along top of levee (Landward side)

M8L	Utility poles along top of levee (Landward side)	Relocation of utility poles may be required.	C5 - Planning to coordinate removal of poles with SCE.	E1	Unless major reconstruction, no permits	X	Why are some utility poles an issue, and some are not?	Utility poles within the embankment prism (only 1 on SCR-1) must be relocated. These poles do not require relocation.
Arroyo Simi Flood Wall (AS-7) – Right Side Category 2								
M1R	A missing section of chain link fence on top of channel wall (Riverward side)	Install a double swing gate for the chain link fence.	C1	E1	Fencing repair not regulated		This fence has been replaced.	Noted
M2R	48" RCP w/o a closure device (Sta.119+06.5)	Install a closure device, if appropriate.	C5 - Survey needed for drain elevation, Maybe City of Simi Valley	E2	Install of headwall =excav/concrete in levee	X	Is this flap gate required? Who will determine ownership?	Determination of the need for a flap gate will require a channel hydraulic analysis and an interior drainage analysis. These analyses will be performed during the next phase of work. If as-builts are not available to determine ownership a survey will be required to establish elevations of the storm drain inverts and tops of outlet, inlets, manholes..etc.

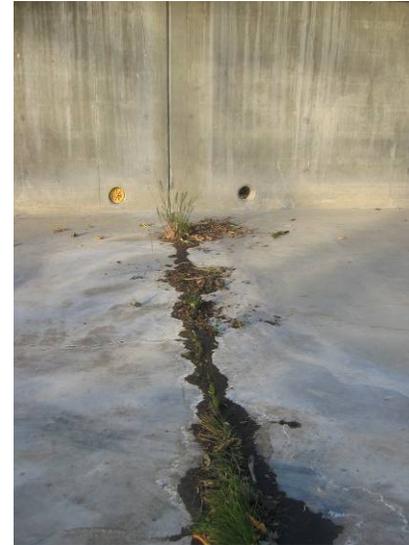
Arroyo Simi Floodwall (AS-7) (Photo No. M3R) – Seepage through 4 expansion joints of vertical wall (Riverward side)

M3R	Seepage through 4 expansion joints of vertical wall (Riverward side)	Additional engineering analysis recommended	C5 - Obtain direction from D&C.	Depends on corrective action	E2 if need to excavate and recompact, install new drain		What degree of seepage becomes a problem that prevents certification?	Further analysis is required to make that determination. Provided that the wall and channel bottom have been designed to accommodate this condition and that existing and anticipated future groundwater conditions are within the anticipated ranges utilized in design, certification may proceed.
M4R	Vegetation within 15' of floodwall face or 8' from foundation (Landward side)	Vegetation and root ball may need to be removed. Then, fill voids with impervious material and firmly compact.	C5 - PR issue with landowner.	E1	Landward veg removal not regulated	X	Is this vegetation on private property? Is this wall a flood wall?	In this particular case, vegetation removal is not required, since the foundation of the reinforced concrete channel is well below the influence of the vegetation root system.

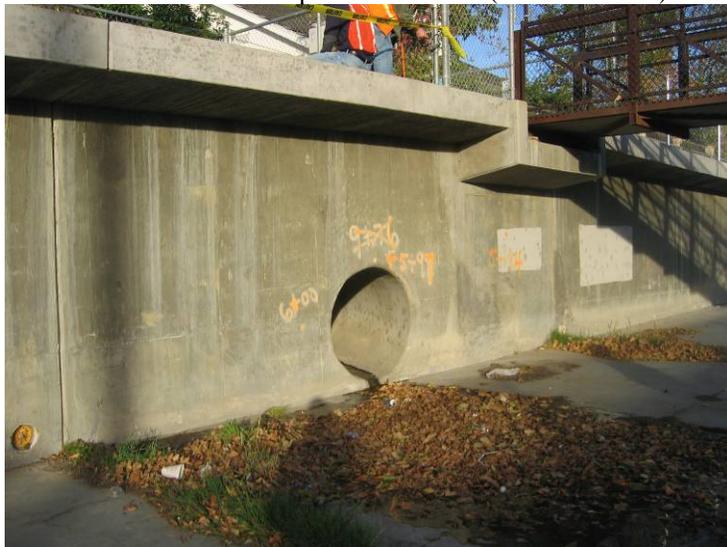
Arroyo Simi Floodwall (AS-7) (Photo No. M2R) – 48” RCP w/o a closure device (Sta.119+06.5)

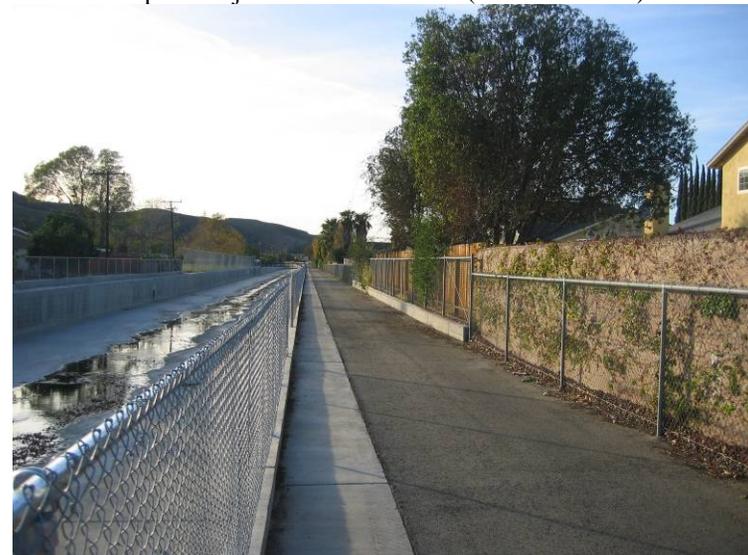
Arroyo Simi Floodwall (AS-7) (Photo No. M4R) – Vegetation within 15’ of floodwall face or 8’ from foundation (Landward side)
