**FEMA Levee Certification
Ventura County, California**

**Santa Clara River Levee (SCR-1)
Highway 101 to Saticoy**

**Evaluation Report
February 13, 2009**

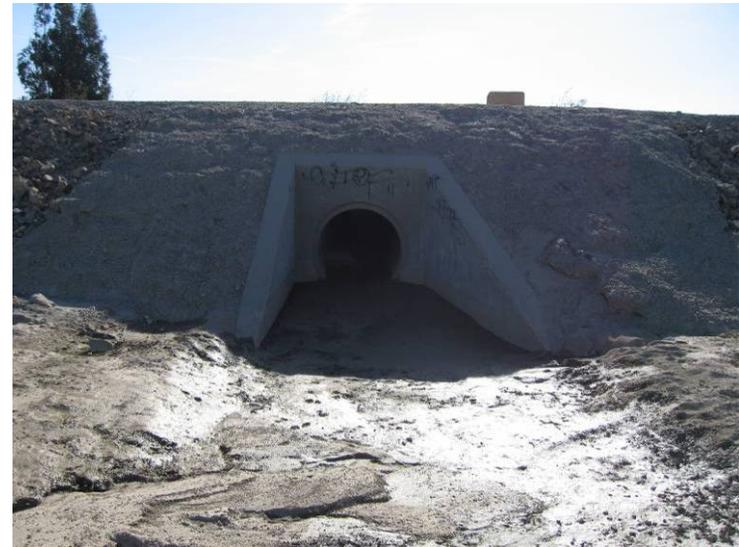
Santa Clara River Levee, From Hwy 101 to Saticoy. (Photo No. P5) – 12” metal pipe, commercial drain from process plant (riverward side)

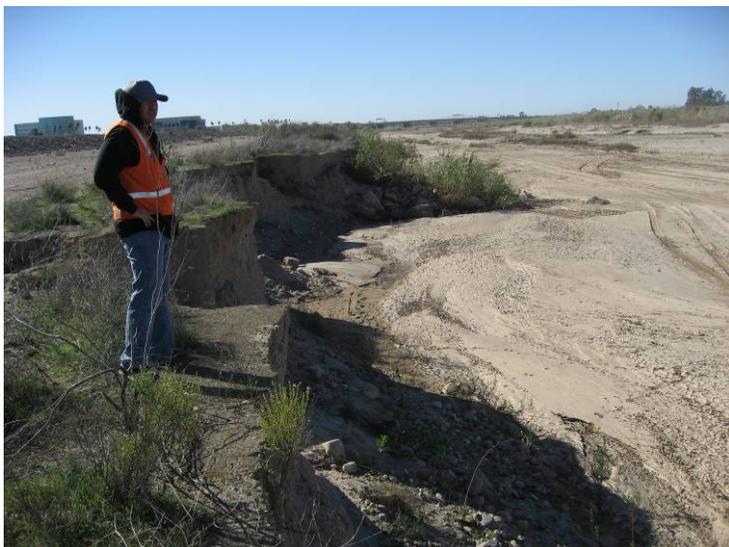
Santa Clara River Levee, From Hwy 101 to Saticoy. (Photo No. F2) –
20' -25' high erosion cut eroding towards levee, looking u/s (riverward)

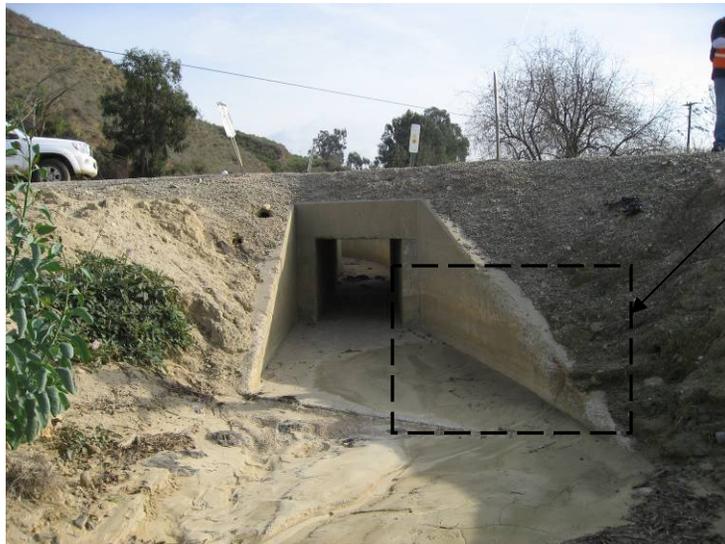
Santa Clara River Levee, From Hwy 101 to Saticoy. (Photo No. M1) –
Damaged concrete on Side Drain 1A headwall with rebar exposed

GPS		*Photo No.	Description	Action Required
Lat	Long			
<i>Santa Clara River Levee (SCR-1)</i>				
N34.28292	W119.12323	M1, M2	Damaged concrete on Side Drain 1A headwall with rebar exposed (riverward side)	Repair the concrete headwall of outlet structure
N34.28300	W119.12337	M3	Sediment spoils (riverward side)	Remove spoils from levee
N34.28128	W119.12649	M4, M5	Sediment deposition in Side Drain No. 1, 42” RCP inlet and outlet. Flap gate is stuck open by debris and sediment	Remove sediment and debris and establish a clear passage from pipe to channel (riverward & landward sides)
N34.27899	W119.13102	M6, M7	Wood debris (riverward side)	Remove debris from the levee
N34.27848	W119.13181	M8, M9	Broken stone revetment (riverward side)	Stone revetment may need to be repaired, additional engineering analysis is recommended
N34.27828	W119.13232	M10	Animal burrows at levee toe (riverward side)	Fill voids with impervious material and firmly compact

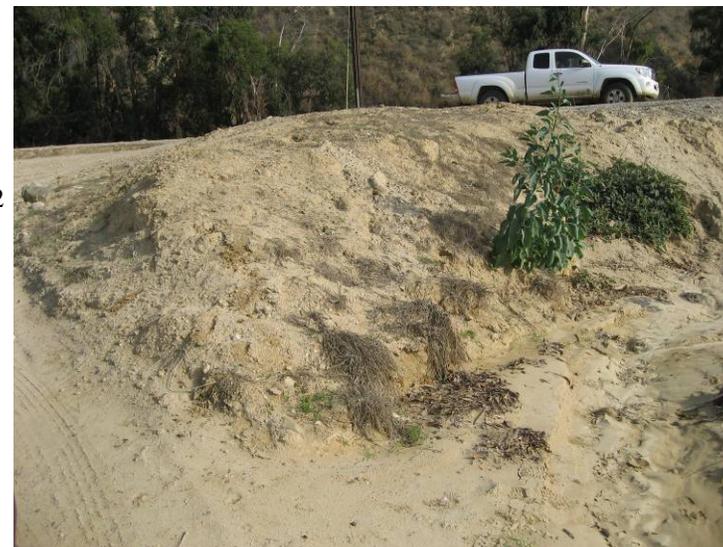
Santa Clara River Levee, From Hwy 101 to Saticoy. (Photo No. M3) –
Sediment spoils, upstream end of levee (riverward side)

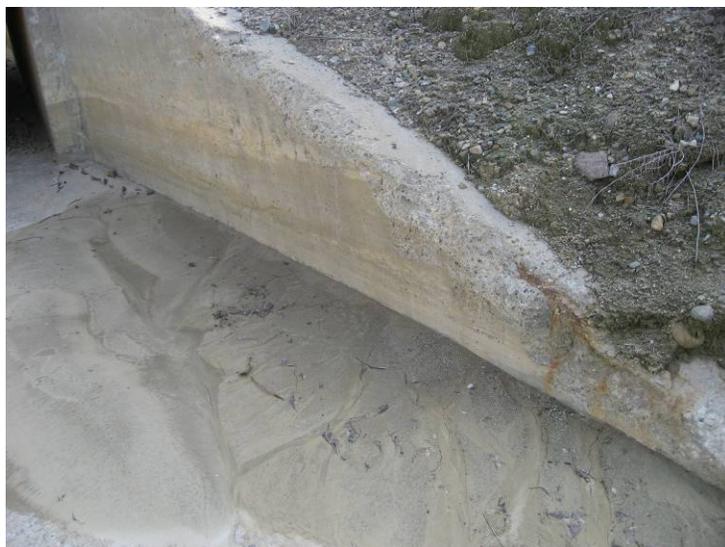
Santa Clara River Levee, From Hwy 101 to Saticoy. (Photo No. M2) –
Detail of damaged concrete headwall & exposed rebar (riverward side)

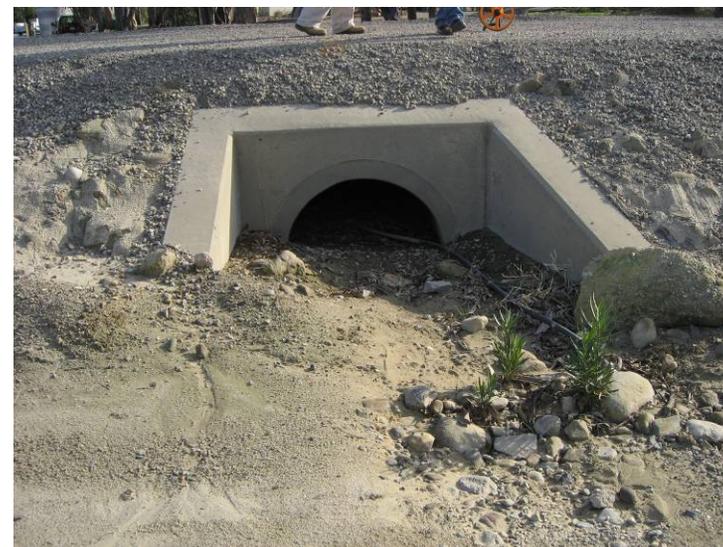
Santa Clara River Levee, From Hwy 101 to Saticoy. (Photo No. M4) –
Sediment deposition in Side Drain No. 1, 42" RCP outlet (riverward side)

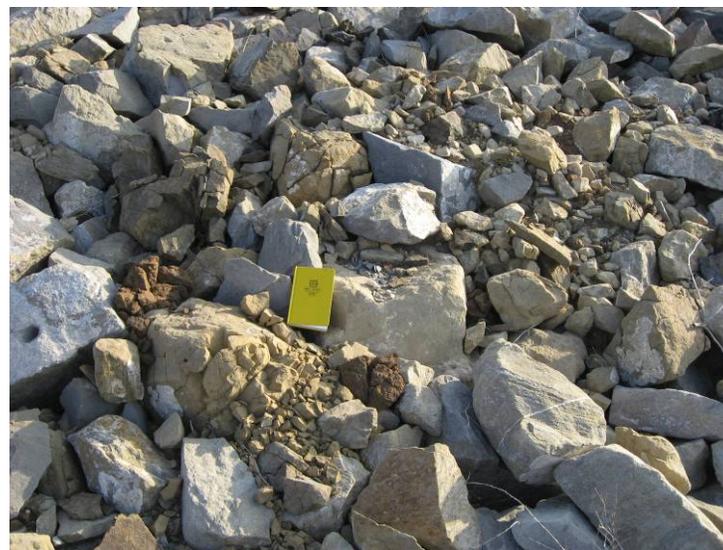
Santa Clara River Levee, From Hwy 101 to Saticoy. (Photo No. M8) –
Broken stone revetment (riverward side)

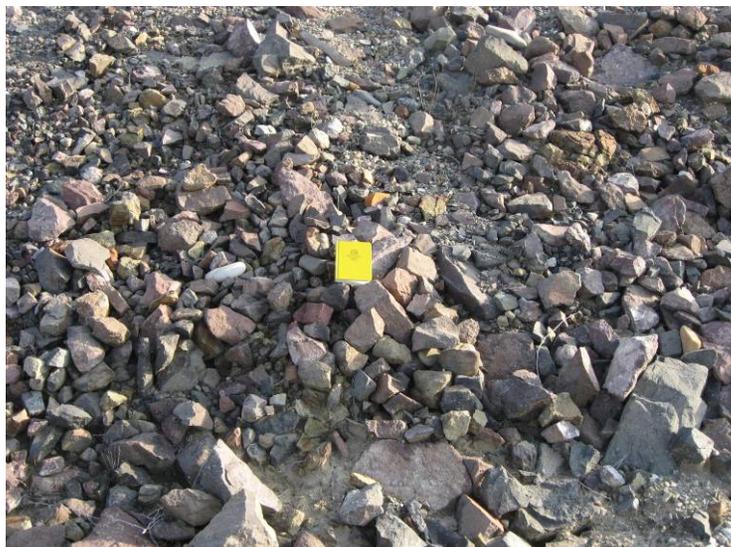
Santa Clara River Levee, From Hwy 101 to Saticoy. (Photo No. M9) –
Broken stone revetment (riverward side)

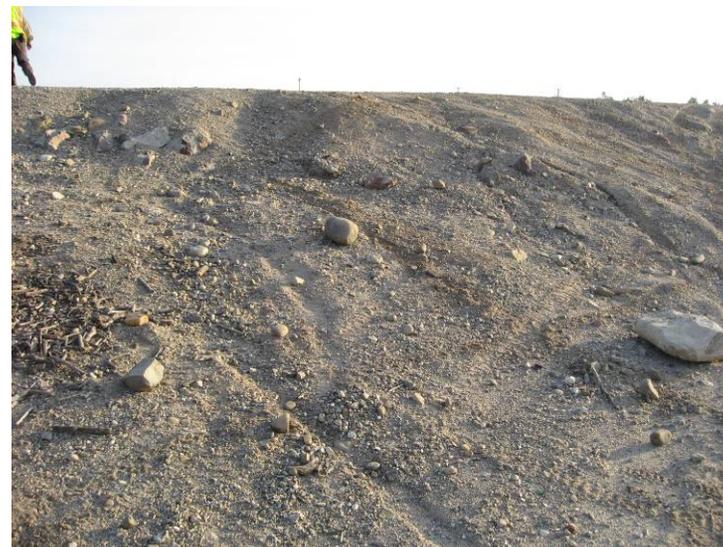
Santa Clara River Levee, From Hwy 101 to Saticoy. (Photo No. M11) –
Erosion of levee embankment (riverward side)

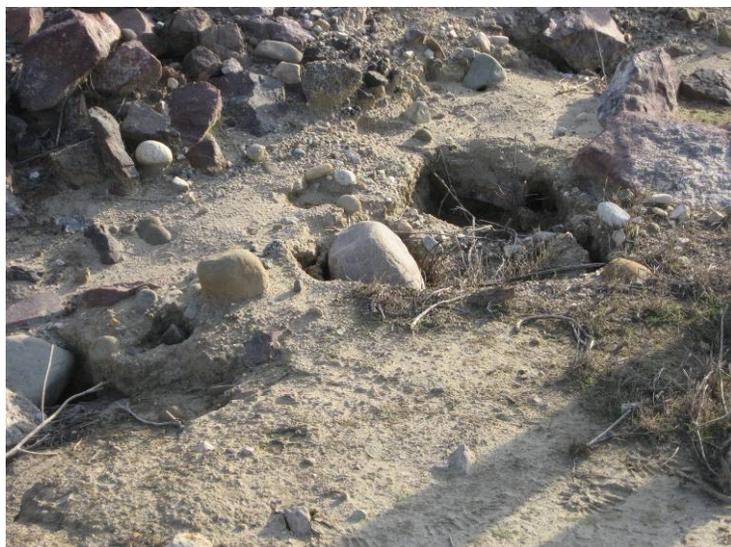
Santa Clara River Levee, From Hwy 101 to Saticoy. (Photo No. M10) –
Animal burrows at levee toe (riverward side)

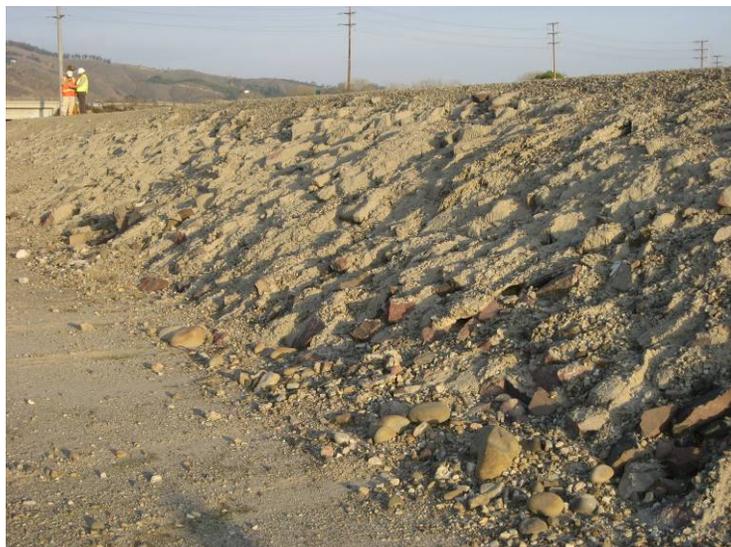
Santa Clara River Levee, From Hwy 101 to Saticoy. (Photo No. M13) –
Concrete spread over levee embankment, looking d/s (riverward side)

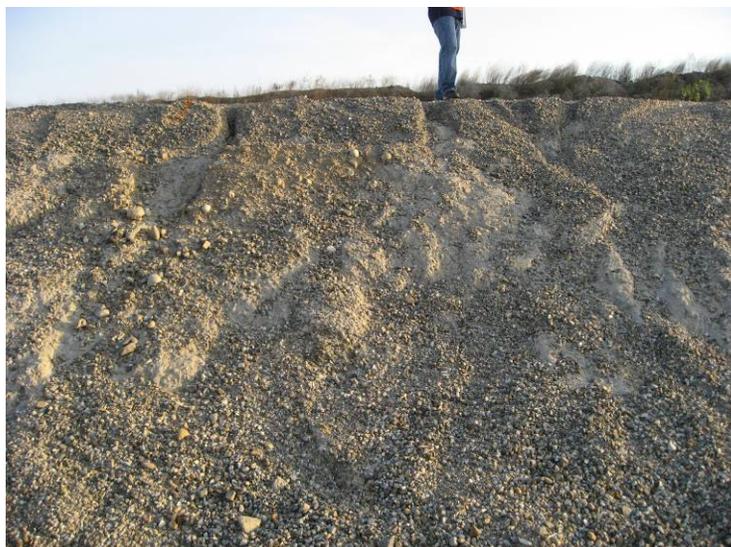
Santa Clara River Levee, From Hwy 101 to Saticoy. (Photo No. M14) –
Erosion on levee embankment, looking d/s (riverward side)

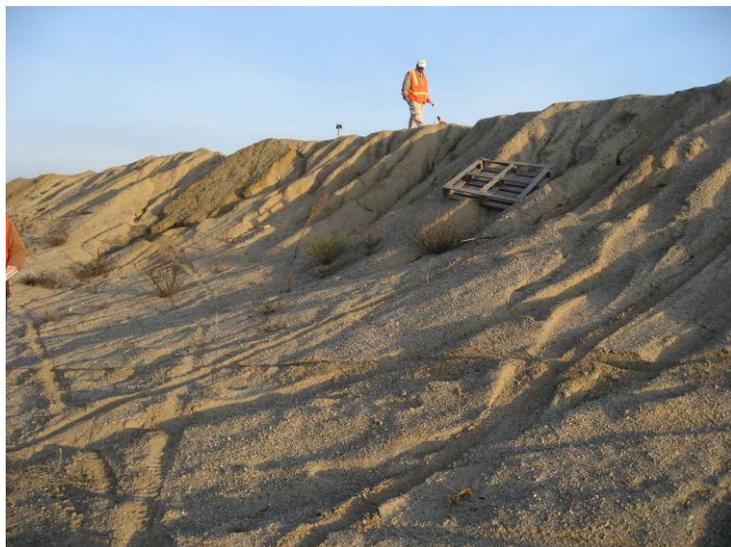
Santa Clara River Levee, From Hwy 101 to Saticoy. (Photo No. M17) – Erosion of levee embankment, adjacent to asphalt plant (riverward side)

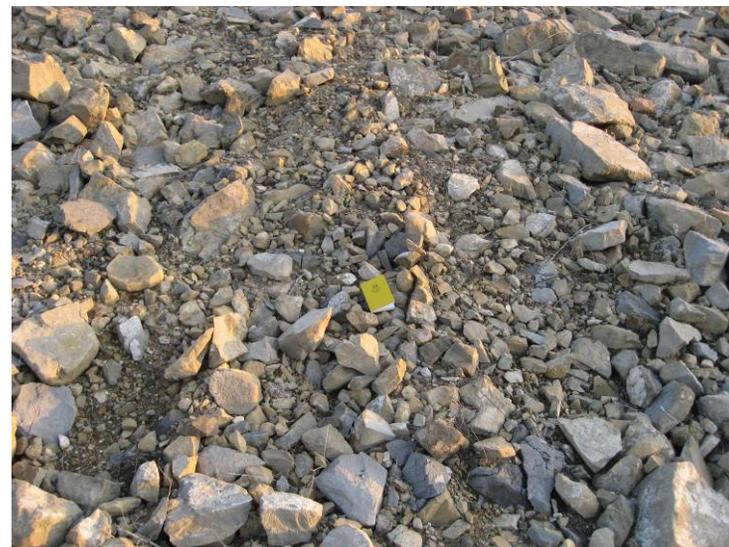
3. Rock revetment is of several different types (sandstone/igneous/ conglomerate) of rock and a lot of it is desiccated and broken down into smaller pieces along entire length of the levee. The ability of this rock revetment to provide the appropriate level of protection is questionable.

Santa Clara River Levee, From Hwy 101 to Saticoy. (Photo No. M19) – Broken stone revetment (riverward side)

N34.27188	W119.14478	M19	Broken stone revetment (riverward side)	Stone revetment may need to be repaired, additional engineering analysis is recommended
N34.27117	W119.14602	M20	Sediment deposition in Side Drain No. 3, 48” RCP outlet (riverward side)	Remove sediment and establish a clear passage from pipe to channel

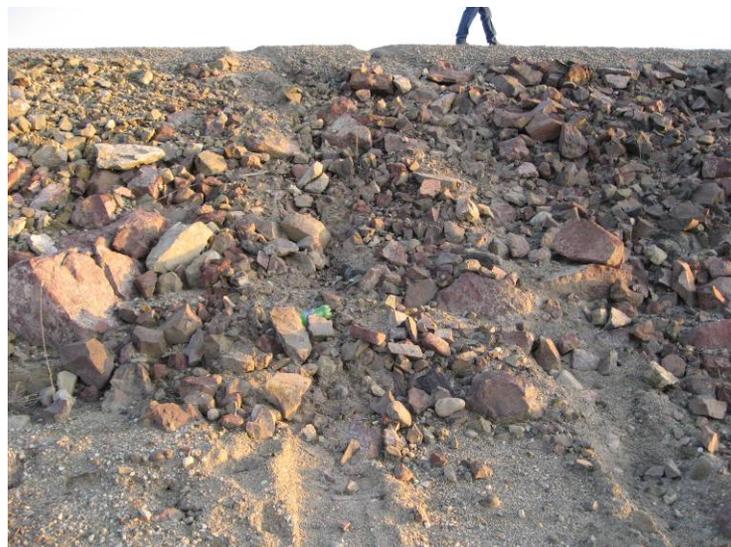
Santa Clara River Levee, From Hwy 101 to Saticoy. (Photo No. M18) – Levee embankment erosion caused by vehicles (riverward side)

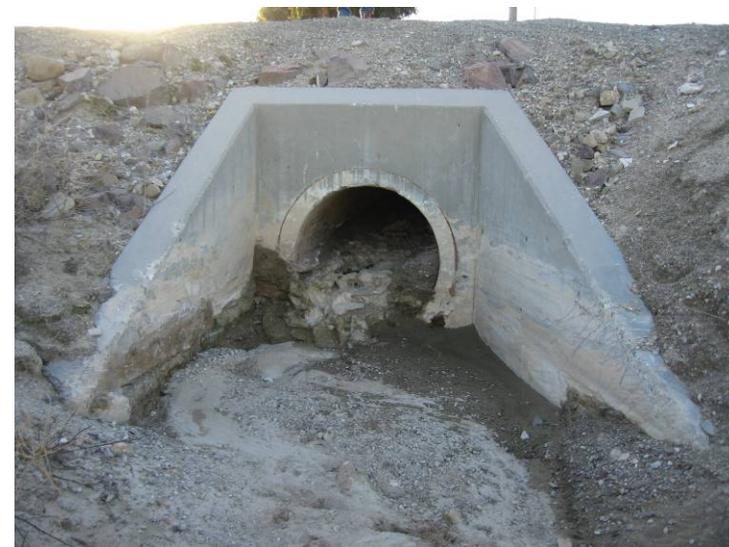
Santa Clara River Levee, From Hwy 101 to Saticoy. (Photo No. M20) – Sediment deposition in Side Drain No. 3, 48" RCP outlet (riverward side)

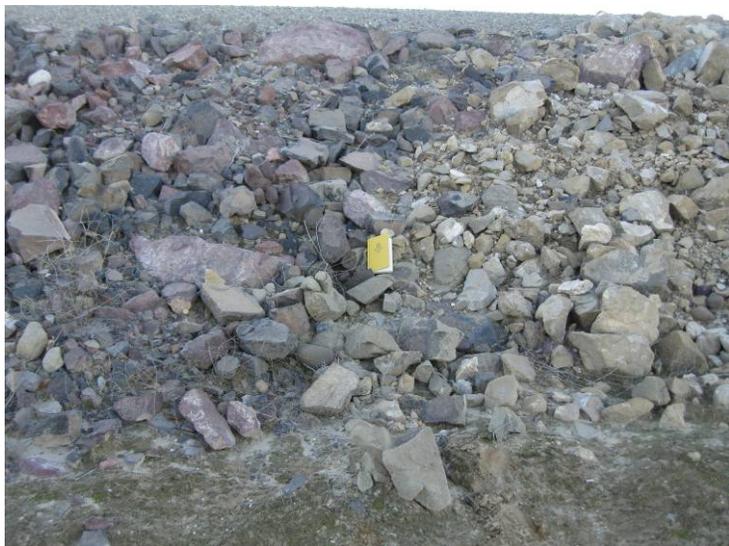
Santa Clara River Levee, From Hwy 101 to Saticoy. (Photo No. M21) –
Broken stone revetment (riverward side)

GPS		*Photo No.	Description	Action Required
Lat	Long			
<i>Santa Clara River Levee (SCR-1)</i>				
N34.27086	W119.14668	M21	Broken stone revetment (riverward side)	Additional engineering analysis is recommended
N34.26952	W119.14963	M22, M23	Erosion on top of levee caused by vehicular traffic (landward side)	Reestablish top of levee to meet design elevations
N34.26663	W119.15408	M24	Levee embankment erosion caused by vehicular traffic (riverward side)	Reestablish levee revetment with design specifications. Fill voids with impervious material and firmly compact
N34.26585	W119.15552	M25	Broken stone revetment (riverward side)	Additional engineering analysis is recommended
N34.26352	W119.15907	M26	Broken concrete pipe debris along levee toe (riverward side)	Remove unauthorized concrete pipe debris from levee embankment
N34.25950	W119.16435	M27	Unauthorized ramp on levee (riverward side)	Remove unauthorized earthen ramp

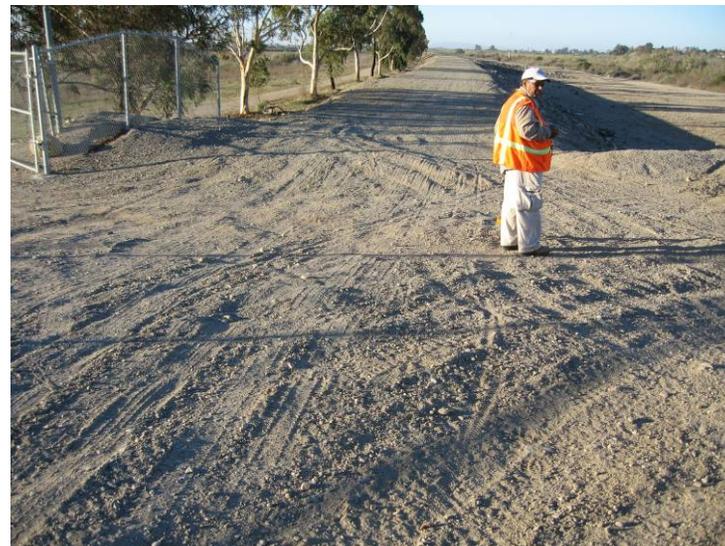
Santa Clara River Levee, From Hwy 101 to Saticoy. (Photo No. M23) –
Erosion on top of levee caused by vehicles, looking d/s (riverward side)

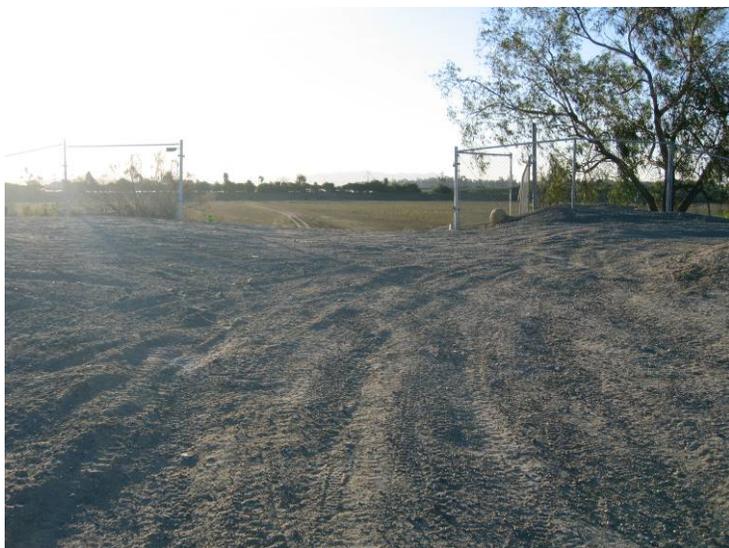
Santa Clara River Levee, From Hwy 101 to Saticoy. (Photo No. M22) –
Erosion on top of levee caused by vehicles (riverward side)

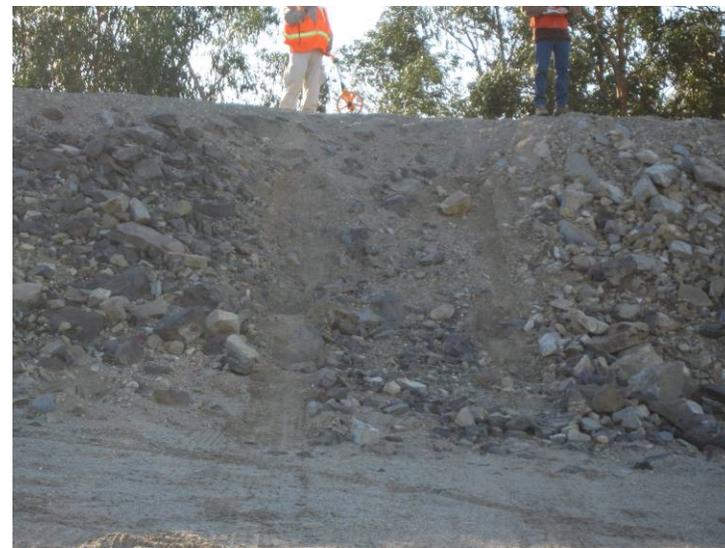
Santa Clara River Levee, From Hwy 101 to Saticoy. (Photo No. M24) –
Levee embankment erosion caused by vehicles (riverward side)

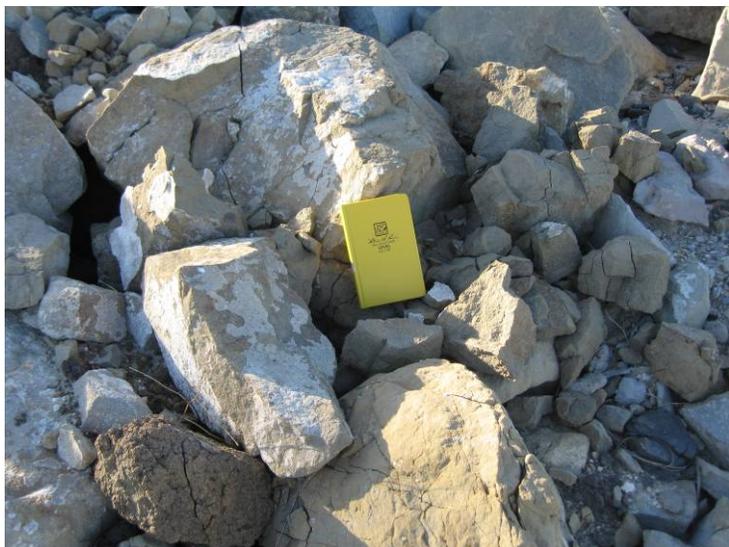
**Santa Clara River Levee, From Hwy 101 to Saticoy. (Photo No. M25) –
Broken stone revetment (riverward side)**

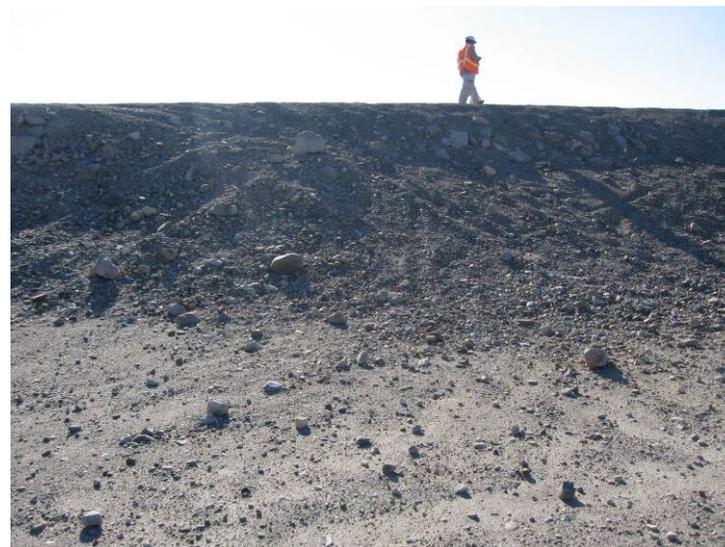
**Santa Clara River Levee, From Hwy 101 to Saticoy. (Photo No. M27) –
Unauthorized ramp on levee (riverward side)**

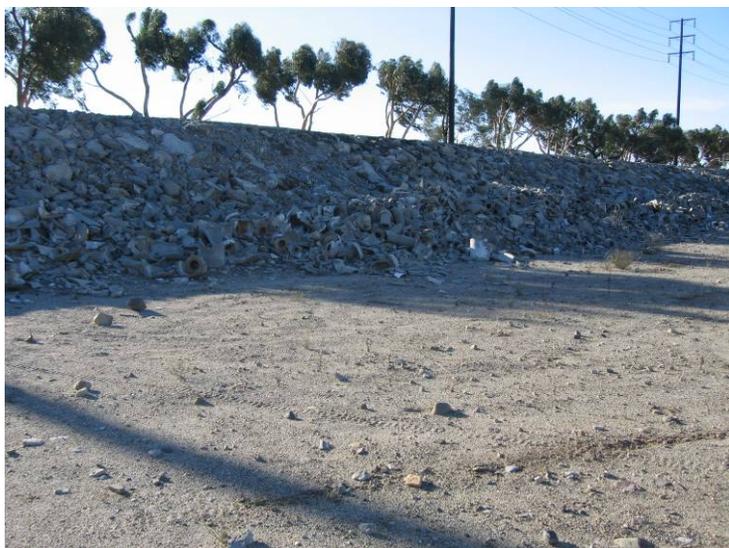
**Santa Clara River Levee, From Hwy 101 to Saticoy. (Photo No. M26) –
Concrete pipe debris along levee toe, looking d/s (riverward side)**

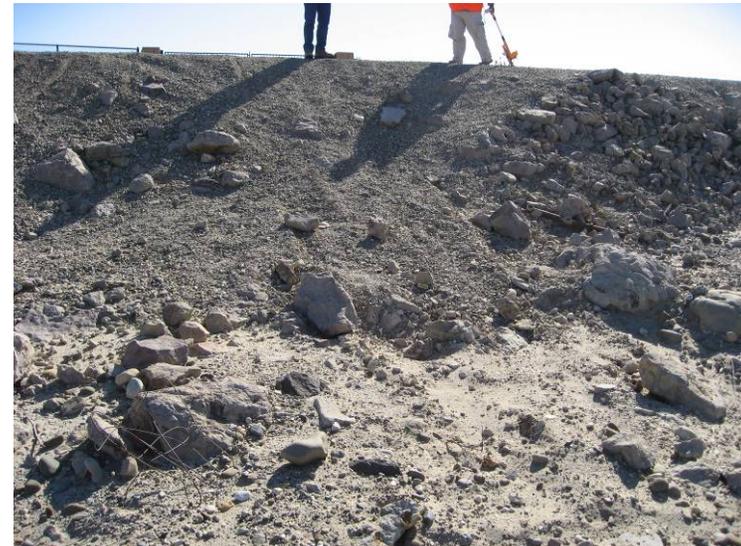
Santa Clara River Levee, From Hwy 101 to Saticoy. (Photo No. M31) – Sloughing levee embankment protection (riverward side)

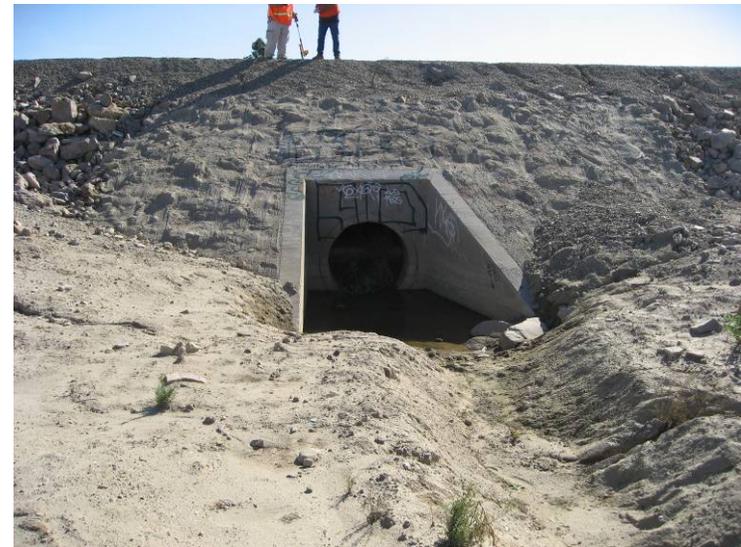
Santa Clara River Levee, From Hwy 101 to Saticoy. (Photo No. M32) – Sediment deposition in Side Drain No. 4, 48” RCP outlet (riverward side)

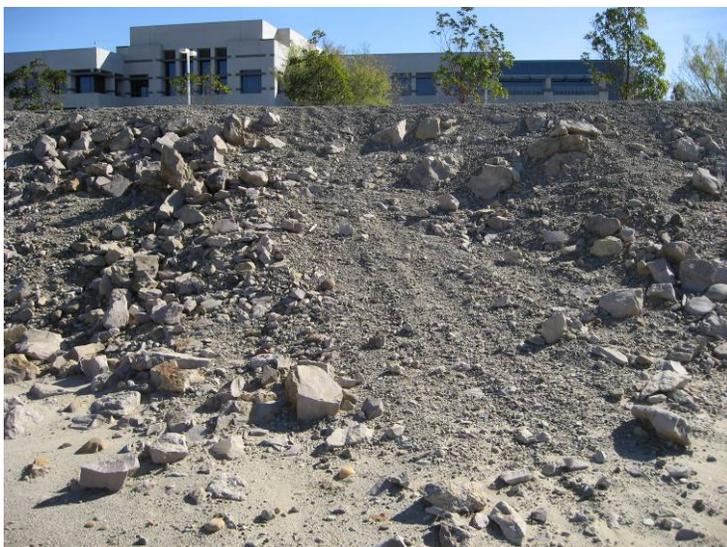
Santa Clara River Levee, From Hwy 101 to Saticoy. (Photo No. M38) – Unauthorized ramp with missing levee embankment protection (riverward)

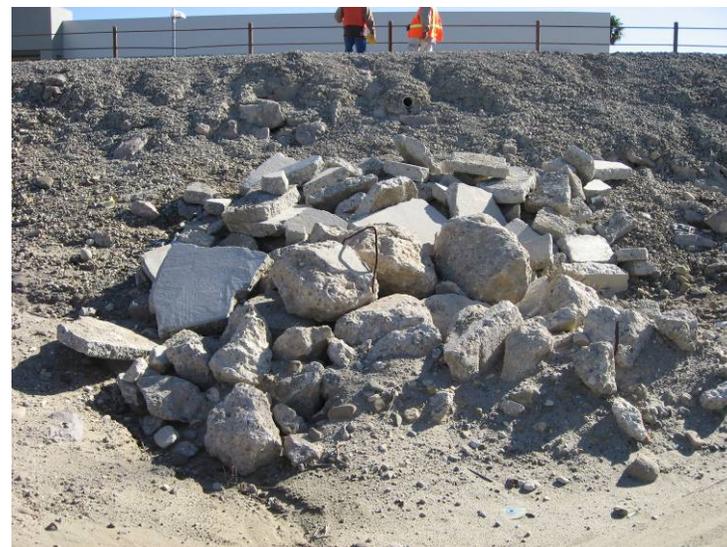
Santa Clara River Levee, From Hwy 101 to Saticoy. (Photo No. M40) – Dumped concrete debris at levee toe (riverward side)

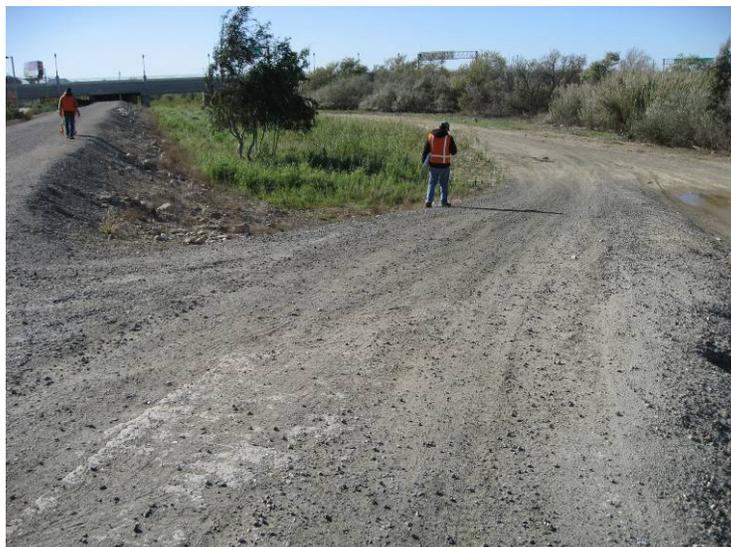
Santa Clara River Levee, From Hwy 101 to Saticoy. (Photo No. M41) –
Vegetation within 15' levee toe, looking d/s (riverward side)

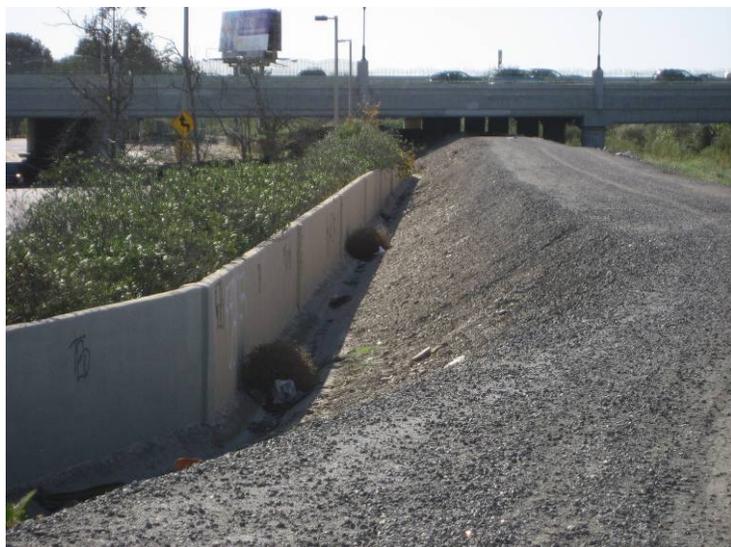
Santa Clara River Levee, From Hwy 101 to Saticoy. (Photo No. M42) –
Vegetation within 15-feet of levee toe looking d/s (landward side)

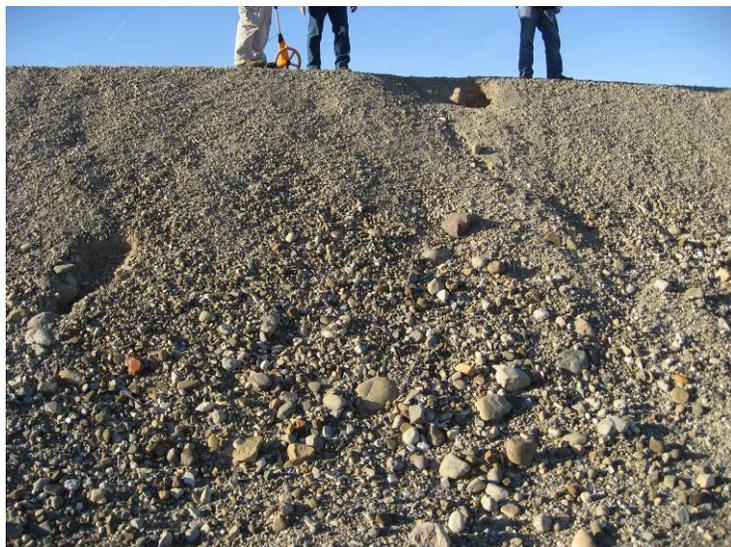
Santa Clara River Levee, From Hwy 101 to Saticoy, (Photo No. M53) –
Animal burrows at top of levee (landward side)

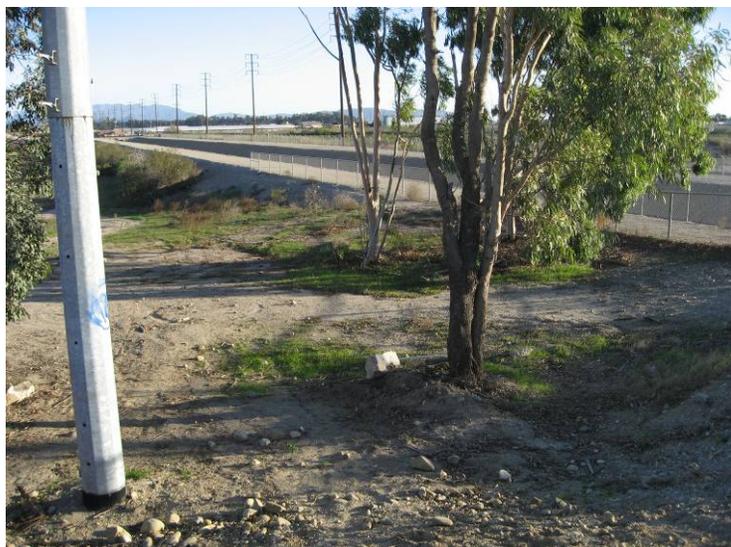
Santa Clara River Levee, From Hwy 101 to Saticoy, (Photo No. M54) –
Tree within 15' of levee toe, looking downstream (landward side)

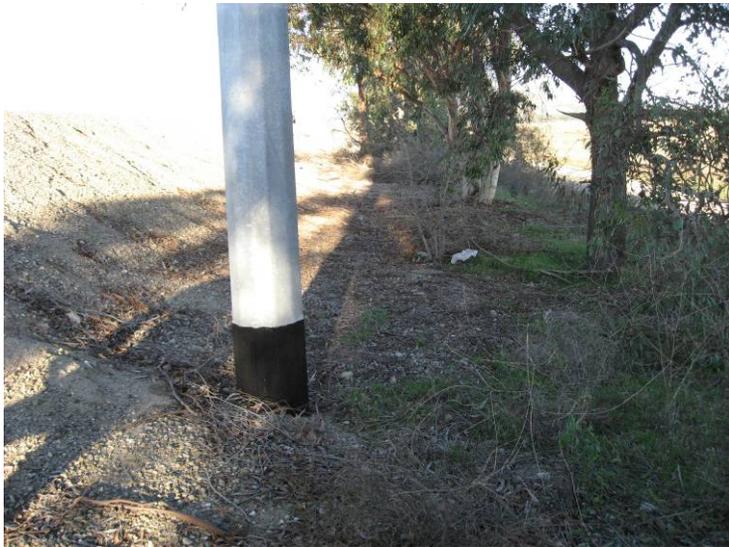
Santa Clara River Levee, From Hwy 101 to Saticoy, (Photo No. M57) –
Power poles within 15' of levee toe, looking upstream (landward side)

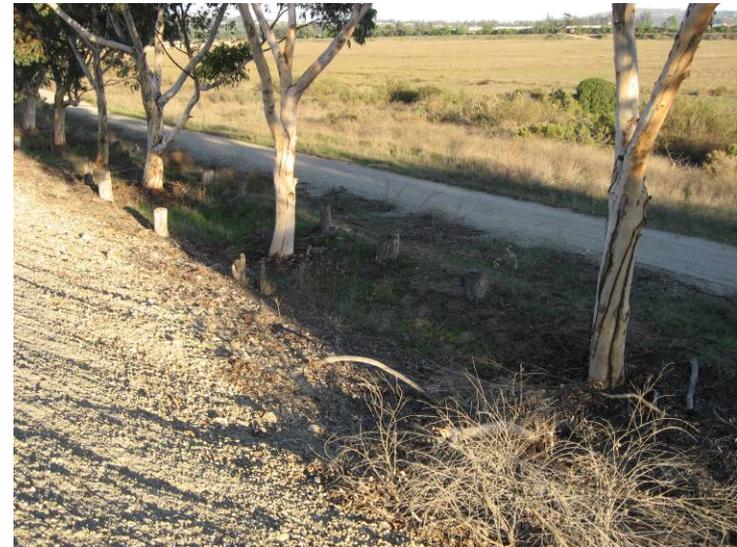
Santa Clara River Levee, From Hwy 101 to Saticoy, (Photo No. M59) –
Trees within 15' of levee toe, looking u/s (landward side)

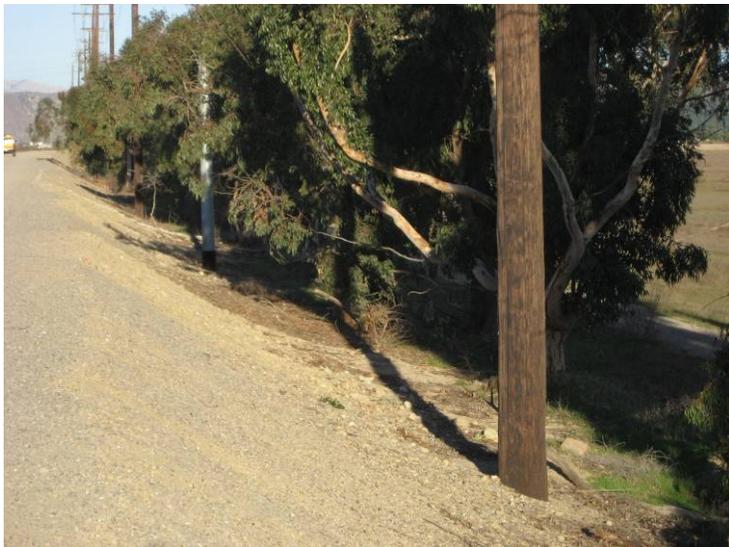
Santa Clara River Levee, From Hwy 101 to Saticoy, (Photo No. M58) –
Power poles within 15' of levee toe, looking upstream (landward side)

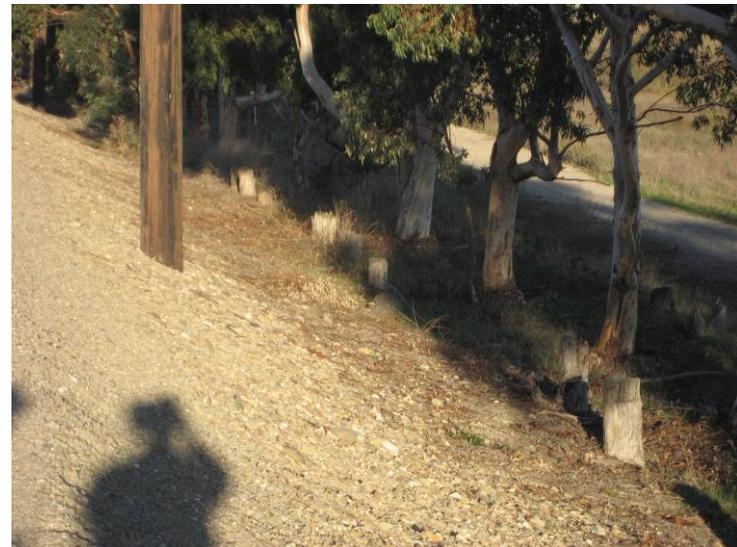
Santa Clara River Levee, From Hwy 101 to Saticoy, (Photo No. M60) –
Trees, power poles & stumps within 15' of toe, looking u/s (landward side)

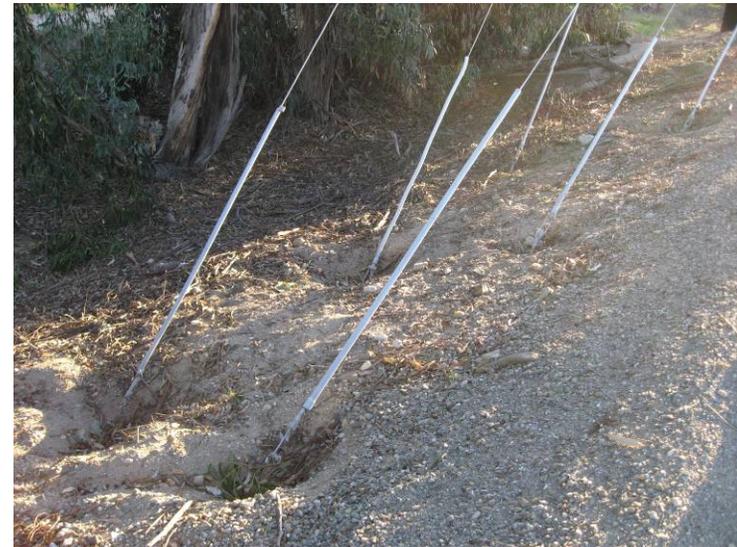
Santa Clara River Levee, From Hwy 101 to Saticoy, (Photo No. M63) –
Power poles guy wires anchored in levee bank, looking d/s (landward side)

N34.26498	W119.15623	M61, M63, M64	Fallen trees on levee embankment (landward side)	Remove vegetation and root ball, fill voids with impervious material and firmly compact.
N34.26918	W119.14969	M65	Trees and fallen trees within 15' along levee toe (landward side)	Remove vegetation and root ball, fill voids with impervious material and firmly compact.
N34.26929	W119.14954	M66	Erosion on top of levee caused by vehicles (landward side)	Reestablish top of levee and fill voids with impervious material and firmly compact
N34.26933	W119.14939	M67	Vegetation within 15-feet of levee toe (landward side)	Remove vegetation and root ball, fill voids with impervious material and firmly compact.
N34.27027 to N34.27071	W119.14750 to W119.14673	M68	Vegetation within 15-feet of levee toe approximately 150-feet along levee (landward side)	Remove vegetation and root ball, fill voids with impervious material and firmly compact.

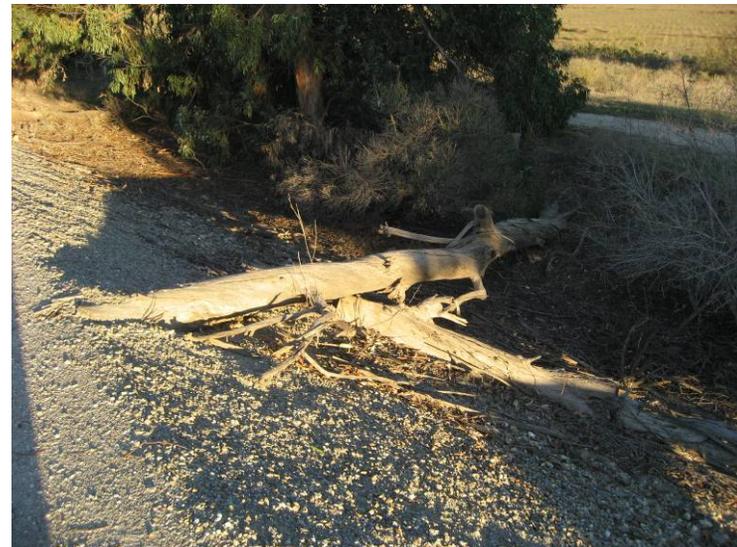
Santa Clara River Levee, From Hwy 101 to Saticoy, (Photo No. M64) –
Fallen trees and vegetation on levee bank, looking u/s (landward side)

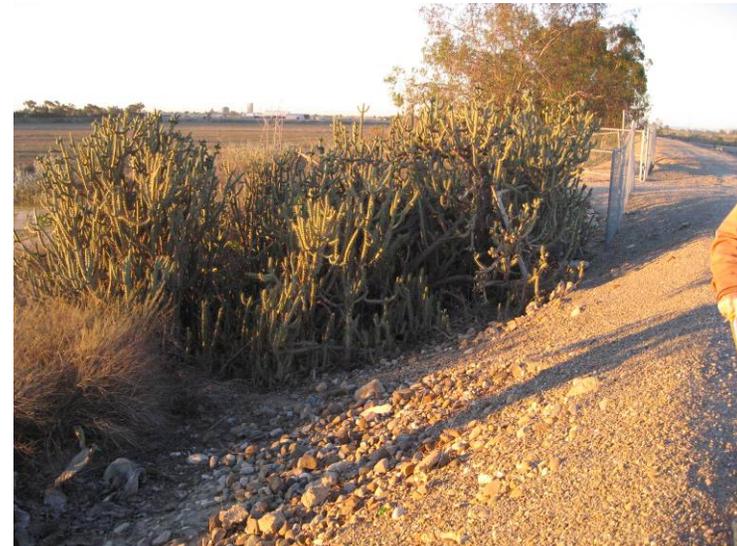
Santa Clara River Levee, From Hwy 101 to Saticoy, (Photo No. M67) –
Vegetation within 15-feet of levee toe, looking downstream (landward side)

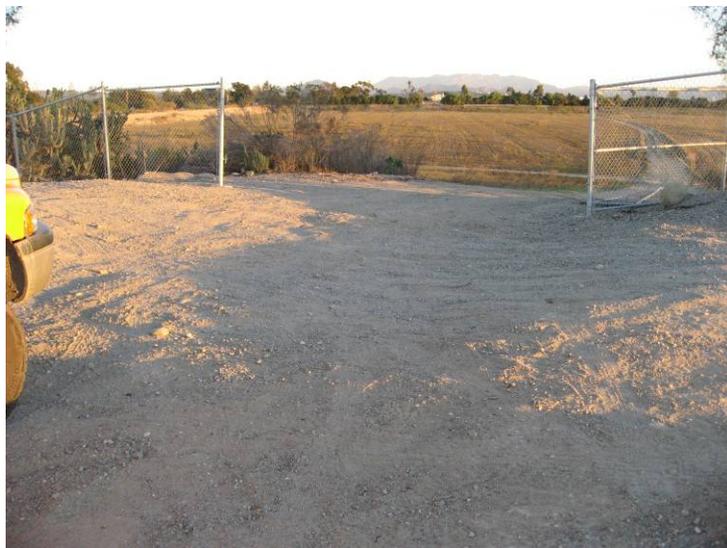
Santa Clara River Levee, From Hwy 101 to Saticoy, (Photo No. M66) –
Erosion on top of levee caused by vehicles, looking S/E (landward side)

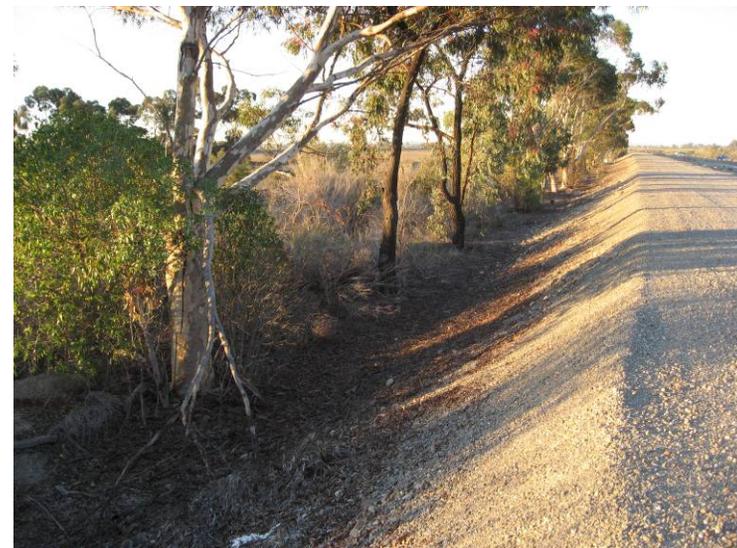
Santa Clara River Levee, From Hwy 101 to Saticoy, (Photo No. M68) –
Vegetation within 15-feet of levee toe, looking d/s (landward side)

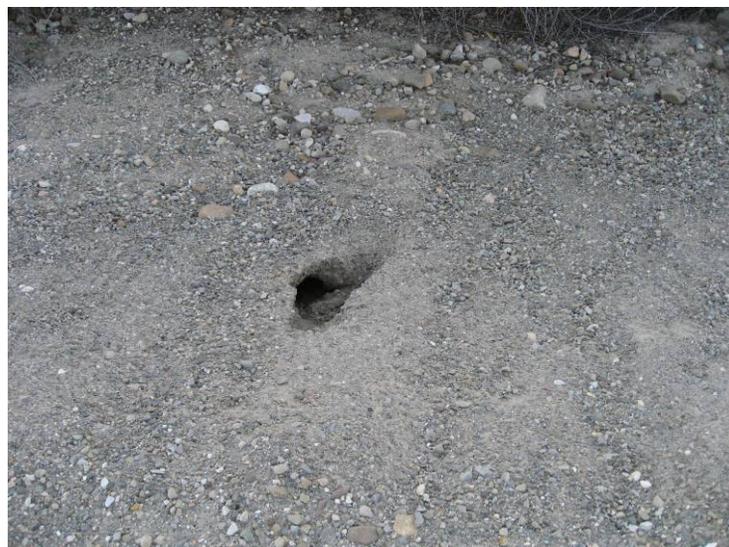
Santa Clara River Levee, From Hwy 101 to Saticoy, (Photo No. M70) –
Animal burrow on top of levee (landward side)

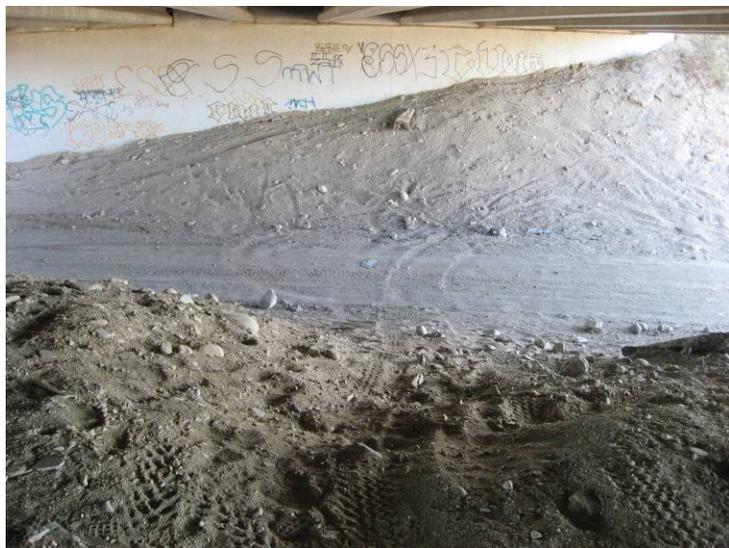
Santa Clara River Levee, From Hwy 101 to Saticoy, (Photo No. M74) –
Erosion caused by vehicles under L.A. Ave. Bridge (landward side)

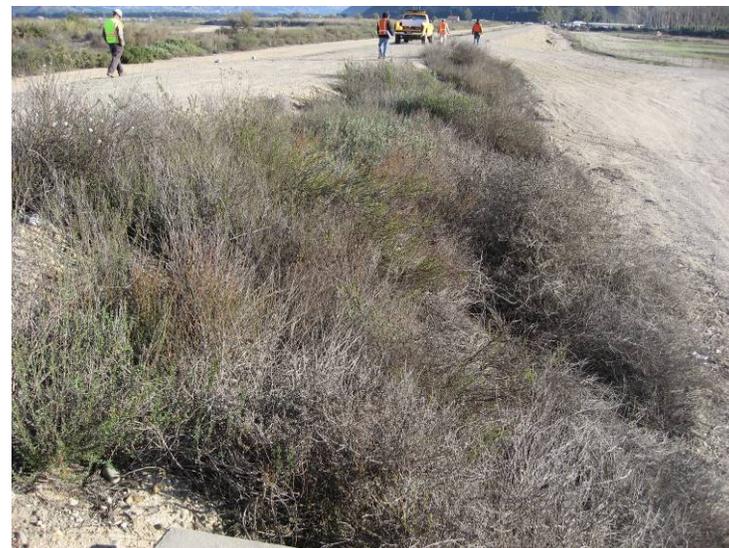
Santa Clara River Levee, From Hwy 101 to Saticoy, (Photo No. M76) –
Vegetation within 15-feet of levee toe, looking downstream (landward side)

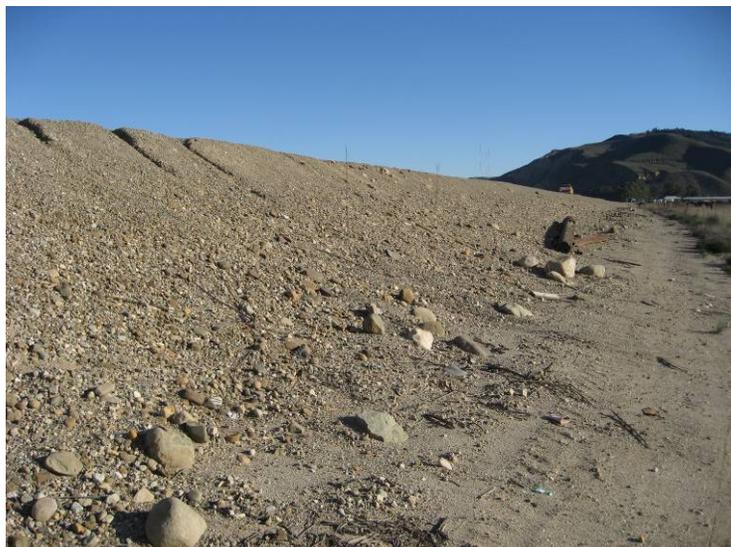
Santa Clara River Levee, From Hwy 101 to Saticoy, (Photo No. M77) –
Erosion at top of levee with debris at toe, looking d/s (landward side)

N34.27638	W119.13571	M77	Erosion at top of levee with miscellaneous debris at toe (landward side)	Repair erosion and remove miscellaneous debris
N34.27671	W119.13503	M78	Animal burrows at top of levee (landward side)	Remove animal burrows, fill voids with impervious material and firmly compact
N34.27997 to N34.28052	W119.12884 to W119.12786	M79	Trees within 15-feet of levee toe, approximately 200-feet along levee (landward side)	Remove vegetation and root ball, fill voids with impervious material and firmly compact.
N34.28123	W119.12643	M80	Sediment deposition and debris in Side Drain No. 1, 42" RCP inlet invert (landward side)	Remove sediment and debris and establish a clear passage from pipe to channel (riverward & landward sides)
N34.28123 to N34.28155	W119.12643 to W119.12585	M81	Vegetation within 15-feet of toe, approximately 1,200-feet along levee toe (landward side)	Remove vegetation and root ball, fill voids with impervious material and firmly compact.

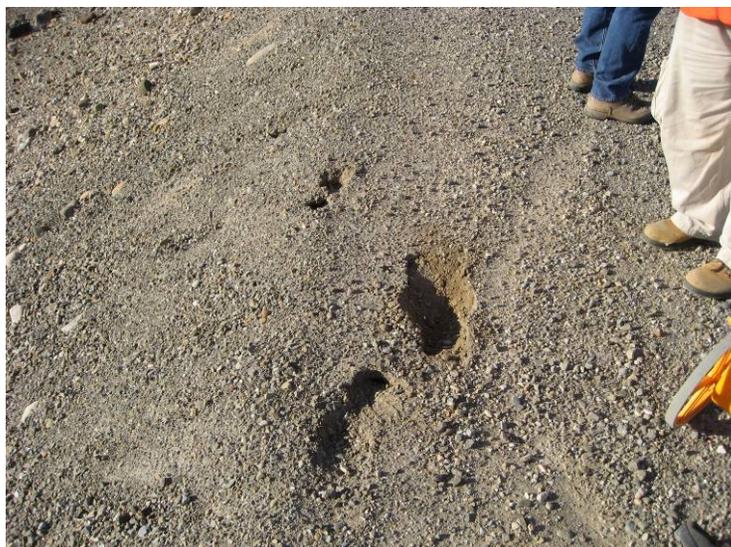
Santa Clara River Levee, From Hwy 101 to Saticoy, (Photo No. M78) –
Animal burrows at top of levee (landward side)

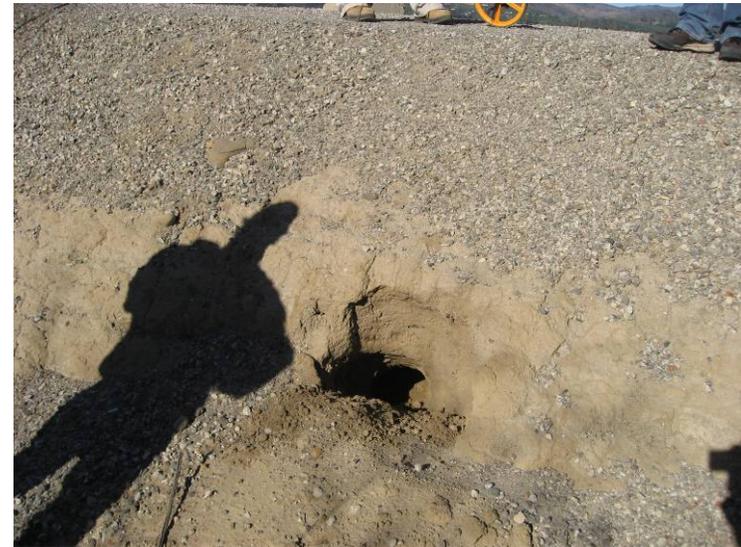
Santa Clara River Levee, From Hwy 101 to Saticoy, (Photo No. M83) –
Animal burrows at levee toe (landward side)
