**FEMA Levee Certification
Ventura County, California**

**Ventura River Levee and Floodwall (VR-3)
At Live Oaks**

**Evaluation Report
February 13, 2009**

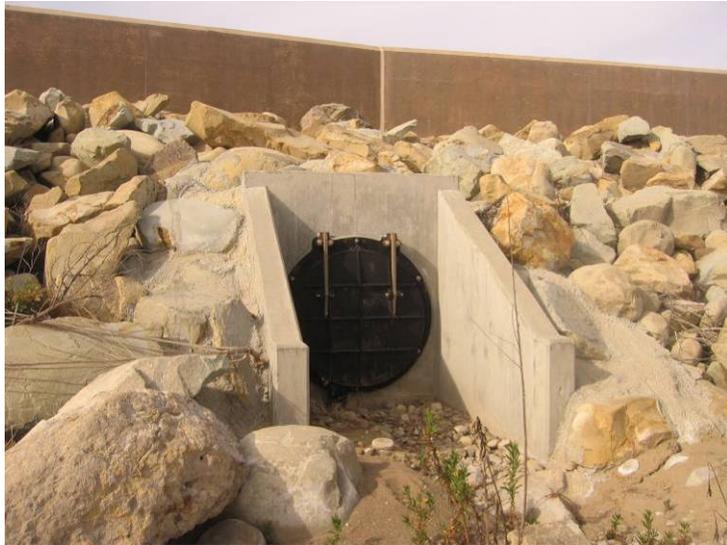
Ventura River Levee and Floodwall (Photo No. P1) – 48” RCP with a concrete outlet structure and Flap Gate

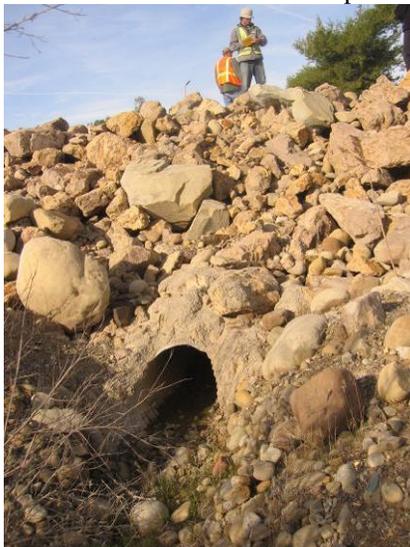
Ventura River Levee and Floodwall (Photo No. P2) – 24” CMP w/o a closure device

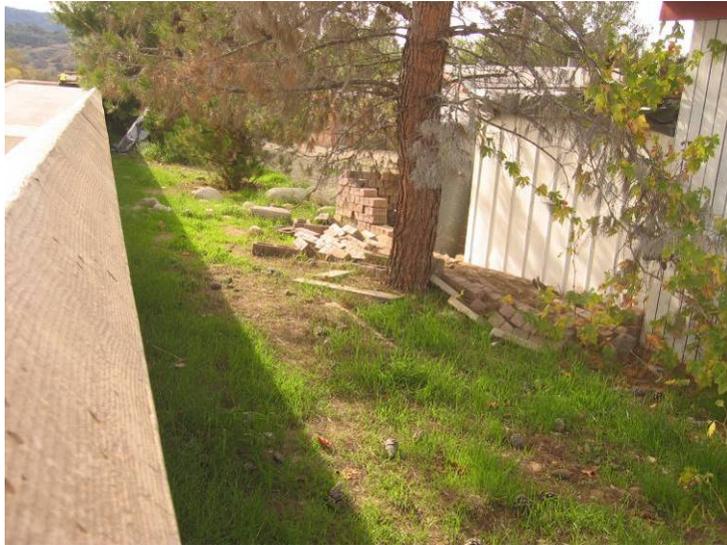
Ventura River Levee and Floodwall (Photo No. M1) – Vegetation within 15' of Toe (Landward Side)

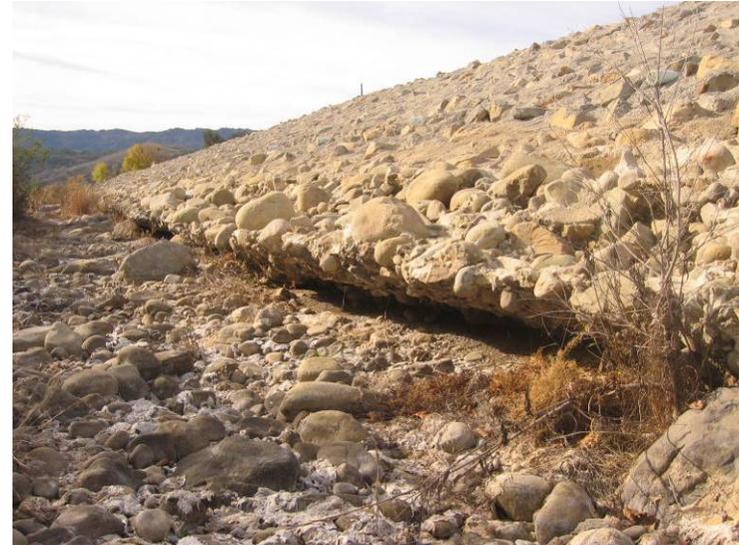
During the site visit, erosion at the toe of the riverside levee slope was observed and erosion of the toe was undermining the revetment. Evaluation of this erosion should be conducted.

Ventura River Levee and Floodwall (Photo No. M3) – Erosion along levee toe below revetment (Riverward side)

M3	Erosion along levee toe below revetment (Riverward side)	Re-establish bank revetment with adequate toedown protection. Additional engineering analysis recommended.	C3/C4	E3	Endangered species habitat			
Ventura River Levee and Floodwall (VR-3) - Along Live Oak Diversion Outlet Channel, Category 3								
M4	Encroachment. Structures and trees within 15' of toe (Landward Side)	Remove structures and trees within the 15'-zone as appropriate.	C5 - letter to landowners before removing trees, and structure	E2	Try to avoid removing large oaks	X		
M5	Vegetation within 15' of toe (Landward Side)	Remove vegetation and root ball, fill voids with impervious material and firmly compact. Remove irrigation lines within levee embankment.	C2, C5 - Mitigation project, work with Pam	E3	WPD mitigation site, will need to replace veg elsewhere	X	Definition of impervious material	For all vegetation removal under 4" trunk diameter, no documentation is necessary. For larger rootball removal where excavation & compaction is required, documentation of the impacted material shall be conducted by a certified testing & materials lab familiar to the District. The documentation shall include a report provided by the lab. AMEC will periodically observe these locations & will require a copy of the report for documentation & review. Figure 2 attached outlines the excavation & compaction details. Documentation of the removal & replacement/re-compaction of the impacted material shall be conducted by a certified testing & materials lab familiar to the District. The documentation shall include a report provided by the lab. AMEC will periodically observe these locations & will require a copy of the report for documentation & review. In-kind backfill would be materials free of organic or deleterious debris that has similar or lower permeability than the levee material. These materials could consist of excavated soil, imported soil, concrete, or slurry, & shall be evaluated by the lab.

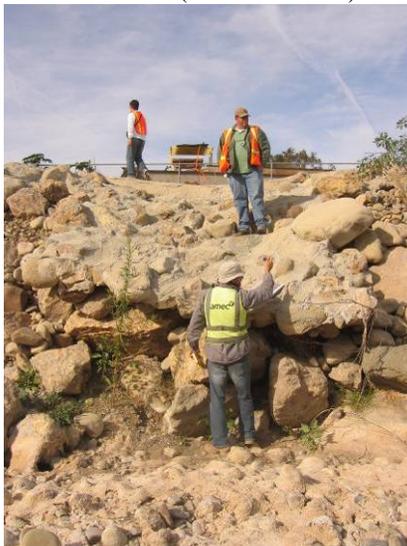
Ventura River Levee and Floodwall (Photo No. M2) – Undercut at the bottom of grouted stone apron of the levee top drain

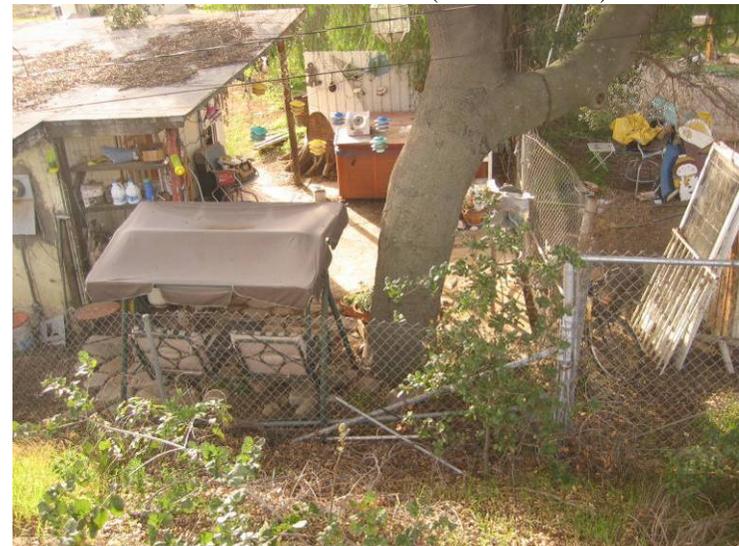
Ventura River Levee and Floodwall (Photo No. M4) – Encroachment. Structures within 15' of toe (Landward Side)

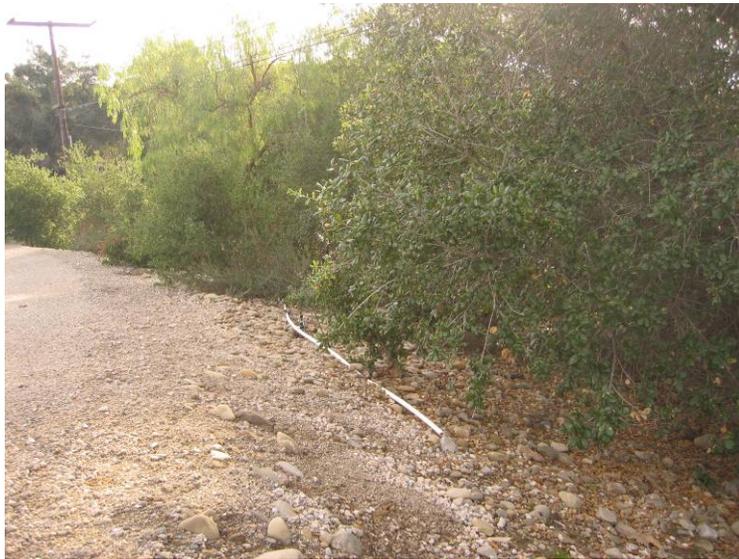
Ventura River Levee and Floodwall (Photo No. M5) – Vegetation within 15' of Toe (Landward Side)

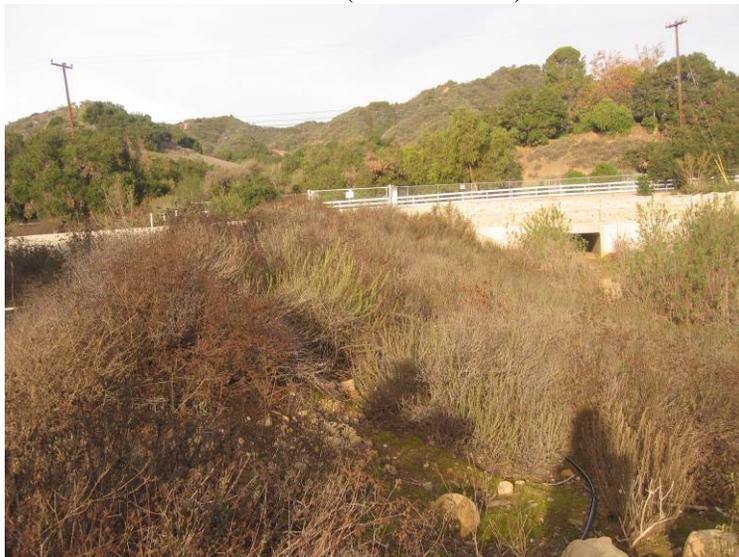
Ventura River Levee and Floodwall (Photo No. M6) – Vegetation on Levee embankment and toe (Riverward Side)

M6	Vegetation on Levee embankment and toe (Riverward Side). Vegetation is currently maintained by the County.	Remove vegetation and root ball, fill voids with impervious material and firmly compact. Remove irrigation lines within levee embankment.	C2, C5 - Mitigation project, letter to landowners, work with Pam	E3	WPD mitigation site, will need to replace veg elsewhere	X	Definition of impervious material	For all vegetation removal under 4" trunk diameter, no documentation is necessary. For larger rootball removal where excavation & compaction is required, documentation of the impacted material shall be conducted by a certified testing & materials lab familiar to the District. The documentation shall include a report provided by the lab. AMEC will periodically observe these locations & will require a copy of the report for documentation & review. Figure 2 attached outlines the excavation & compaction details. Documentation of the removal & replacement/re-compaction of the impacted material shall be conducted by a certified testing & materials lab familiar to the District. The documentation shall include a report provided by the lab. AMEC will periodically observe these locations & will require a copy of the report for documentation & review. In-kind backfill would be materials free of organic or deleterious debris that has similar or lower permeability than the levee material. These materials could consist of excavated soil, imported soil, concrete, or slurry, & shall be evaluated by the lab.
