**FEMA Levee Certification
Ventura County, California**

**Ventura River Levee (VR-1)
Pacific Ocean to Canada de San Joaquin**

**Evaluation Report
February 20, 2009**

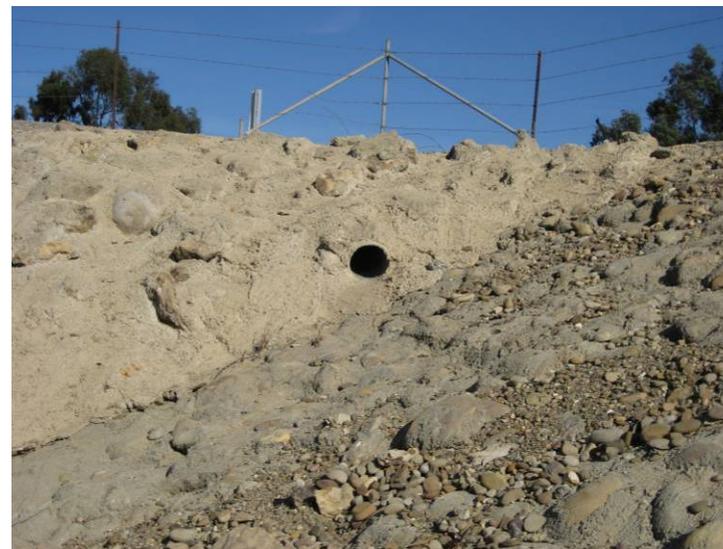
Ventura River Levee, From Ocean to Canada de San Joaquin. (Photo No. P3) - 12" CMP, drains turn out area adjacent to Hwy 33 (riverward side)

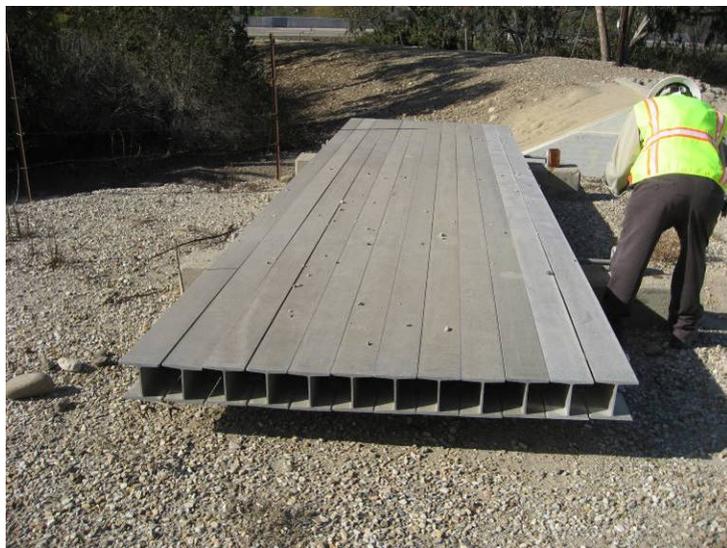
Ventura River Levee, From Ocean to Canada de San Joaquin. (Photo No. P2) - 12 beams for stop log system located on top of levee

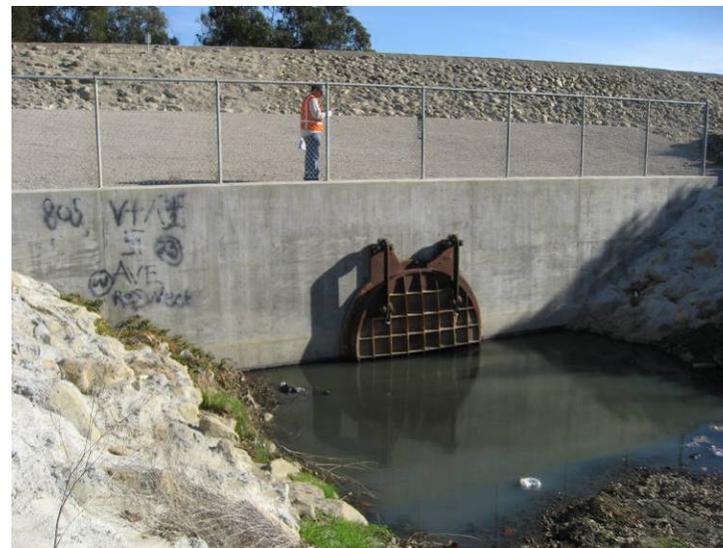
Ventura River Levee, From Ocean to Canada de San Joaquin. (Photo No. P4) - 90" RCP with flap gate, New Dent Drain (riverward side)

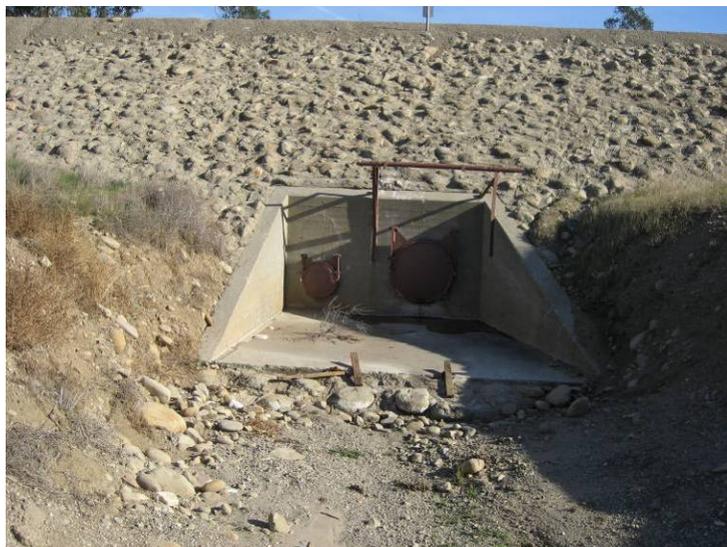
Ventura River Levee, From Ocean to Canada de San Joaquin. (Photo No. P5) - 24" & 42" CMP with flap gates, Old Dent Drain (riverward side)

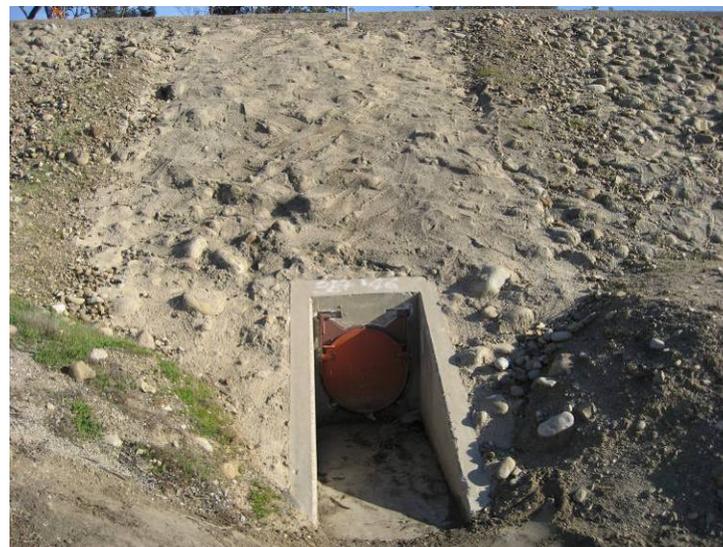
Ventura River Levee, From Ocean to Canada de San Joaquin. (Photo No. P7) - 36" Flap Gate, FWY #4 Drain (riverward side)

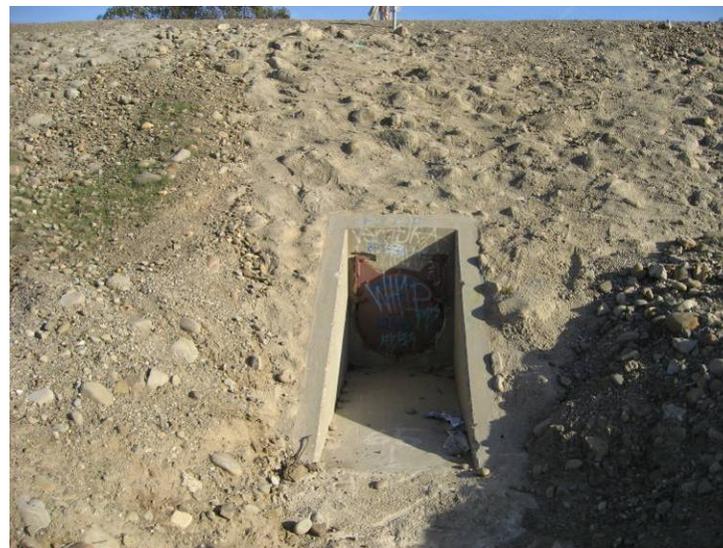
Ventura River Levee, From Ocean to Canada de San Joaquin. (Photo No. P8) - 36" Flap Gate, Vince Drain (riverward side)

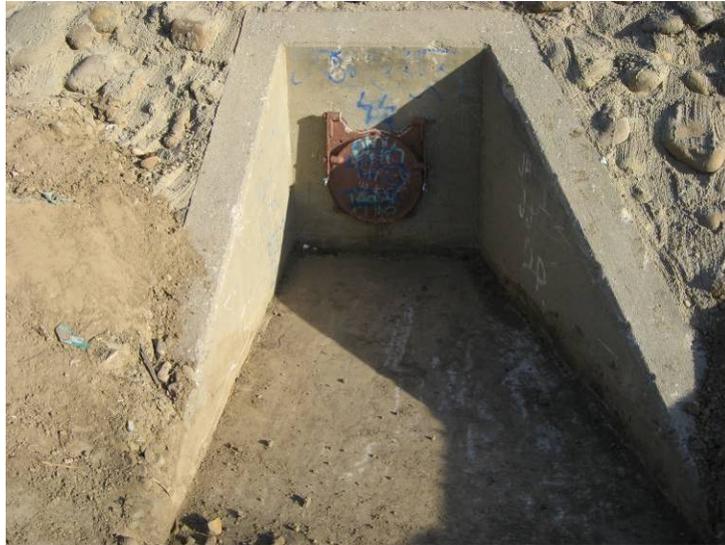
Ventura River Levee, From Ocean to Canada de San Joaquin. (Photo No. P9) - 24" CMP with flap gate, FWY #3 Drain (riverward side)

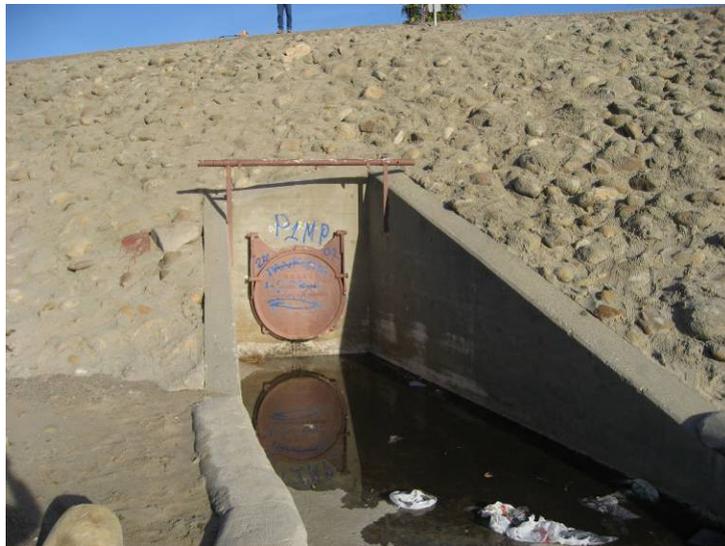
Ventura River Levee, From Ocean to Canada de San Joaquin. (Photo No. P10) - 48" CMP with flap gate, FWY #2 Drain (riverward side)

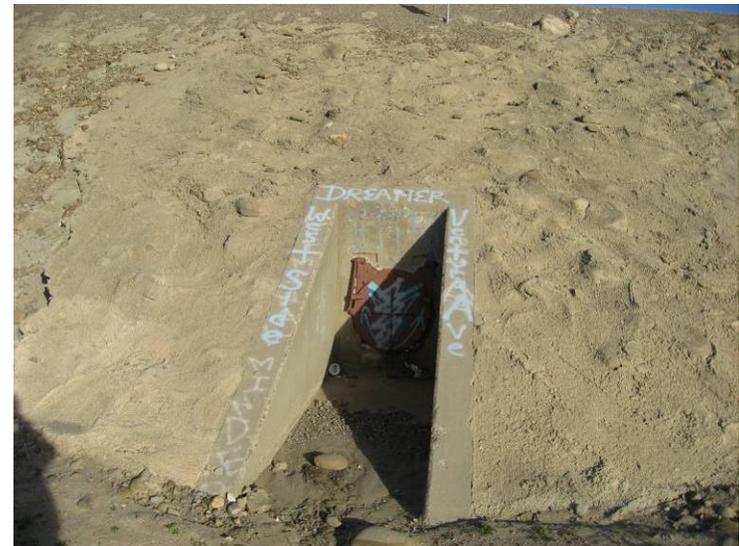
Ventura River Levee, From Ocean to Canada de San Joaquin. (Photo No. P12) - 24" RCP with flap gate, FWY #1 Drain (riverward side)

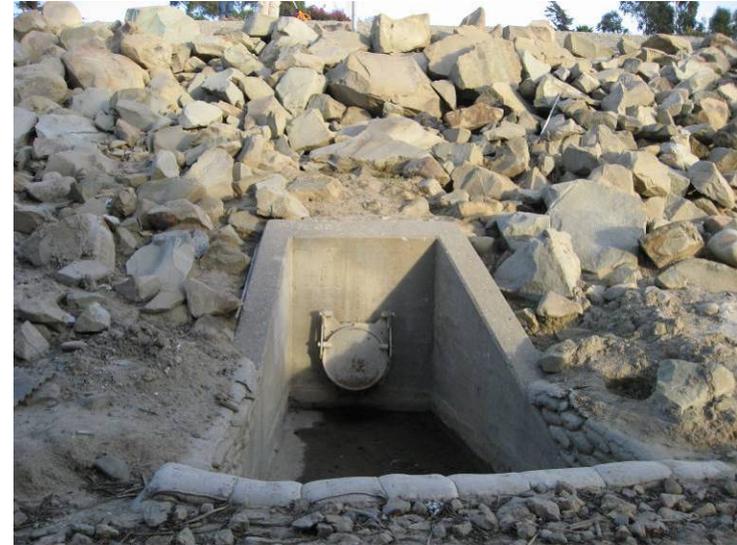
Ventura River Levee, From Ocean to Canada de San Joaquin. (Photo No. P15) - 24" CMP with flap Gate, Peking Drain (riverward side)

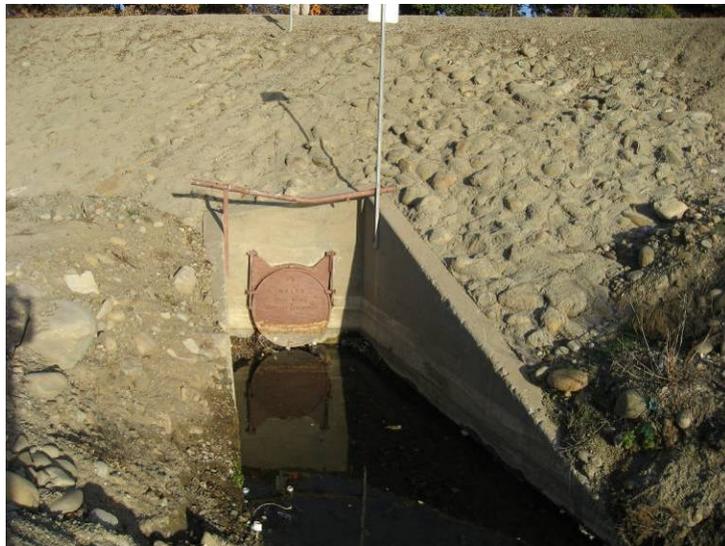
Ventura River Levee, From Ocean to Canada de San Joaquin. (Photo No. P14) - 48" CMP with flap gate, Harrison Drain (riverward side)

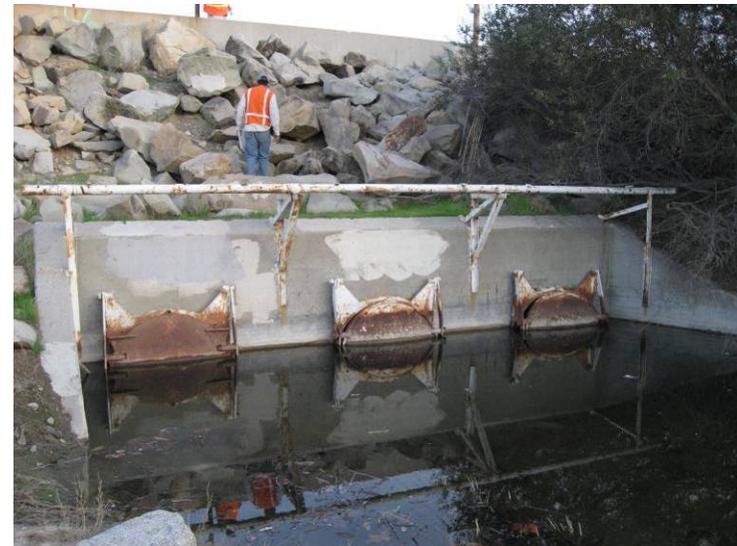
Ventura River Levee, From Ocean to Canada de San Joaquin. (Photo No. P16) - 3-48" CMP with flap gates (riverward side)

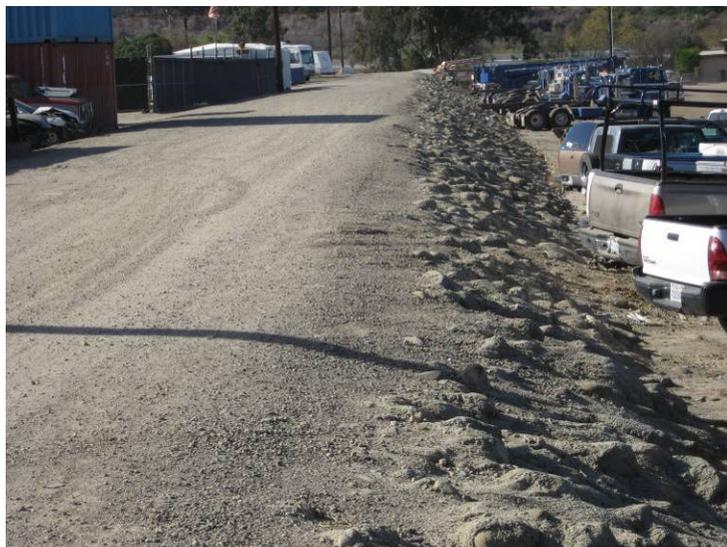
Ventura River Levee, From Ocean to Canada de San Joaquin. (Photo No. F1) – Top of levee looking downstream at grouted levee bank (riverward)

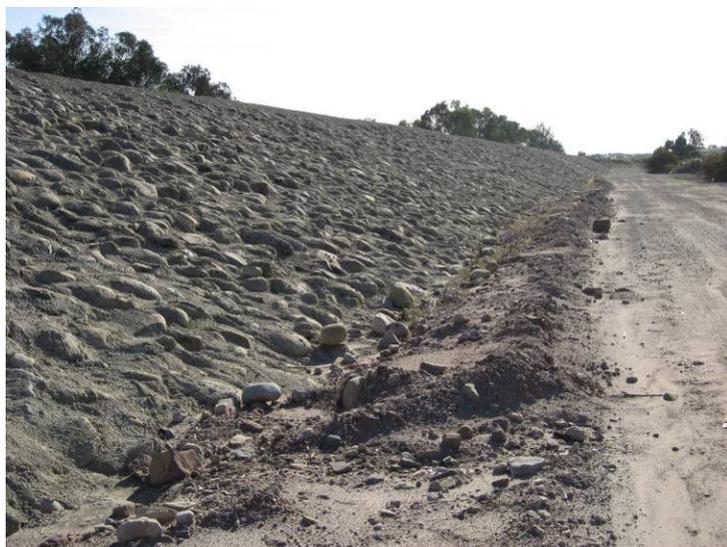
Ventura River Levee, From Ocean to Canada de San Joaquin. (Photo No. F2) – At toe of levee looking downstream (riverward side)

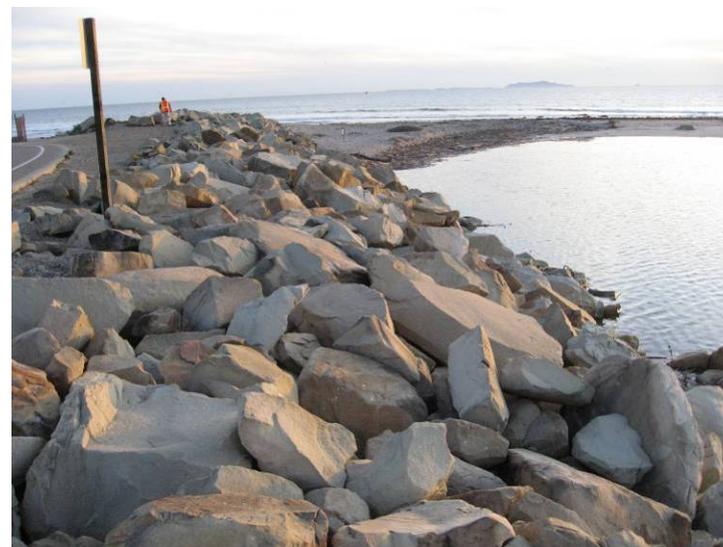
Ventura River Levee, From Ocean to Canada de San Joaquin. (Photo No. F4) – Looking d/s at ungrouted levee bank protection (riverward side)

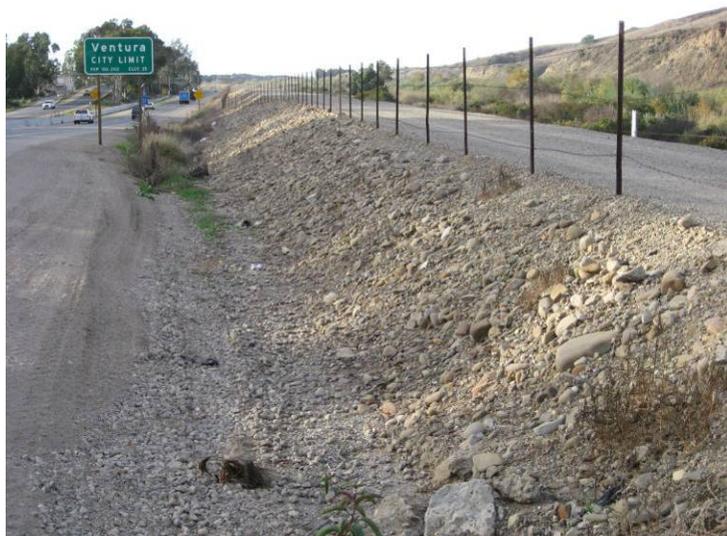
Ventura River Levee, From Ocean to Canada de San Joaquin. (Photo No. F5) – Looking downstream at levee embankment & toe (landward side)

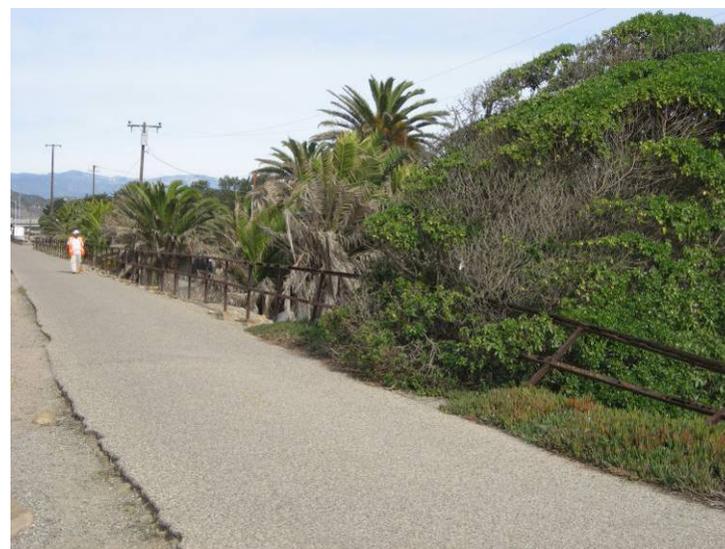
Ventura River Levee, From Ocean to Canada de San Joaquin. (Photo No. F7) – Looking u/s at bike path on top of levee (landward side)

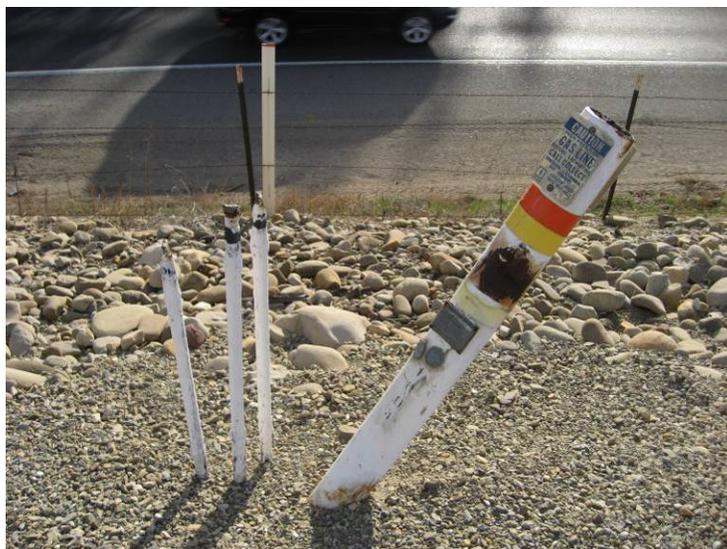
Ventura River Levee, From Ocean to Canada de San Joaquin. (Photo No. F6) – Gas line crossing (landward side)

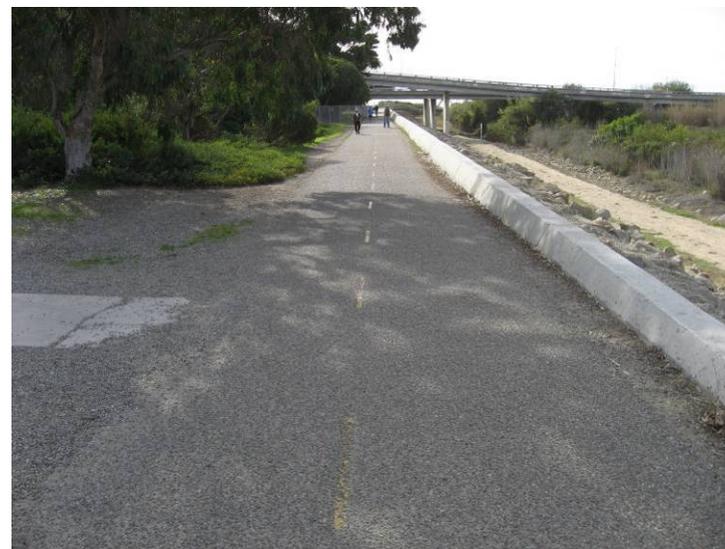
Ventura River Levee, From Ocean to Canada de San Joaquin. (Photo No. F8) – Looking d/s at bike path and flood wall on top of levee
