**FEMA Levee Certification
Ventura County, California**

**Santa Clara River Levee (SCR-1)
Highway 101 to Saticoy**

**Evaluation Report
February 13, 2009**

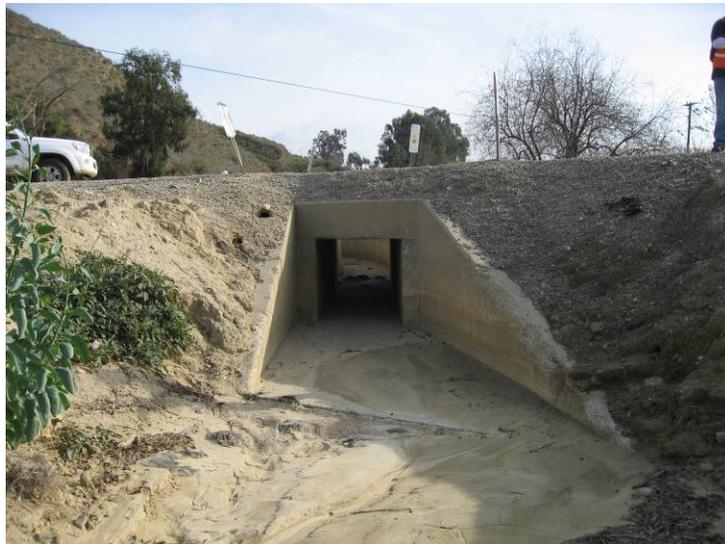
Santa Clara River Levee, From Hwy 101 to Saticoy. (Photo No. P1 – Side drain 1-A, 4' x 4' R.C.B located at upstream end of levee (riverward side))

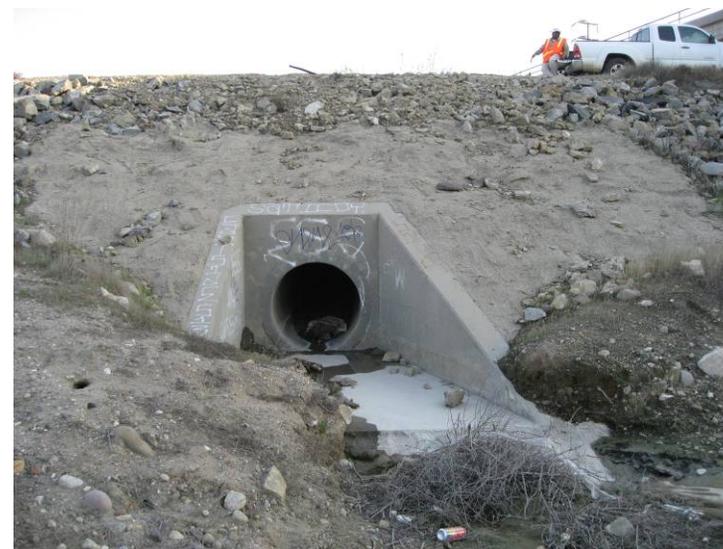
Santa Clara River Levee, From Hwy 101 to Saticoy. (Photo No. P3) – Side Drain No. 2, 48" RCP located just U/S of L.A. Ave. (riverward side)

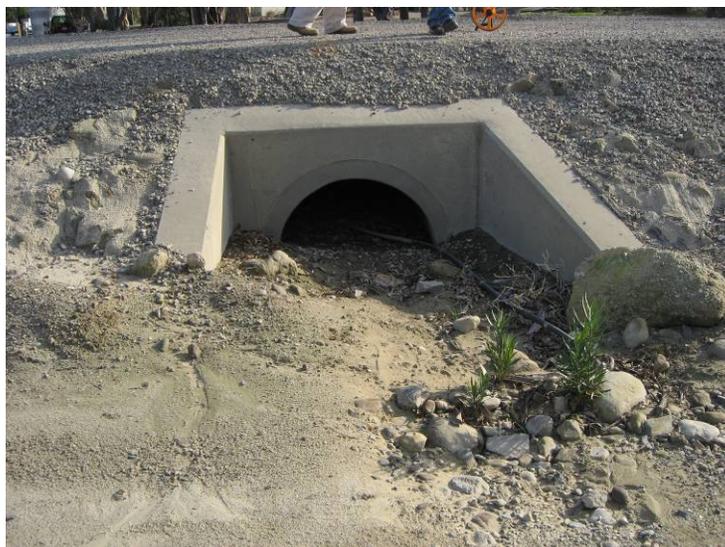
Santa Clara River Levee, From Hwy 101 to Saticoy. (Photo No. P2) – Side Drain No. 1, 42" RCP (riverward side)

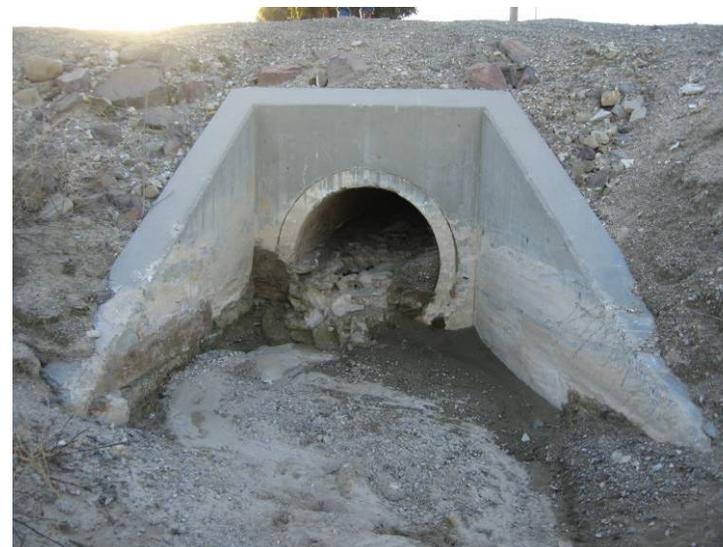
Santa Clara River Levee, From Hwy 101 to Saticoy. (Photo No. P4) – Side Drain No. 3, 48" RCP (riverward side)

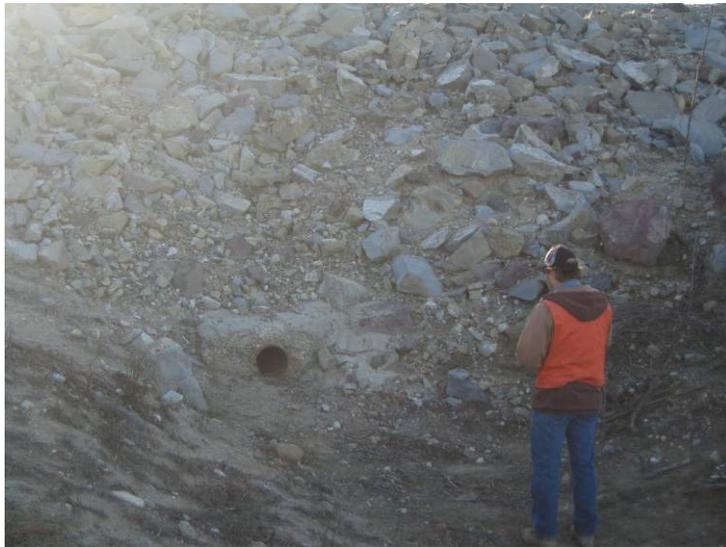
Santa Clara River Levee, From Hwy 101 to Saticoy. (Photo No. P5) – 12” metal pipe, commercial drain from process plant (riverward side)

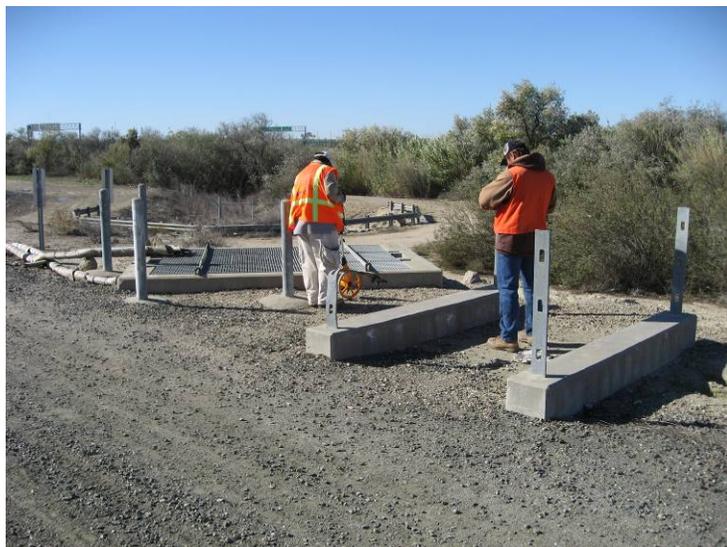
Santa Clara River Levee, From Hwy 101 to Saticoy. (Photo No. P9) –
Stroube Drain – Unit I, Stop Log Structure looking downstream

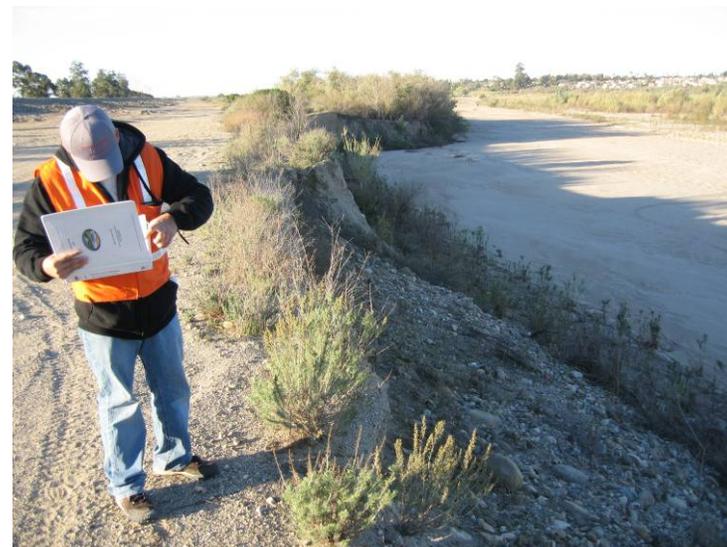
Santa Clara River Levee, From Hwy 101 to Saticoy. (Photo No. F1) –
20' -25' high erosion cut eroding towards levee, looking d/s (riverward)

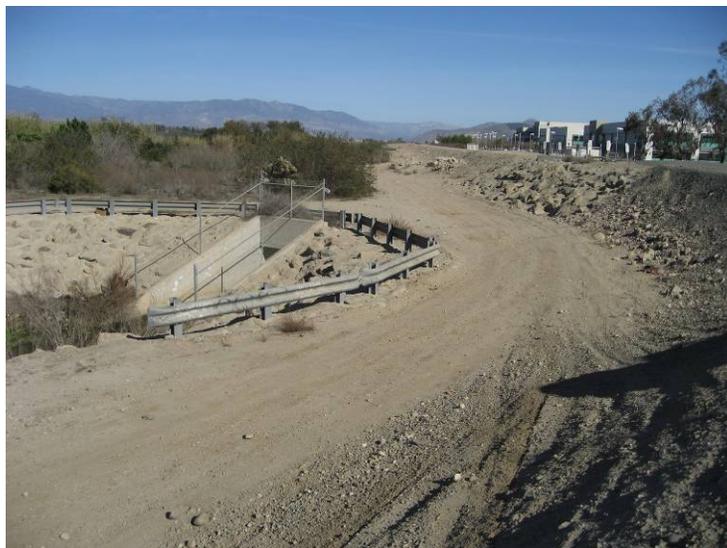
Santa Clara River Levee, From Hwy 101 to Saticoy. (Photo No. P10) –
Stroube Drain – Unit I, 10'Wx8'H RCB looking upstream

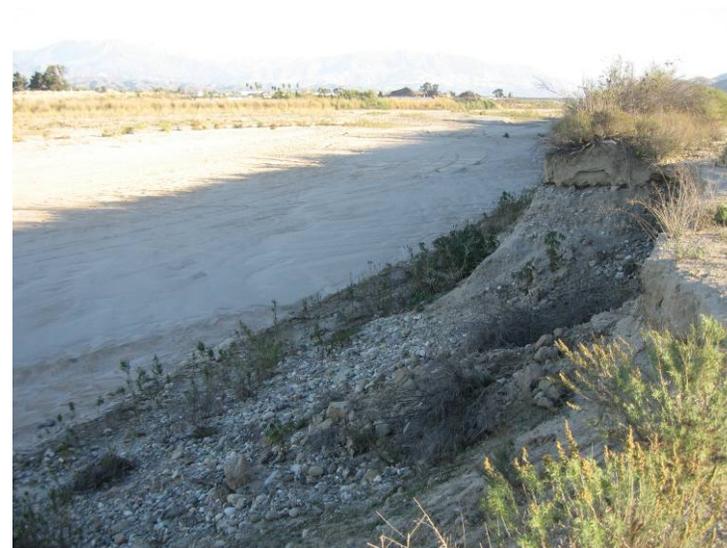
Santa Clara River Levee, From Hwy 101 to Saticoy. (Photo No. F2) –
20' -25' high erosion cut eroding towards levee, looking u/s (riverward)

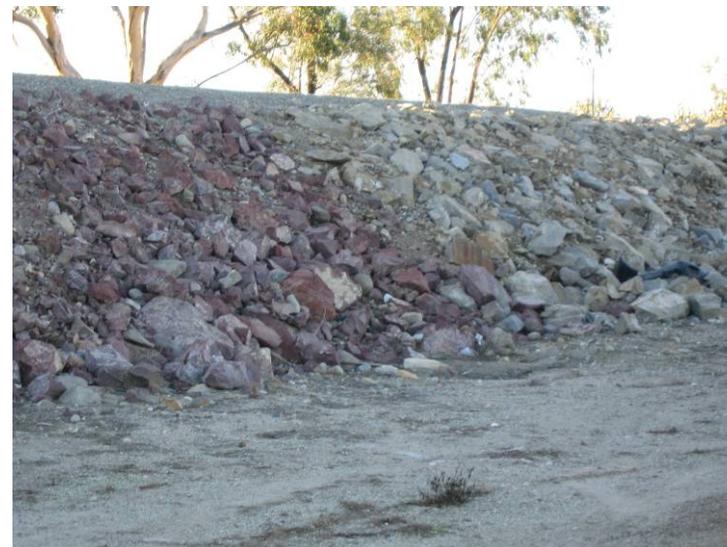
Santa Clara River Levee, From Hwy 101 to Saticoy. (Photo No. F5) – Levee bank stone protection, two different types of stone (riverward side)

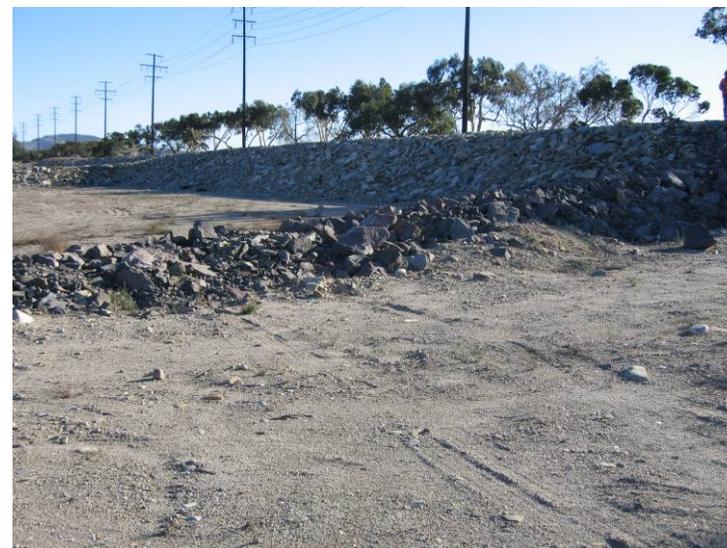
Santa Clara River Levee, From Hwy 101 to Saticoy. (Photo No. F6) – Groin and levee embankment, looking downstream (riverward side)

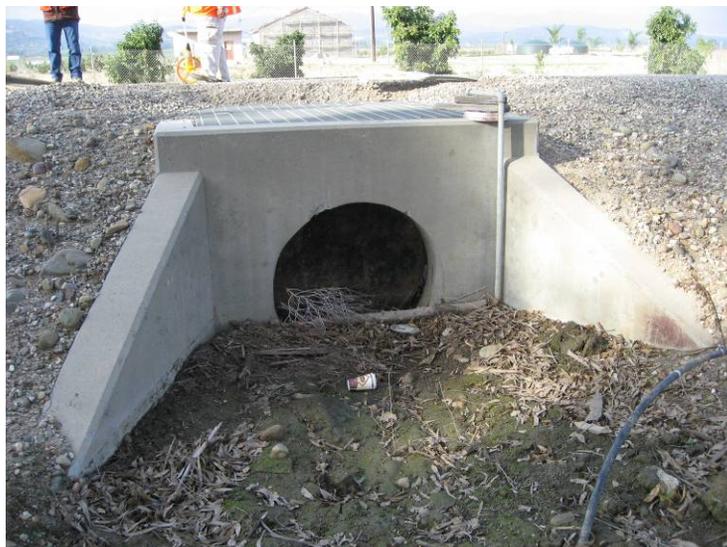
Santa Clara River Levee, From Hwy 101 to Saticoy. (Photo No. M5) –
Sediment deposition in Side Drain No. 1, 42” RCP inlet (landward side)

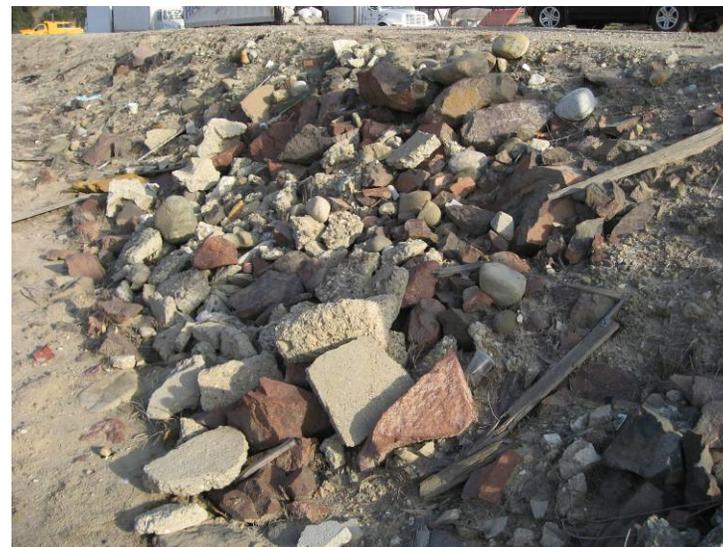
Santa Clara River Levee, From Hwy 101 to Saticoy. (Photo No. M7) –
Wood debris adjacent to nursery looking upstream (riverward side)

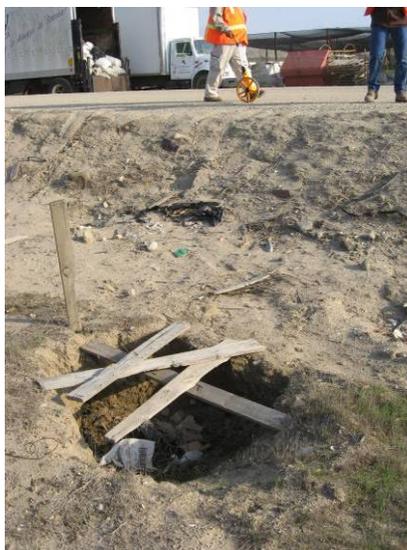
Santa Clara River Levee, From Hwy 101 to Saticoy. (Photo No. M6) –
Wood debris adjacent to nursery looking upstream (riverward side)

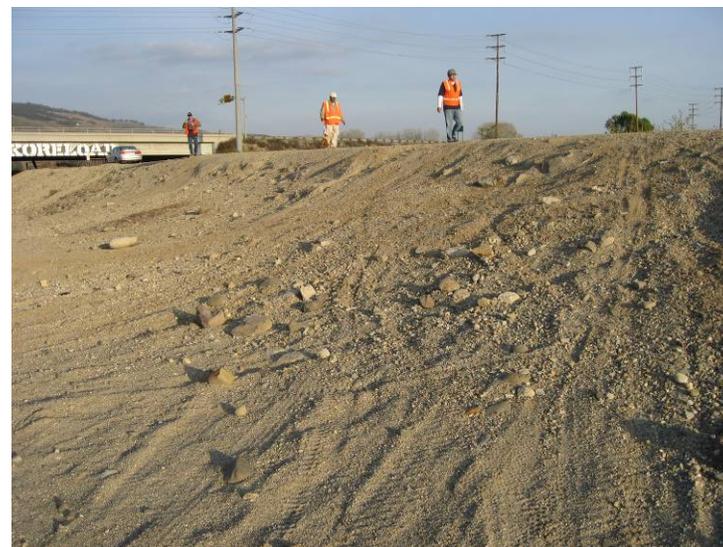
Santa Clara River Levee, From Hwy 101 to Saticoy. (Photo No. M12) –
Erosion of levee embankment just downstream of L.A. Ave.(riverward side)

M11, M12	Levee embankment erosion (riverward side)	Reestablish levee embankment and fill voids with impervious material and firmly compact	C1/C4, or C5 - fencing needed, redesign needed?, How do we stop the vehicle issue?	E2	Excavate & recompact existing levee, in kind		Definition of impervious material	Erosion should be repaired as indicated with in-kind material and documented. Documentation of the removal and replacement/re-compaction of the impacted material shall be conducted by a certified testing and materials lab that the District is familiar with. The documentation shall include a report provided by the testing and materials lab. AMEC will periodically observe these locations and will require a copy of the report for documentation and review. In-kind backfill would be materials free of organic or deleterious debris that has similar or lower permeability than the levee material. These materials could consist of excavated soil, imported soil, concrete, or slurry, and shall be evaluated by the testing and materials lab. compaction requirements are detailed on the attached Figure 1. Major repair examples include any erosion feature that is deeper than 1 foot or that is greater than 2 feet wide. Additionally, revetment protection evaluation including rock sizing analysis should be incorporated in repair of revetment material. Additionally, revetment protection evaluation including rock sizing analysis should be incorporated in repair of revetment material.

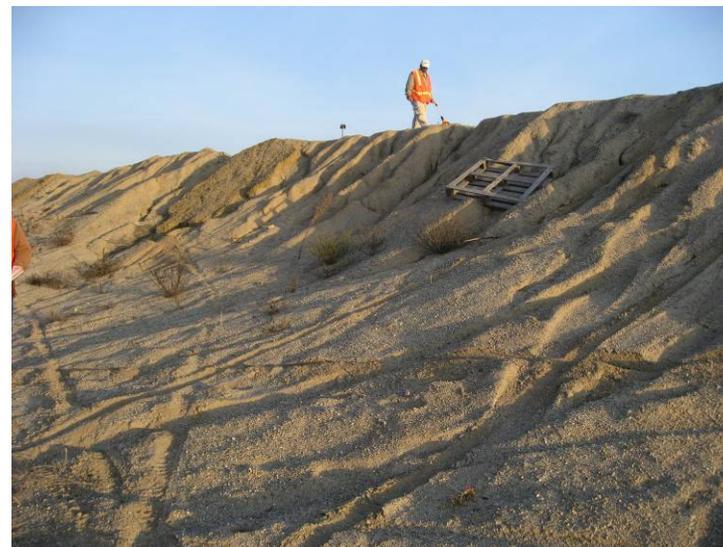
Santa Clara River Levee, From Hwy 101 to Saticoy. (Photo No. M15) –
Erosion of levee embankment, looking upstream (riverward side)

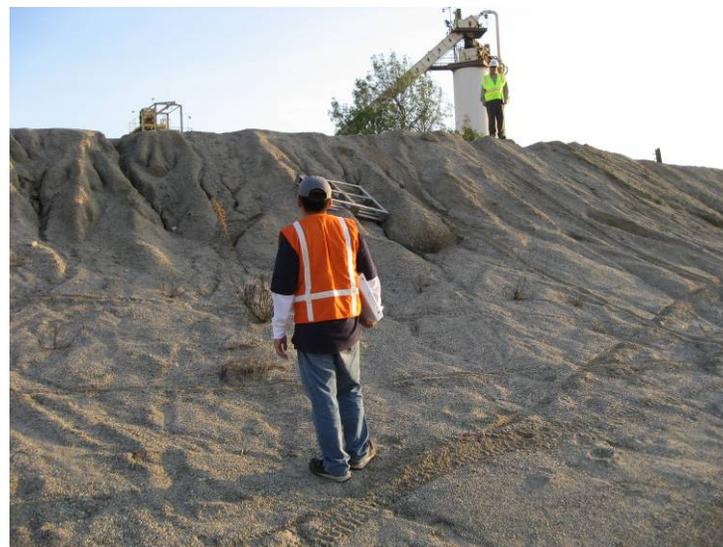
Santa Clara River Levee, From Hwy 101 to Saticoy. (Photo No. M16) –
Erosion of levee embankment, adjacent to asphalt plant (riverward side)

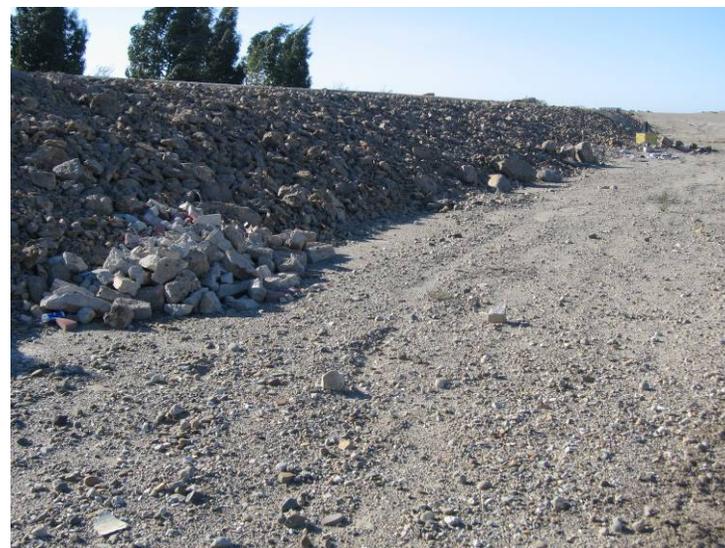
**Santa Clara River Levee, From Hwy 101 to Saticoy. (Photo No. M28) –
Debris along levee toe, looking downstream (riverward side)**

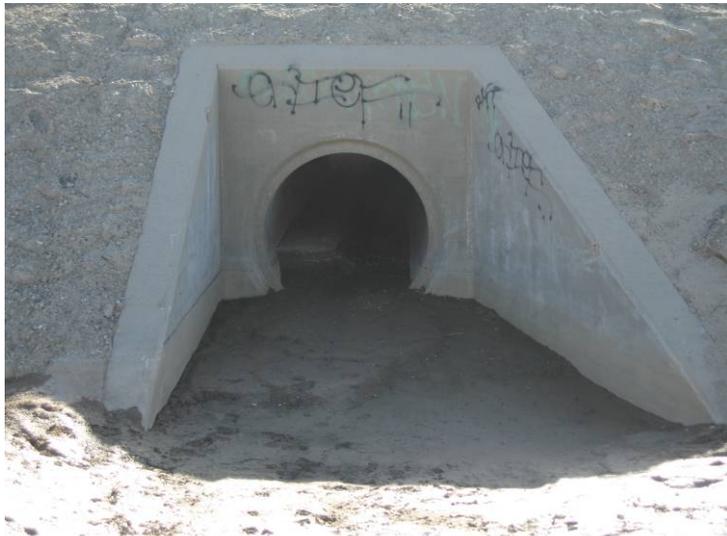
Santa Clara River Levee, From Hwy 101 to Saticoy. (Photo No. M29) – Sediment deposition in Side Drain No. 6, 48” RCP outlet (riverward side)

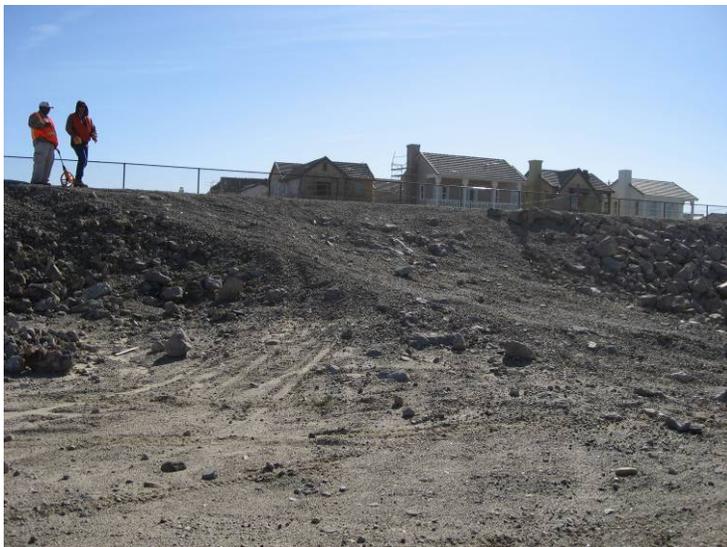
Santa Clara River Levee, From Hwy 101 to Saticoy. (Photo No. M30) – Unauthorized ramp on levee (riverward side)

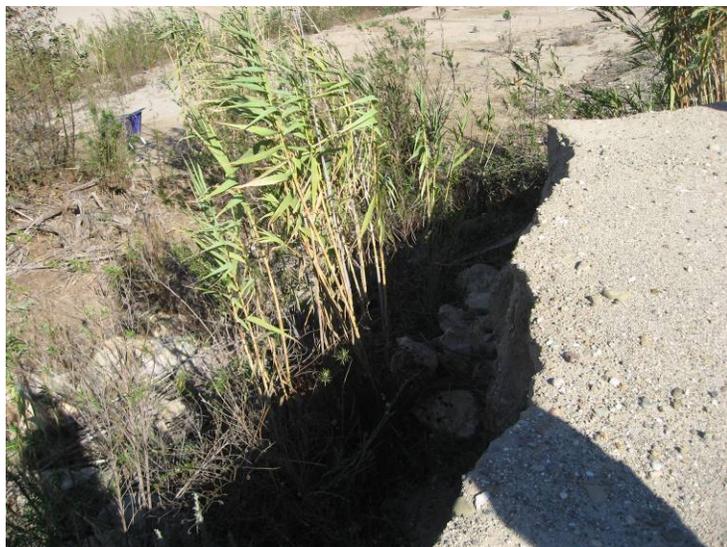
Santa Clara River Levee, From Hwy 101 to Saticoy. (Photo No. M33) – Exposure of tip of buried groin looking downstream (riverward side)

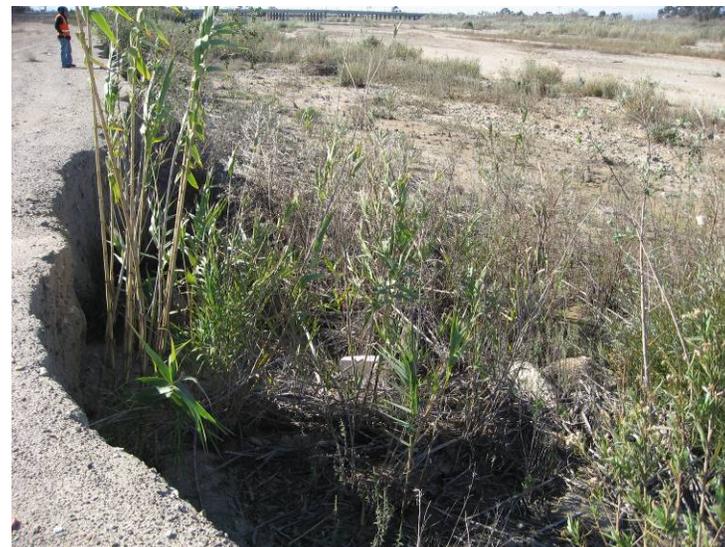
Santa Clara River Levee, From Hwy 101 to Saticoy. (Photo No. M35) – Exposure of tip of buried groin looking downstream (riverward side)

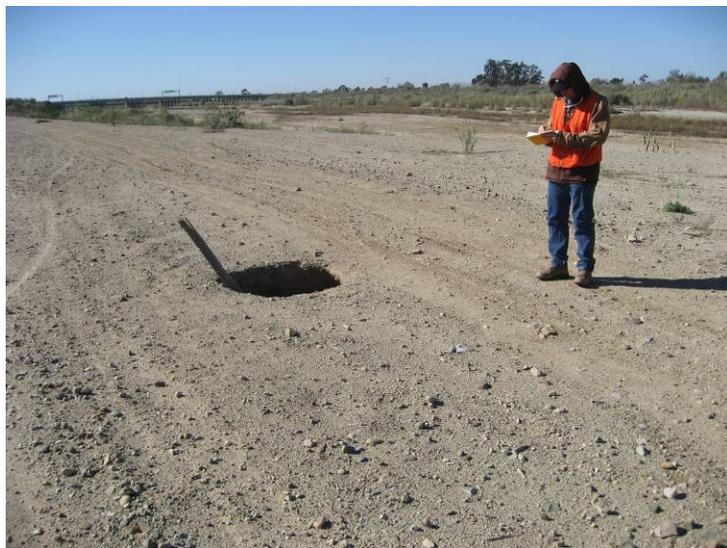
Santa Clara River Levee, From Hwy 101 to Saticoy. (Photo No. M34) – Sink hole in soil covering buried groins looking down/s (riverward side)

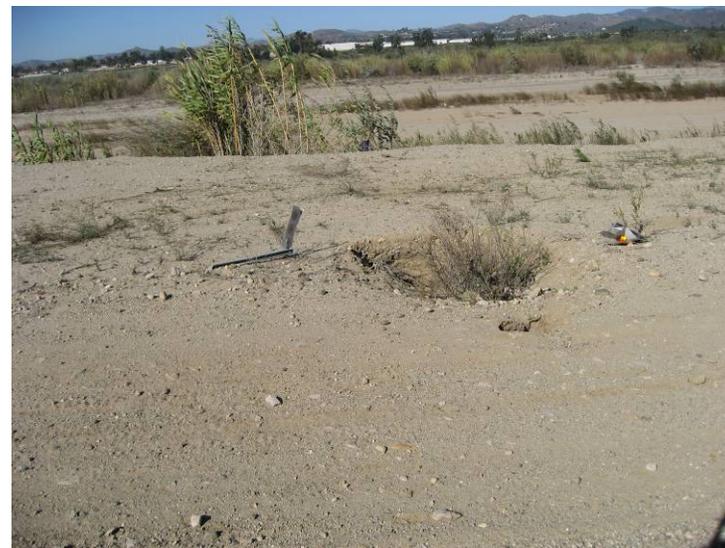
Santa Clara River Levee, From Hwy 101 to Saticoy, (Photo No. M36) – Sink hole in soil covering buried groins (riverward side)

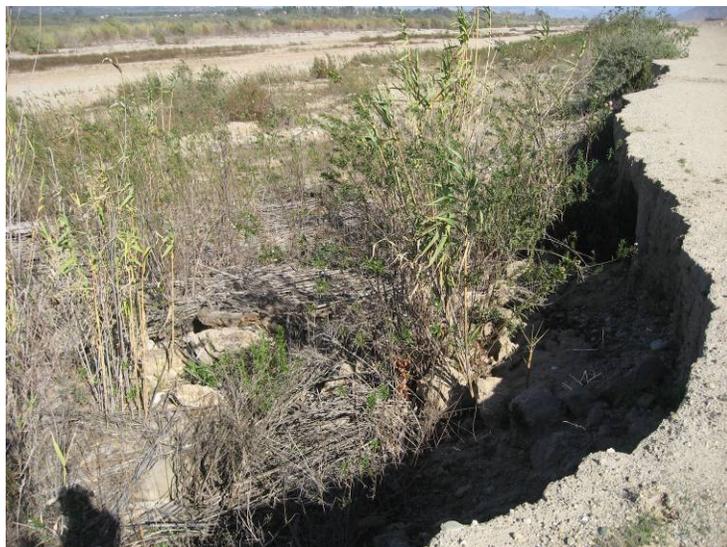
Santa Clara River Levee, From Hwy 101 to Saticoy. (Photo No. M37) – Exposure of tip of buried groin, looking upstream (riverward side)

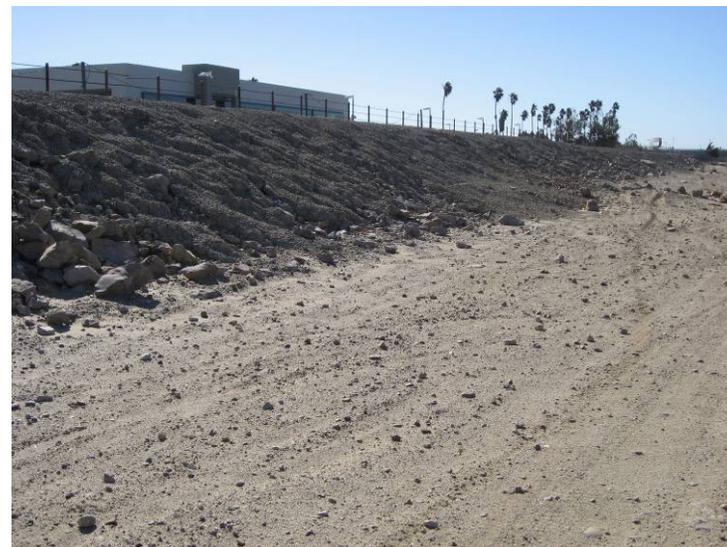
Santa Clara River Levee, From Hwy 101 to Saticoy. (Photo No. M39) – Concrete washout poured over rock protection, looking d/s (riverward side)

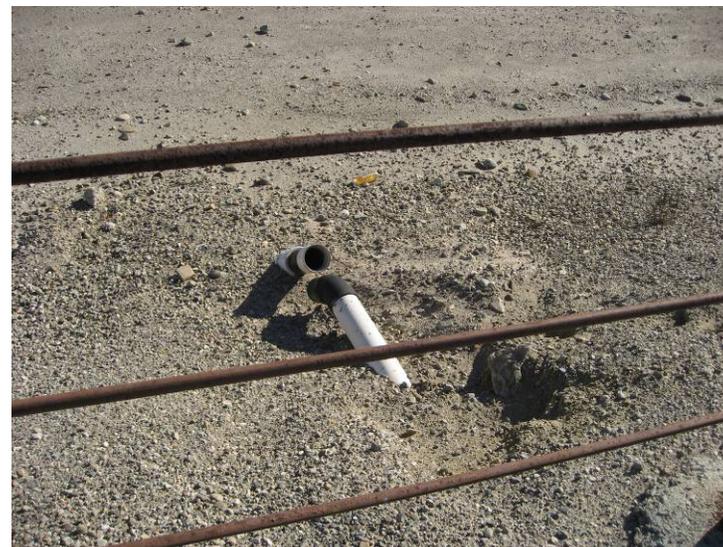
Santa Clara River Levee, From Hwy 101 to Saticoy. (Photo No. M43) –
PVC pipe protruding from levee (landward side)

M43	PVC pipe protruding from top of levee (landward side)	Remove unauthorized PVC pipe and fill voids with impervious material and firmly compact	C1/C4	E1	Excavate & repair in kind			
M44	Erosion on top of levee exposing fence posts (landward side)	Reestablish top of levee and fill voids with impervious material and firmly compact	C1/C4	E1	Repair, redress in kind			
M45	Stone debris approximately 500-feet along levee toe (landward side)	Remove unauthorized stone debris from levee toe	C1/C4	E1	Remove debris			
M46	Erosion on top of levee (landward side)	Reestablish top of levee and fill voids with impervious material and firmly compact	C1/C4	E1	Regrade levee top & bank, in kind repair			
M47, M48	Dumped stone and debris approximately 100 feet along the levee (landward side)	Remove unauthorized stone debris from levee toe	C1/C4	E1	Remove debris			
M49, M50	Sediment deposition in Side Drain No. 4, 48" RCP inlet structure (landward side)	Remove sediment and debris and establish a clear passage from pipe to channel (riverward & landward sides)	C1/C4	E1	Remove sediment & debris

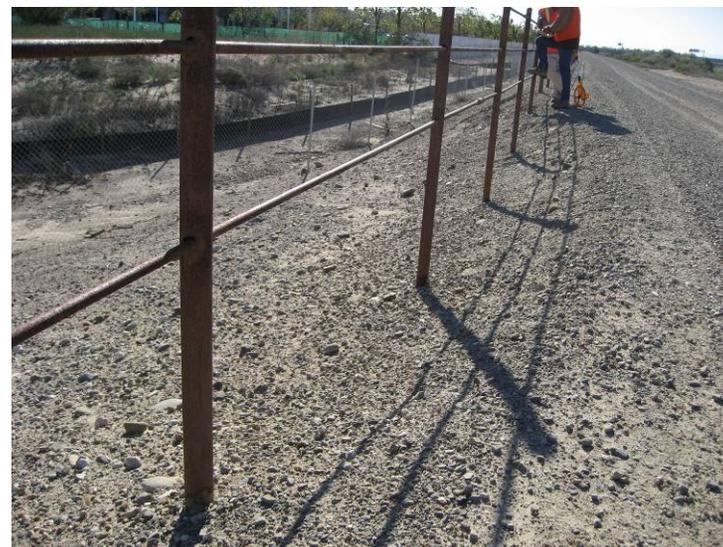
Santa Clara River Levee, From Hwy 101 to Saticoy. (Photo No. M44) –
Erosion on top of levee exposing fence posts, looking d/s (landward side)

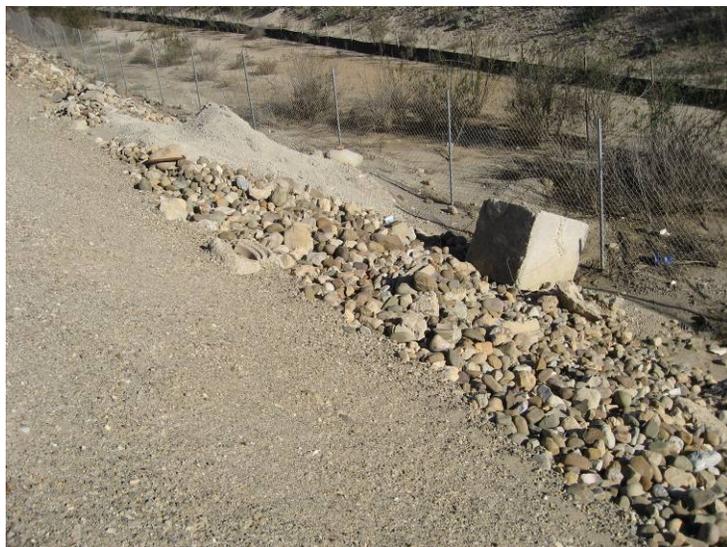
Santa Clara River Levee, From Hwy 101 to Saticoy, (Photo No. M45) –
Stone debris approx. 500' along levee toe, looking u/s (landward side)

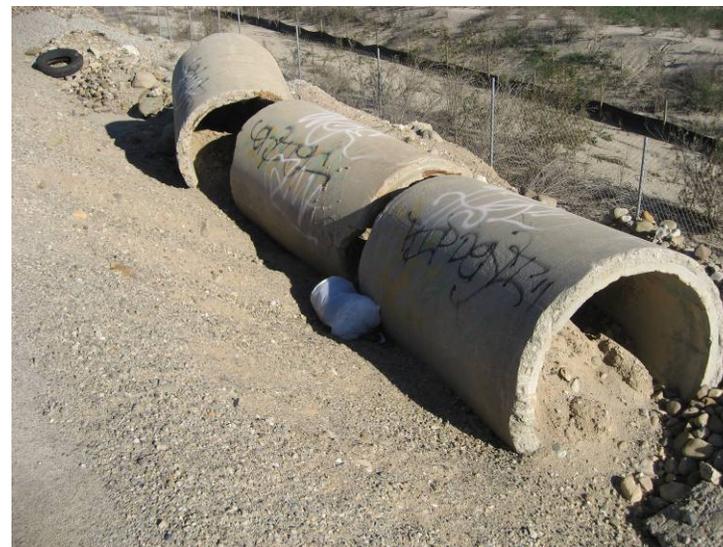
Santa Clara River Levee, From Hwy 101 to Saticoy, (Photo No. M47) –
Debris approx. 100' along levee, looking u/s (riverward side)

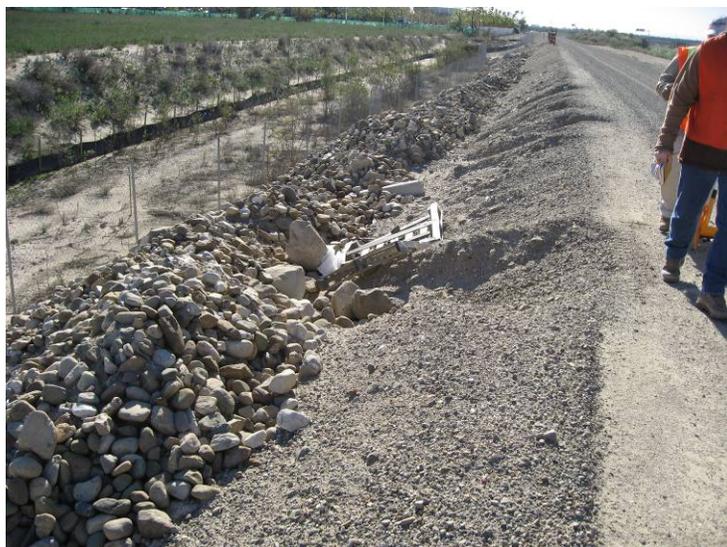
Santa Clara River Levee, From Hwy 101 to Saticoy, (Photo No. M46) –
Erosion on top of levee, looking downstream (riverward side)

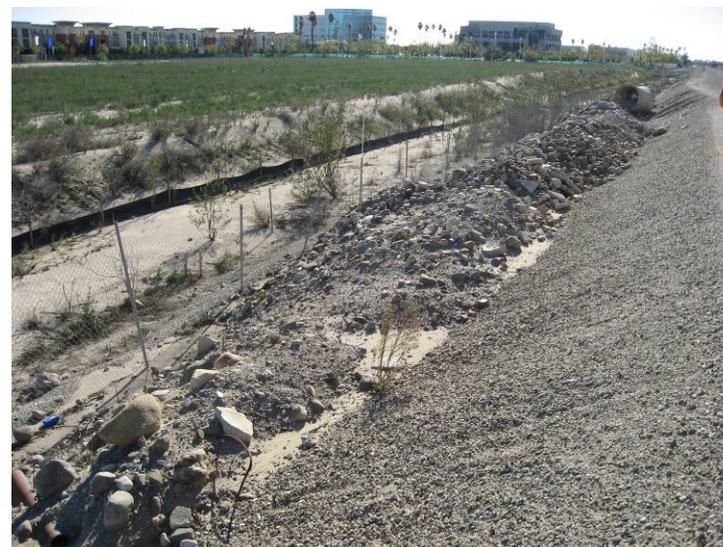
Santa Clara River Levee, From Hwy 101 to Saticoy, (Photo No. M48) –
Debris approx. 100' along levee, looking u/s (riverward side)

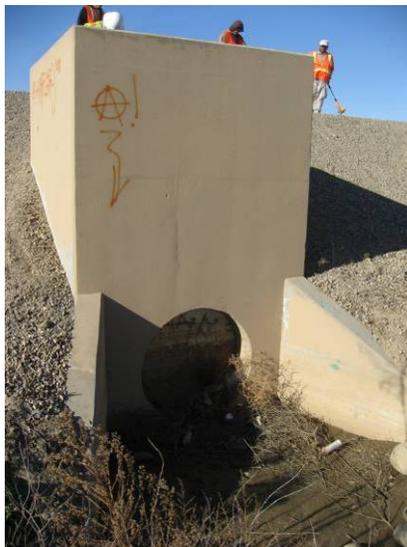
Santa Clara River Levee, From Hwy 101 to Saticoy, (Photo No. M49) –
Sediment deposition in Side Drain No. 4, 48” RCP invert (landward side)

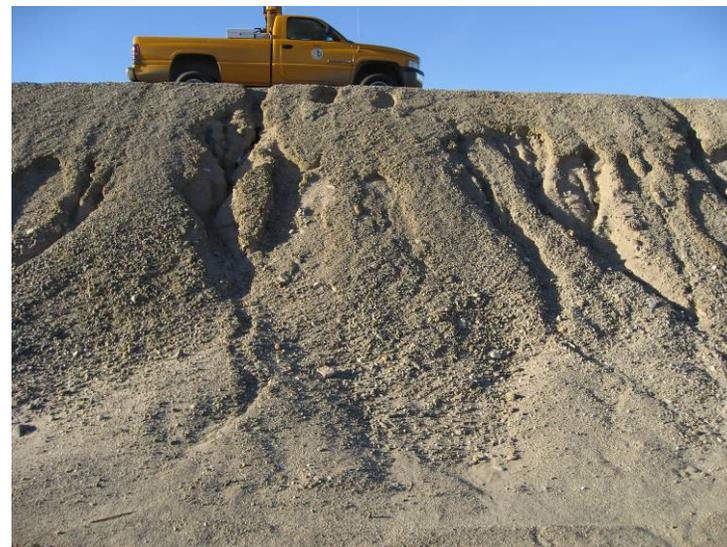
Santa Clara River Levee, From Hwy 101 to Saticoy, (Photo No. M51) –
Erosion on levee embankment, looking upstream (landward side)

M51, M52	Erosion on levee embankment (landward side)	Reestablish levee embankment and fill voids with impervious material and firmly compact	C1/C4	E1	Redress levee slope in kind repair			
M53	Animal burrows near top of levee (landward side)	Remove animal burrows, fill voids with impervious material and firmly compact	C1	E1	Excavate & recompact existing levee, add IPM			
M54	Tree within 15' of levee toe (landward side)	Remove tree and root ball, fill voids with impervious material and firmly compact.	C1/C4	E1	Landward veg removal not regulated	X	Where does the toe start?	The fifteen (15) foot vegetation line is measured from the visual toe of slope to the center line of the trunk (tree), the closest trunk to the toe (multiple trunk trees/plants) or the stock/stem protruding through the soil (large plant connected to a root system)
M55, M56	Trees within 15' along levee toe (landward side)	Remove trees and root ball, fill voids with impervious material and firmly compact.	C1/C4	E1	Landward veg removal not regulated	X	Where does the toe start?	The fifteen (15) foot vegetation line is measured from the visual toe of slope to the center line of the trunk (tree), the closest trunk to the toe (multiple trunk trees/plants) or the stock/stem protruding through the soil (large plant connected to a root system)

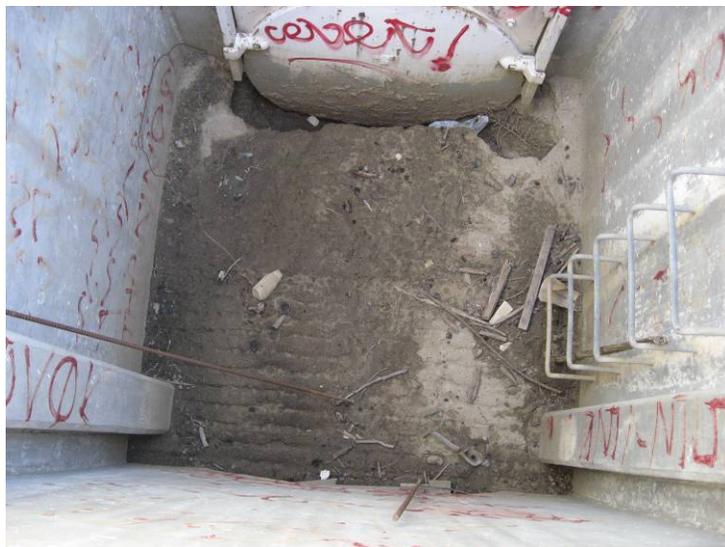
Santa Clara River Levee, From Hwy 101 to Saticoy, (Photo No. M50) –
Looking down at sediment in SD No. 4, inlet structure (landward side)

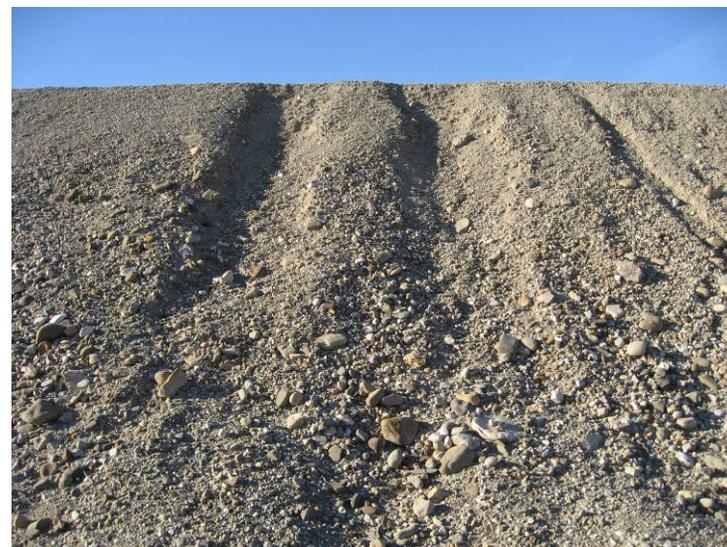
Santa Clara River Levee, From Hwy 101 to Saticoy, (Photo No. M52) –
Erosion on levee embankment, looking downstream (landward side)

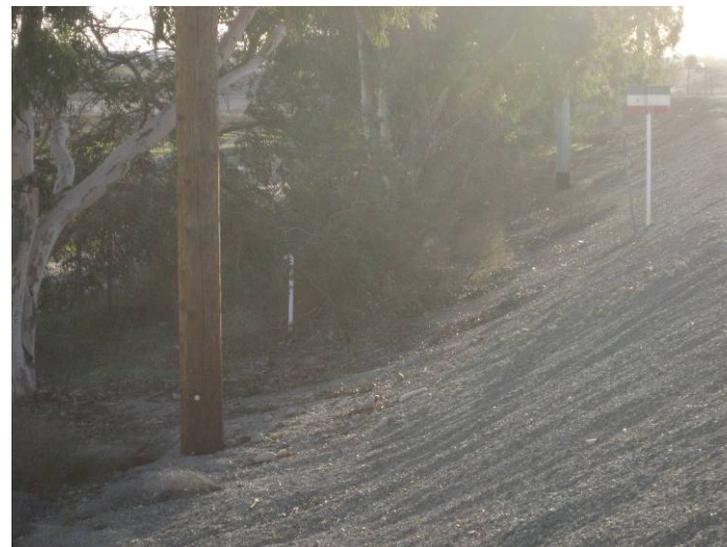
Santa Clara River Levee, From Hwy 101 to Saticoy, (Photo No. M55) –
Trees within 15' of levee toe, looking downstream (landward side)

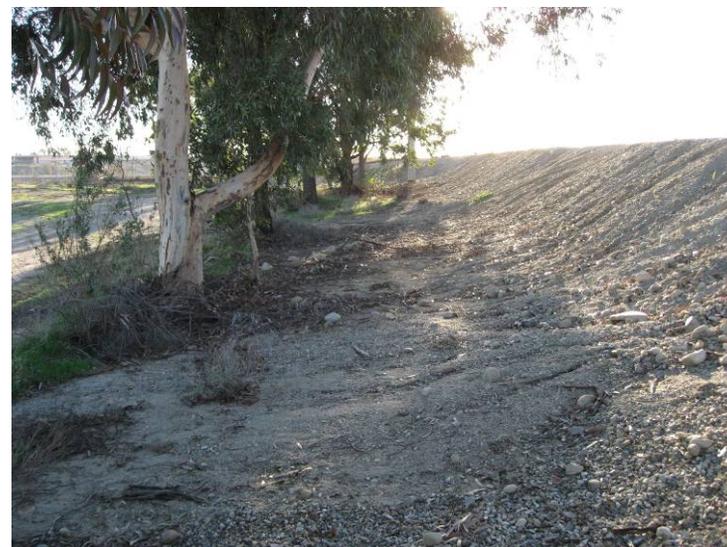
Santa Clara River Levee, From Hwy 101 to Saticoy, (Photo No. M56) –
Trees within 15' of levee toe, looking upstream (landward side)

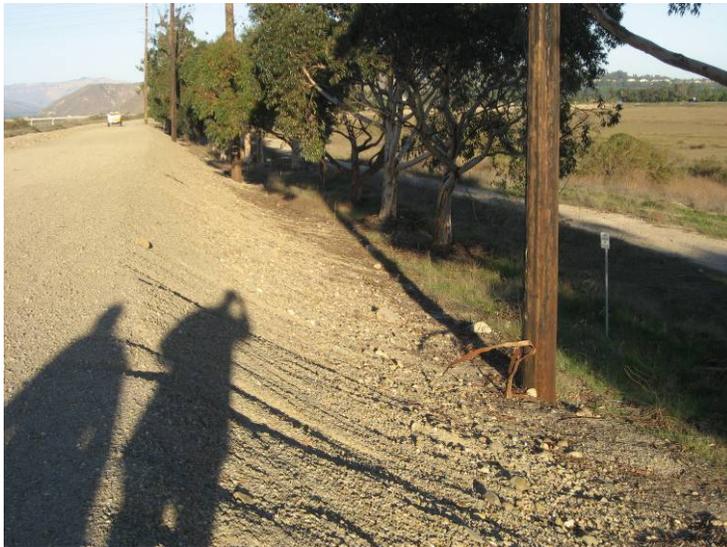
Santa Clara River Levee, From Hwy 101 to Saticoy, (Photo No. M61) –
Power poles on levee embankment, looking upstream (landward side)

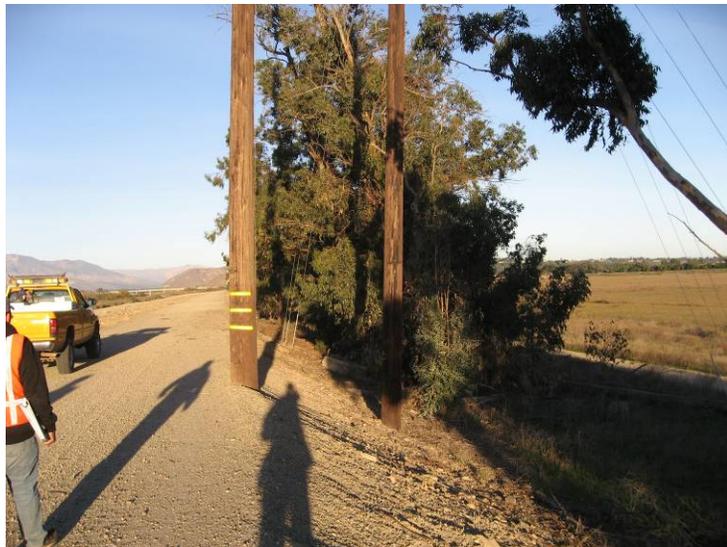
Santa Clara River Levee, From Hwy 101 to Saticoy, (Photo No. M62) –
Power poles on levee embankment, looking upstream (landward side)

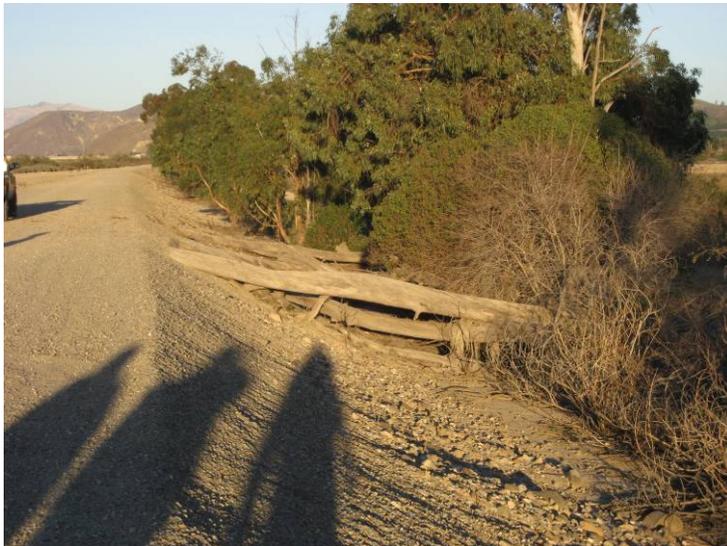
Santa Clara River Levee, From Hwy 101 to Saticoy, (Photo No. M65) –
Trees and fallen trees within 15' of levee toe, looking u/s (landward side)

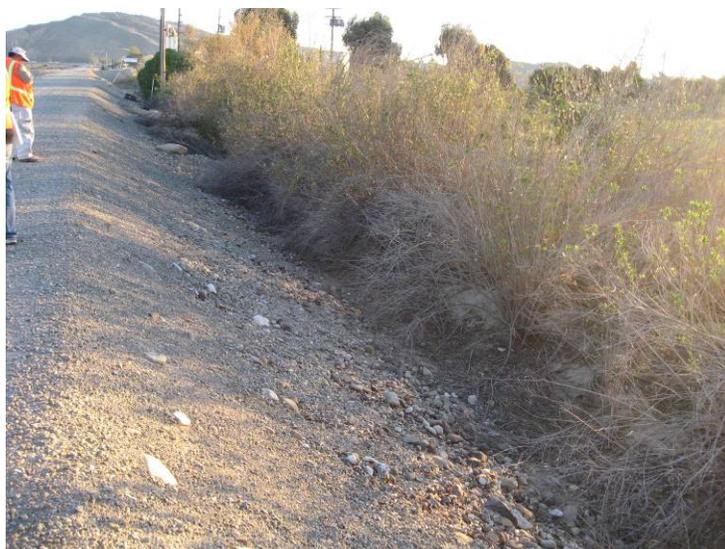
Santa Clara River Levee, From Hwy 101 to Saticoy, (Photo No. M69) –
Vegetation within 15-feet of levee toe, looking u/s (landward side)

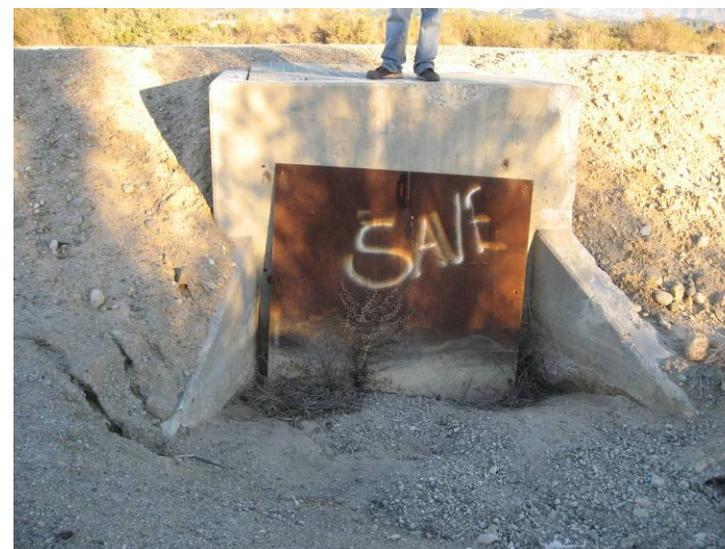
Santa Clara River Levee, From Hwy 101 to Saticoy, (Photo No. M71) –
Sediment & metal debris in Side Drain No. 3 inlet (landward side)

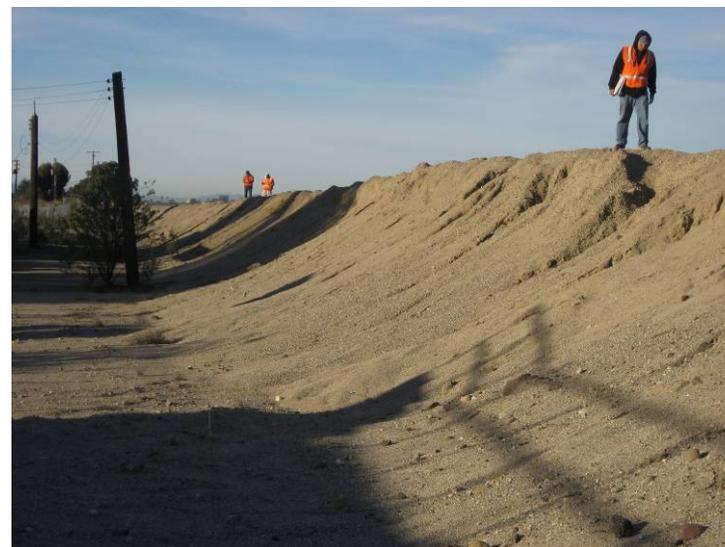
Santa Clara River Levee, From Hwy 101 to Saticoy, (Photo No. M72) –
Erosion on levee embankment, looking downstream (landward side)

M72	Erosion on levee embankment (landward side)	Reestablish levee embankment and fill voids with impervious material and firmly compact	C1/C4	E1	Redress levee slope in kind repair			
M73	Erosion on levee embankment (landward side)	Reestablish levee embankment and fill voids with impervious material and firmly compact	C1/C4	E1	Redress levee slope in kind repair			
M74	Erosion caused by vehicles under Los Angeles bridge crossing (landward side)	Reestablish levee embankment and fill voids with impervious material and firmly compact	C5, Cal-Trans issue	E1	Remove sediment, repair slopes, in kind repair	X	This could be a Cal-Trans issue?	Repair is required
M75, M76	Vegetation within 15-feet of levee toe (landward side)	Remove vegetation and root ball, fill voids with impervious material and firmly compact.	C1/C4	E1	Landward veg removal not regulated			
M77	Erosion at top of levee with miscellaneous debris at toe (landward side)	Repair erosion and remove miscellaneous debris	C1/C4	E1	Redress levee slope in kind repair

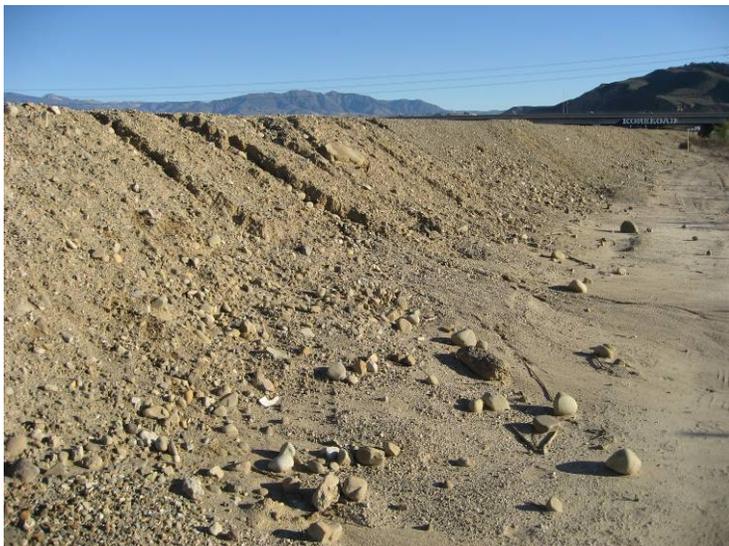
Santa Clara River Levee, From Hwy 101 to Saticoy, (Photo No. M73) –
Erosion on levee embankment, looking upstream (landward side)

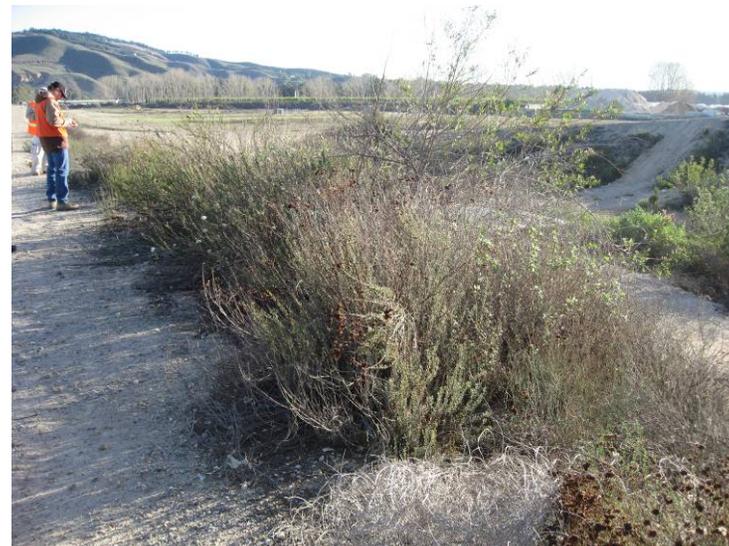
Santa Clara River Levee, From Hwy 101 to Saticoy, (Photo No. M75) –
Vegetation within 15-feet of levee toe, looking downstream (landward side)

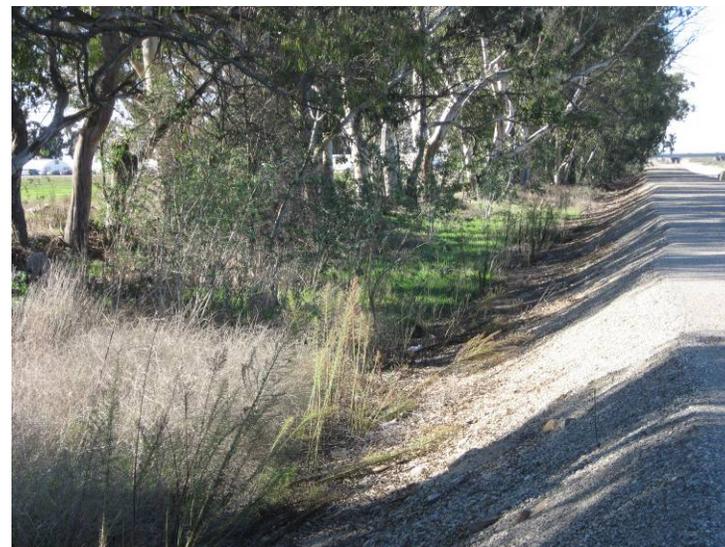
Santa Clara River Levee, From Hwy 101 to Saticoy, (Photo No. M79) –
Trees within 15-feet of levee toe, looking downstream (landward side)

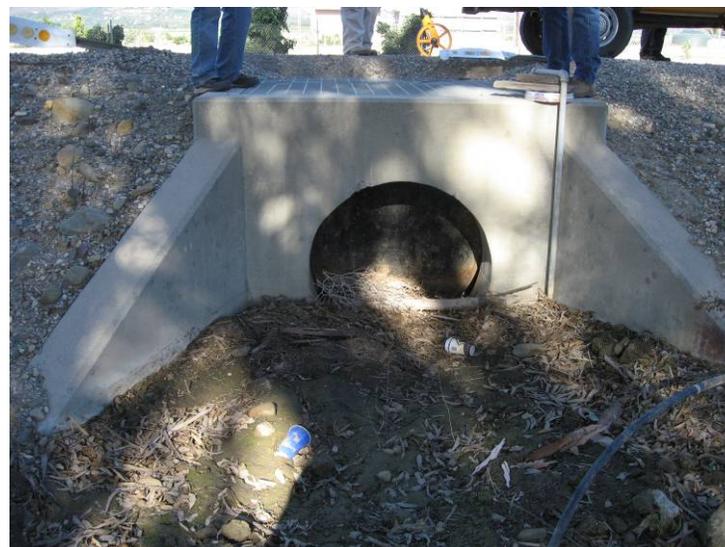
Santa Clara River Levee, From Hwy 101 to Saticoy, (Photo No. M80) –
Sediment and debris in Side Drain No.1, 42” RCP inlet (landward side)

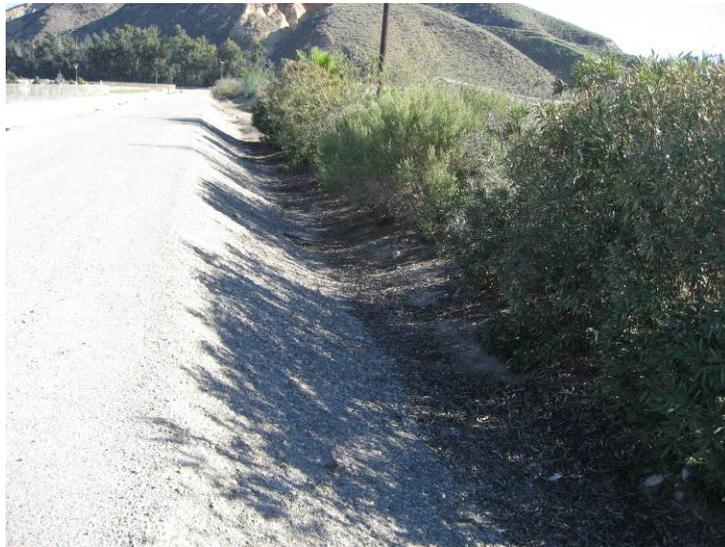
Santa Clara River Levee, From Hwy 101 to Saticoy, (Photo No. M81) –
Vegetation within 15-feet of levee toe, looking upstream (landward side)

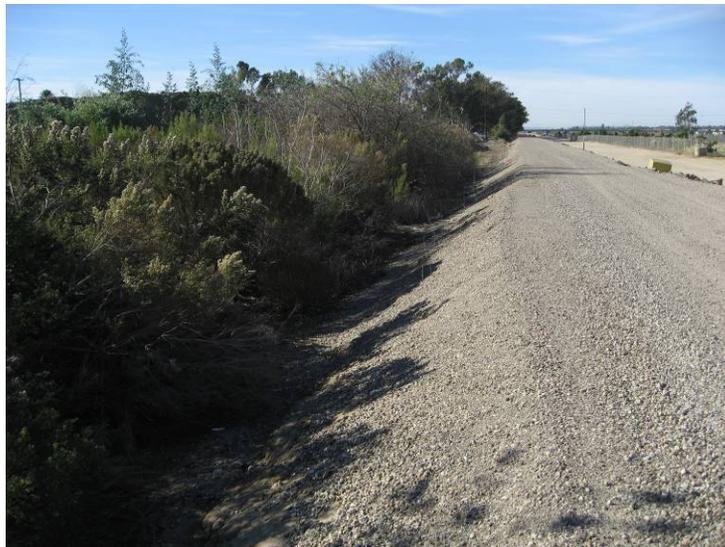
Santa Clara River Levee, From Hwy 101 to Saticoy, (Photo No. M82) –
Vegetation within 15-feet of levee toe, looking downstream (landward side)
