**FEMA Levee Certification
Ventura County, California**

**Ventura River Levee and Floodwall (VR-3)
At Live Oaks**

**Evaluation Report
February 13, 2009**

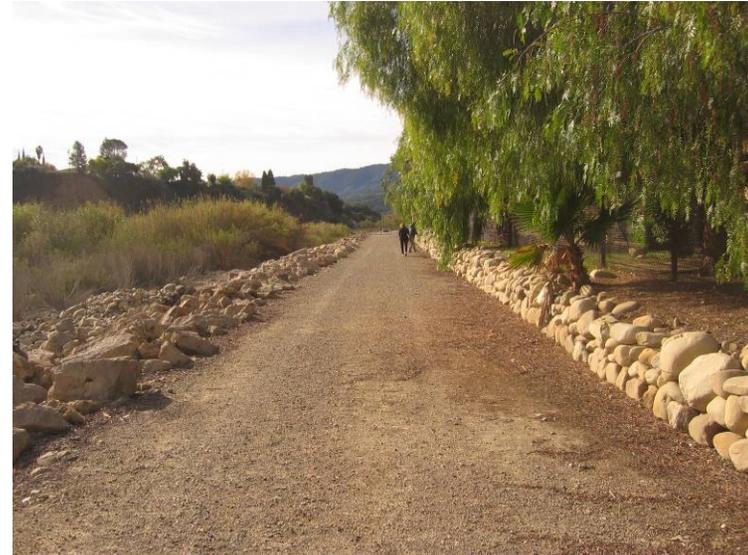
Ventura River Levee and Floodwall (Photo No. F1) – Looking downstream along a top of levee along Ventura River

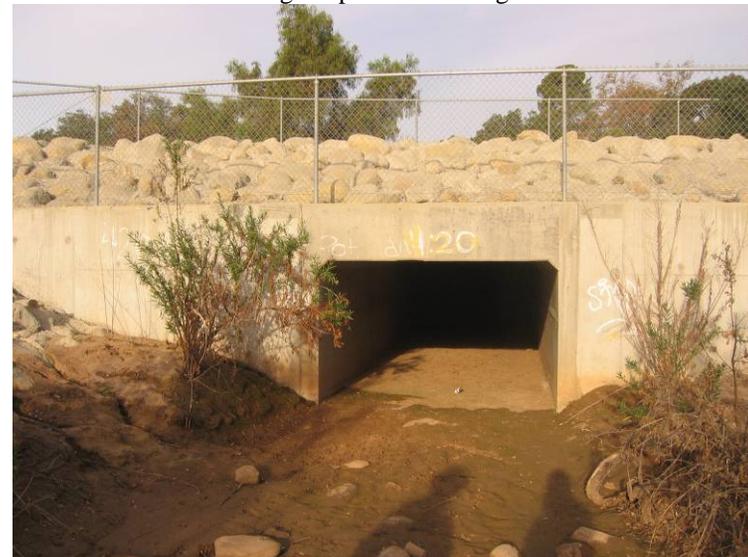
Ventura River Levee and Floodwall (Photo No. F2) – D/S face of 9’x5.6’ RCB outlet for the Live Oak Creek Diversion under Burnham Rd Bridge
