**FEMA Levee Certification
Ventura County, California**

**Arroyo Simi Levee (AS-6)
First Street to Erringer Road**

**Evaluation Report
February 13, 2009**

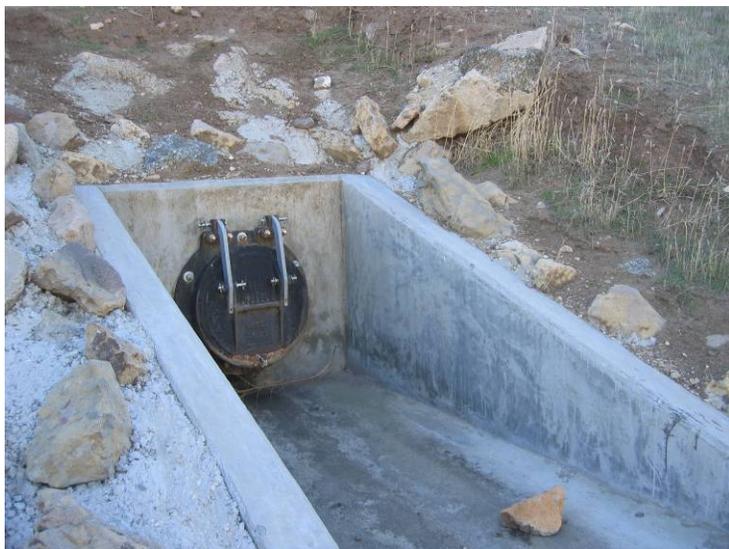
Arroyo Simi AS-6 (Photo No. P2L) – 18" RCP with a Flap Gate and concrete outlet structure

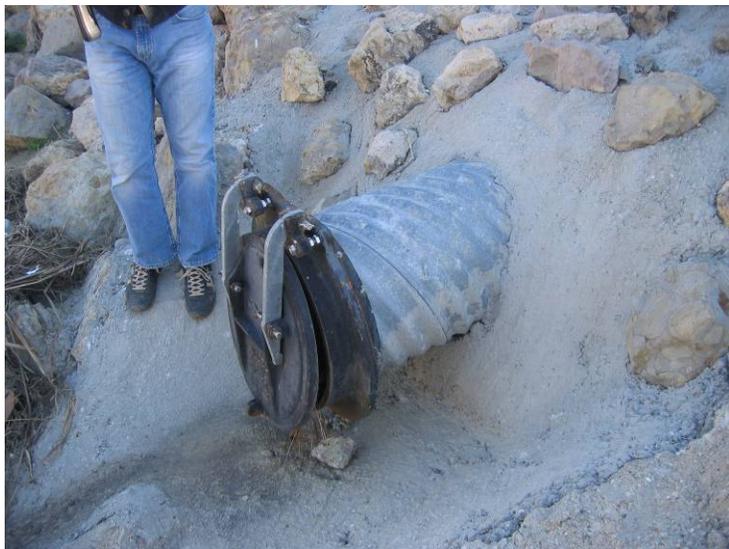
Arroyo Simi AS-6 (Photo No. P5L) – 24" CMP with a Flap Gate. A catch basin is located on the cul-de-sac on the landward side of the levee

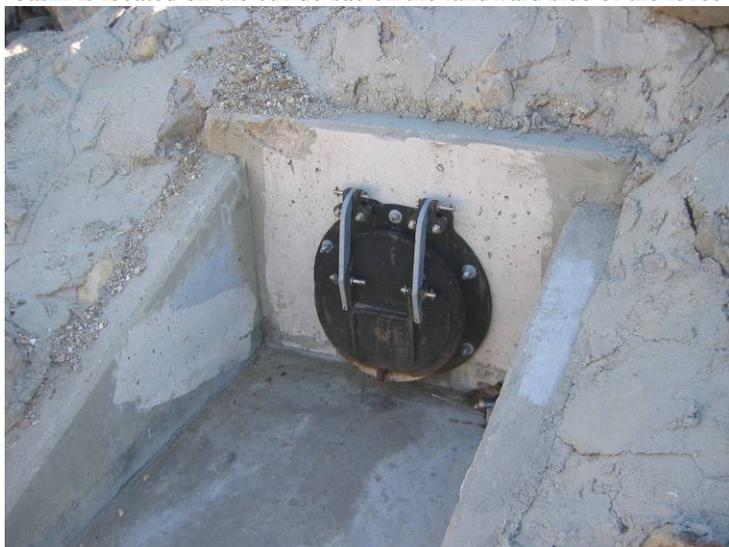
Arroyo Simi AS-6 (Photo No. P6L) – 24" RCP with a Flap Gate and concrete outlet structure

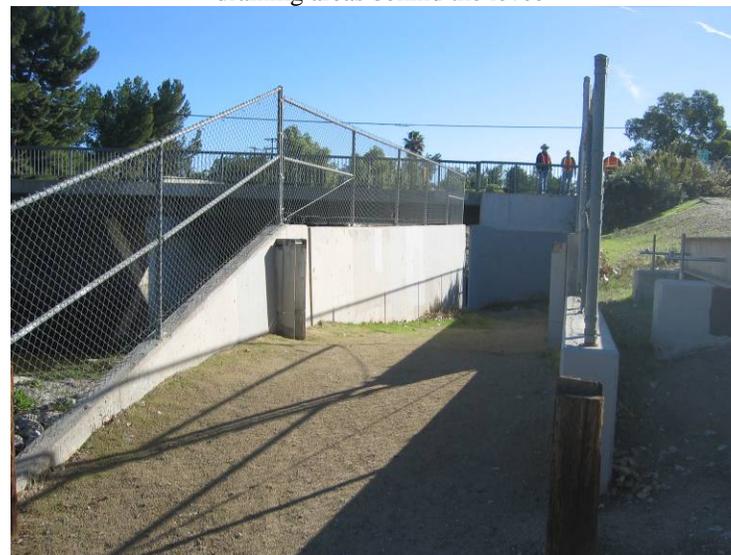
Arroyo Simi AS-6 (Photo No. P12L) – 6-beam sloop log system for access ramp near Erringer Road Bridge.

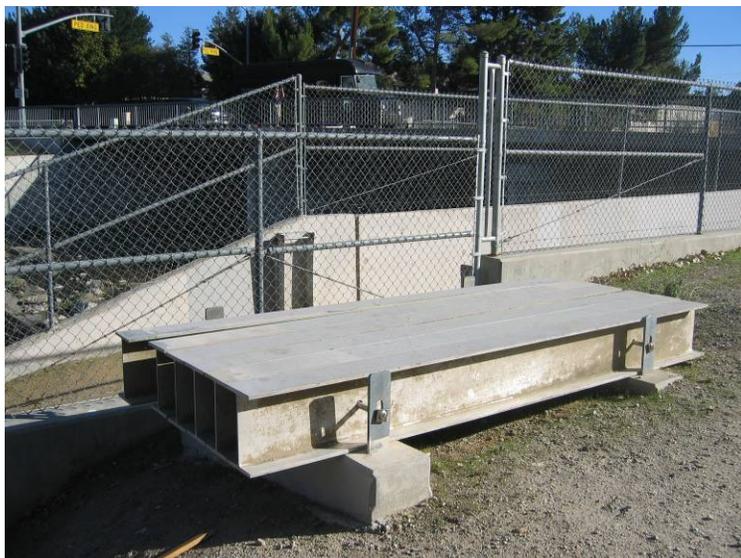
Arroyo Simi AS-6 (Photo No. P13L) – A stockpile of 6 beams for slop log system for access ramp near Erringer Road Bridge

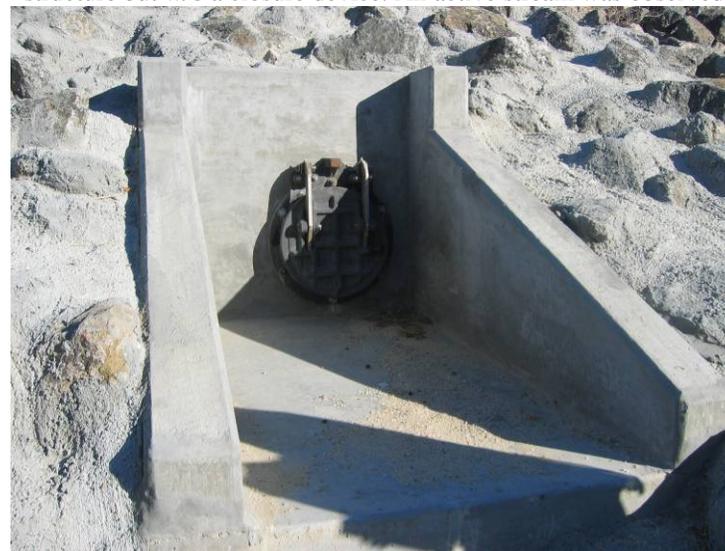
Arroyo Simi AS-6 (Photo No. P12R) – 18" RCP with a Flap Gate and concrete outlet structure

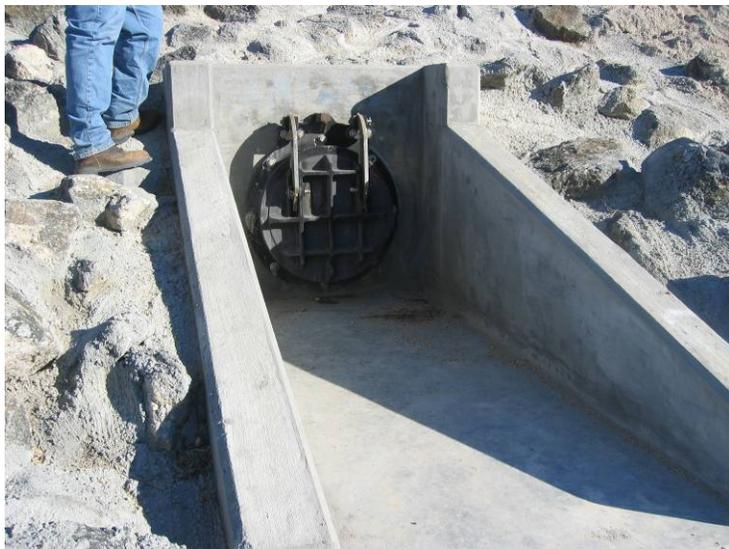
Arroyo Simi AS-6 (Photo No. P13R) – 24" RCP with a Flap Gate and concrete outlet structure

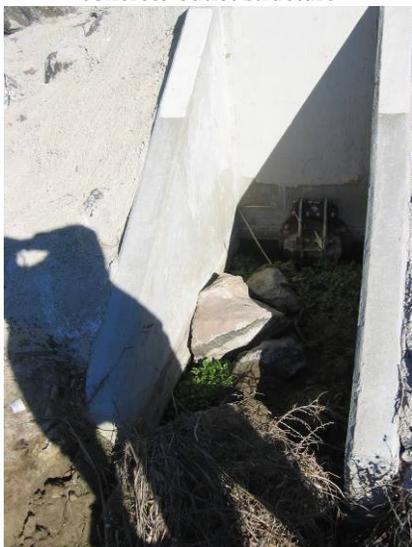
Arroyo Simi AS-6 (Photo No. P14R) – 12" RCP with a Flap Gate and concrete outlet structure

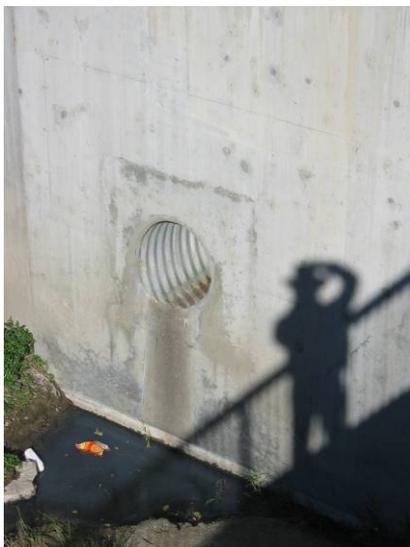
Arroyo Simi AS-6 (Photo No. P18R) – 24" CMP w/o a closure device
through a concrete abutment just downstream of Erringer Road bridge

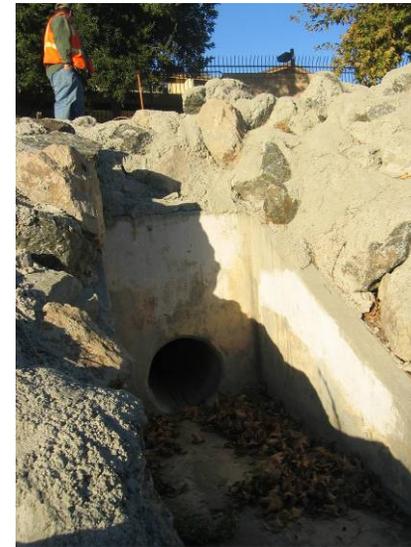
**Arroyo Simi (AS-6), (Photo No. M3R) – 24" RCP w/o a closure device
(Sta.69+38)**

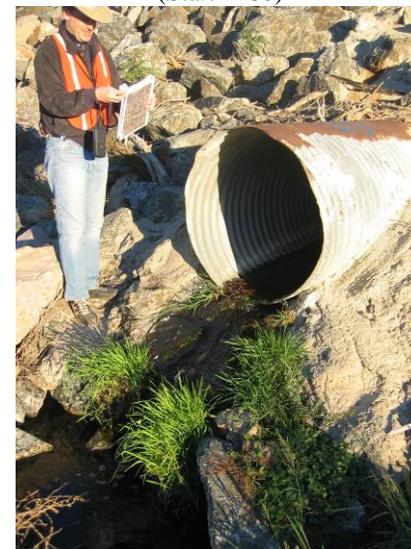
Arroyo Simi (AS-6), (Photo No. M8R) – 36” CMP w/o a closure device (Sta.77+90)

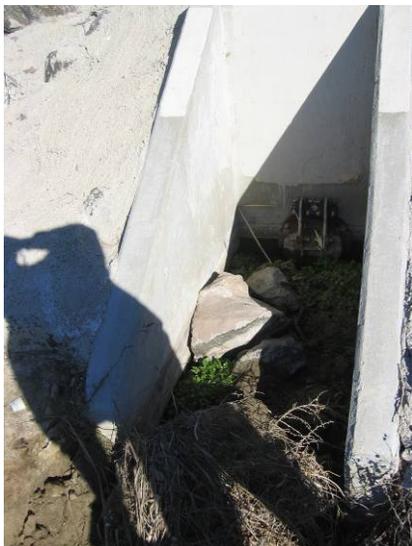
Arroyo Simi (AS-6), (Photo No. M17R) – Debris inside an outlet structure for 12" RCP with a flap gate (Riverward side)

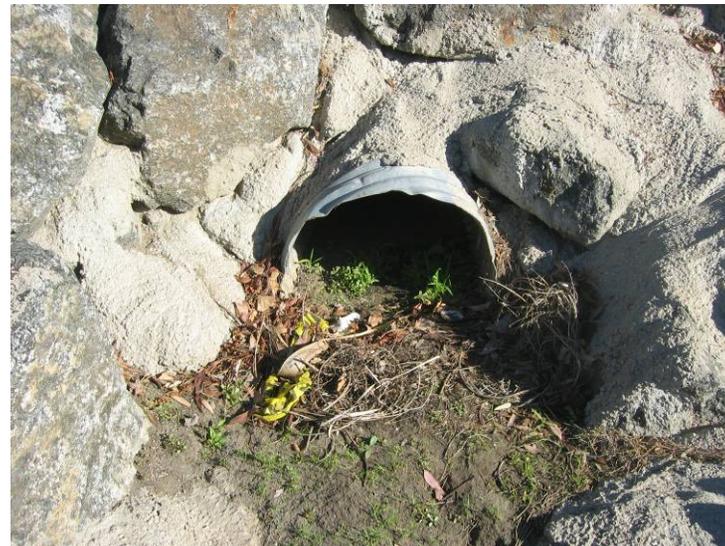
Arroyo Simi (AS-6), (Photo No. M19R) – 24" CMP w/o a closure device (Sta.113+85)

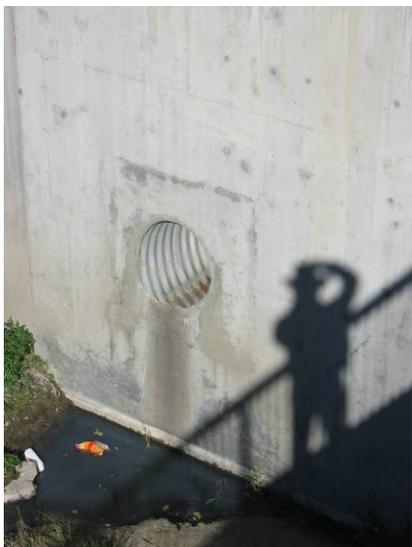
**Arroyo Simi (AS-6), (Photo No. M21R) – 24" CMP w/o a closure device
(Sta.117+15)**

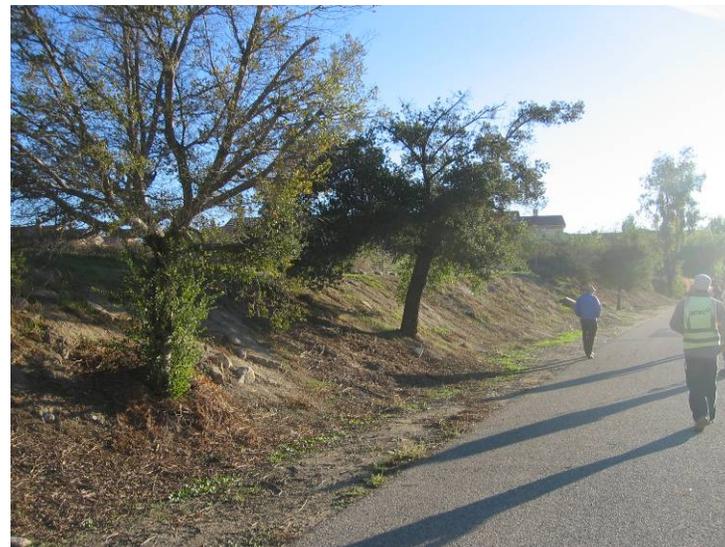
**Arroyo Simi (AS-6), (Photo No. M23R) – Vegetation within 15' of Toe
(Landward Side)**
